Routine Inspection Report

Date: 07/09/2018

Location: Maghtab Environmental Complex, I/o Bahar ic-Caghaq, Malta

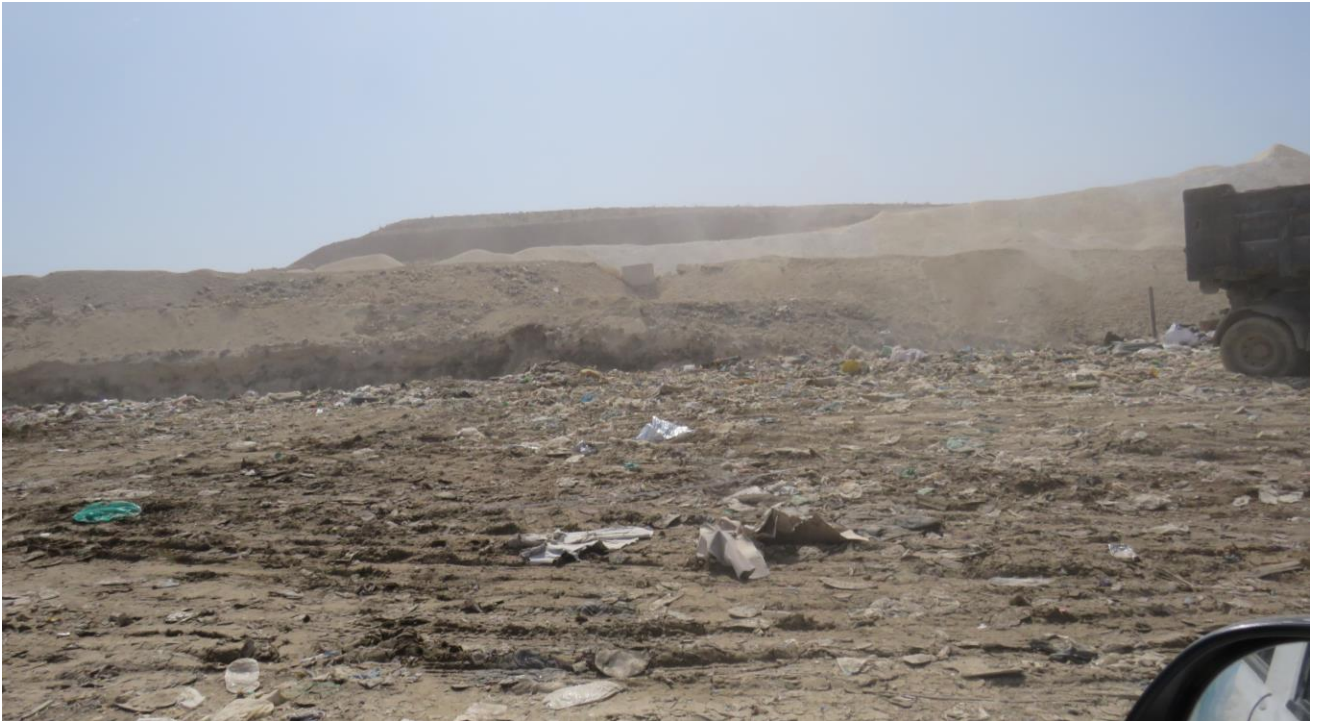
Aspect	Detailed Observations	Actions Required by Operator
Odours in and Around the Facility	Odours on the way to and within the facility were considered normal for the operations being carried out at the time.	N/A
Tipping Face (Cell 8)	<p>The officers inspected the tip face and discussed the decreasing void space available for backfilling and the urgent need for Cell 9 to start being utilised (see Photo 1).</p> <p>The waste acceptance procedure at Ghallis was discussed and it was established that at no point in the facility's operations were all trucks delivering waste being diverted to MBT North prior to reaching the tipping face. Evidence of mixed loads which include potentially recyclable material such as wood, plastics and cardboard were noted on the tipping face.</p>	<p>See point related to Cell 9 below.</p> <p>In view of the limited void space available left for backfilling, notwithstanding the burden on MBT North due to the burning down of the Sant'Antnin Waste Treatment Plant, operator should submit a proposal in order to decrease the amount of landfilled material as part of the renewal and variation process for Ghallis Non-Hazardous Landfill.</p>

Photo 1: Cell 8 levels showing minimal amount of void space left

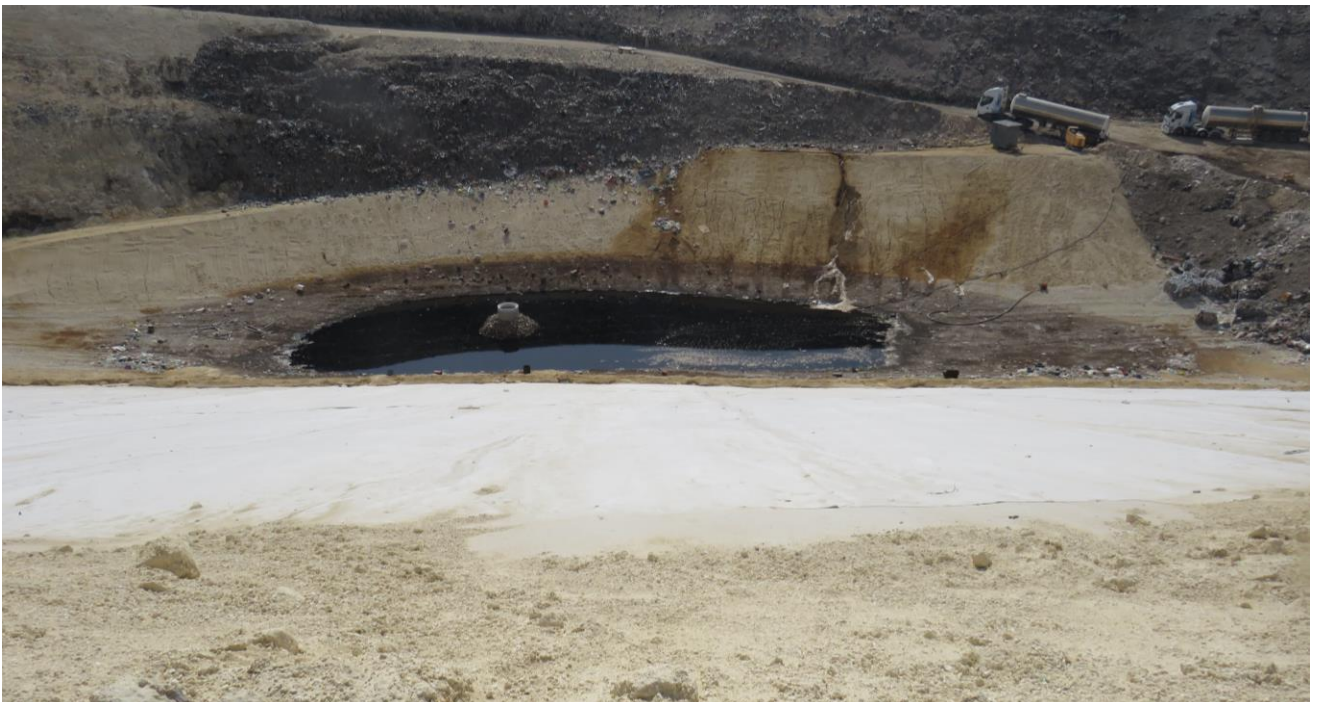
New Cell (Cell 9)	TCP stated that the whole cell has been relined following the discovery that the initially ordered material was inferior in quality and that Wasteserv is awaiting ERA's review of the Construction Quality Assurance Report in order to start using this part of the landfill.	Operator is to ensure that no waste is deposited in this area prior to clearance being issued by the Authority.
Leachate Management	Quite a large pool of leachate was noted at the bottom of Cell 9 which was observed to be being collected by two water tankers (see Photo 2).	As instructed in the previous inspection reports, Wasteserv is to take steps to prevent the build-up of pooled leachate within the facility for extended periods of time. A progress update on this should be provided to ERA within 1 month of the date of the covering letter to this inspection report, along with timeframes envisaged for the completion of the Leachate Management Plan envisaged in the permit's Improvement Programme.

Photo 2: Leachate pool at the bottom of Cell 9

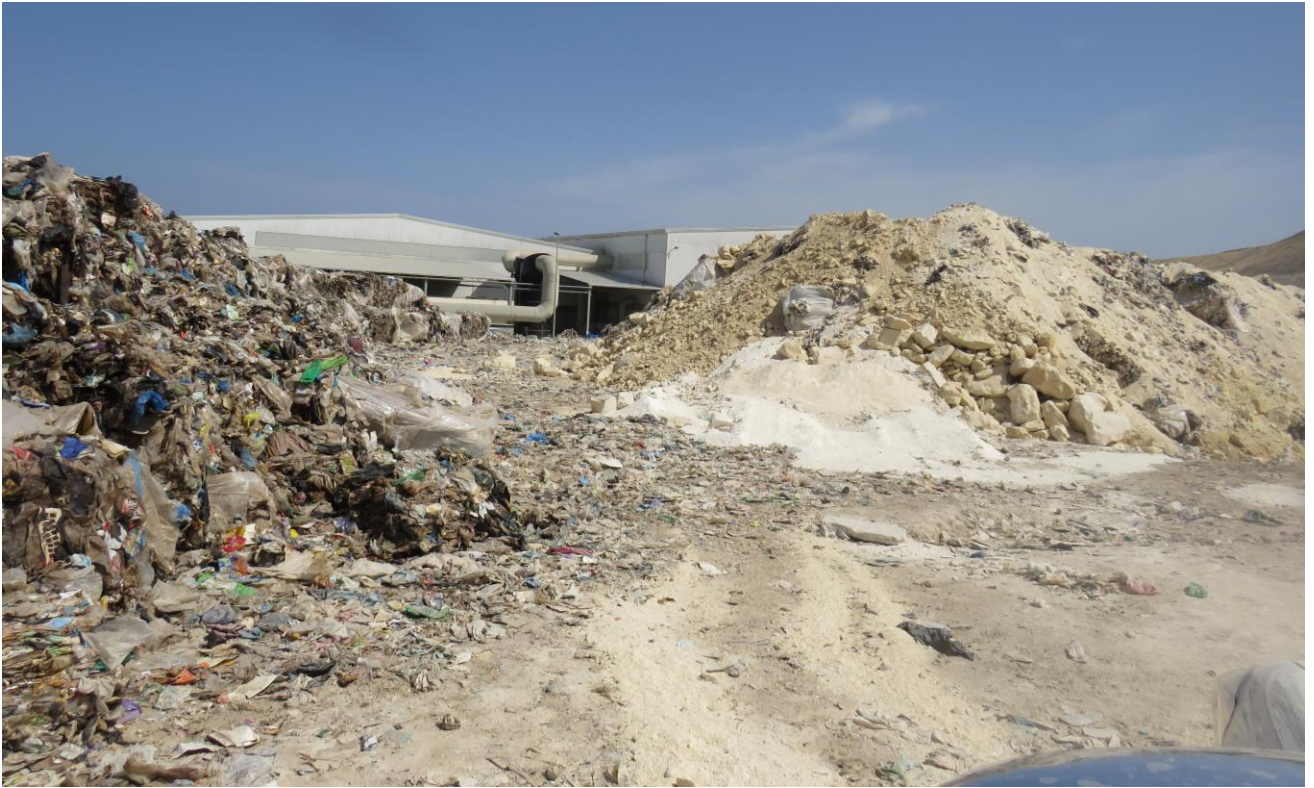
Cell)	stockpiled, crushed and removed offsite by a third party contractor.	
RDF Storage	<p>A considerable amount of RDF is still being stored in one part of this excavation, most of which is buried and some of which was lost due to a major fire incident on 31st August 2018.</p> <p>A new baler was noted being delivered during the time of the inspection</p>	<p>It was established on site that the stockpiled and buried RDF is being moved and extracted by a third party contractor, the integrity of the bales checked and if necessary it is re-baled and then exported through a TFS permit issued by the Environment and Resources Authority to PTMatic.</p>
Fire Incident	The area of the fire incident was visited and the fire incident and the response to it was discussed with the TCP (see Photo 3).	<p>Operator is reminded that a formal Fire Incident Report containing the details laid out in Schedule 1 of the Permit within 2 weeks from the date of the covering letter to this report.</p>

Photo 3: The area of the fire incident showing also rubble used in the firefighting efforts
