Client	Wasteserv Malta EkoCentre Latmija Road Marsaskala, MSK 4613 Malta
Location of interest	Sant' Antnin Waste Treatment Plan, Latmija Road, Marsaskala
Type of Report	Occupational Health and Safety Audit
File Reference	H18-0116-WSM-C
Date of Visit	27 th August 2018
Revision	0
Contact Persons	Mr Stefan Salomone – Senior Manager, Health & Safety
Report compiled by:	Ing. Claude Farrugia - Director B.Eng.(Mech) Hons, Eur.Ing., CMIOSH

Resolve Consulting Limited was engaged to carry out an occupational health and safety audit to establish the approach being adopted by Wasteserv to manage occupational health and safety at the Sant Antnin Waste Treatment Plant in Marsaskala, with particular focus on fire safety management.

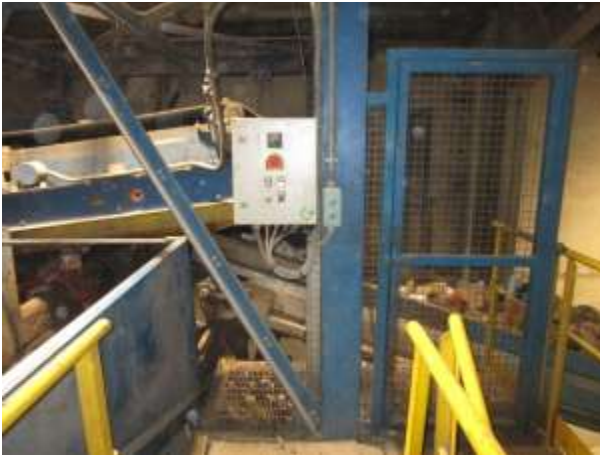
The equipment is designed to incorporate fixed and interlocked guarding around rotating or moving parts to prevent personnel from coming into contact with them. However there were instances noted during the audit of missing fixed guards and open gates that are intended to prevent access to moving parts. Emergency stops and trip wires were also noted around machinery and along most conveyors.

Image 40 – safety gate noted to be left open

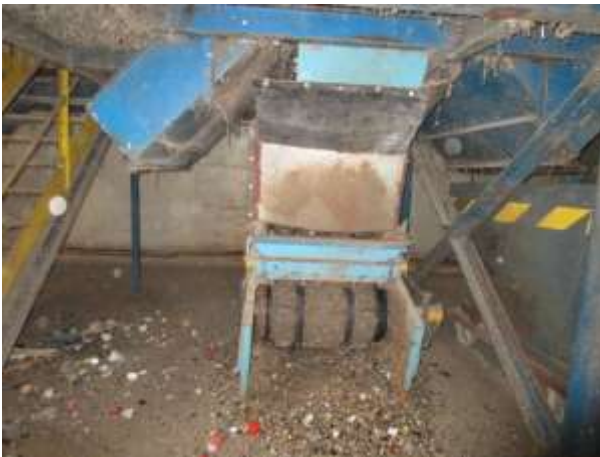
Image 42 – missing guarding over conveyor

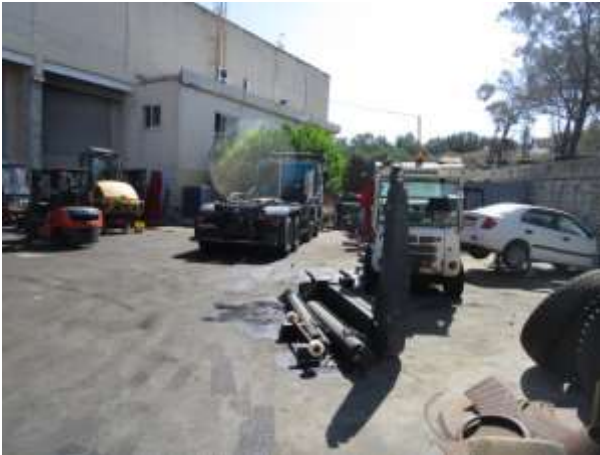
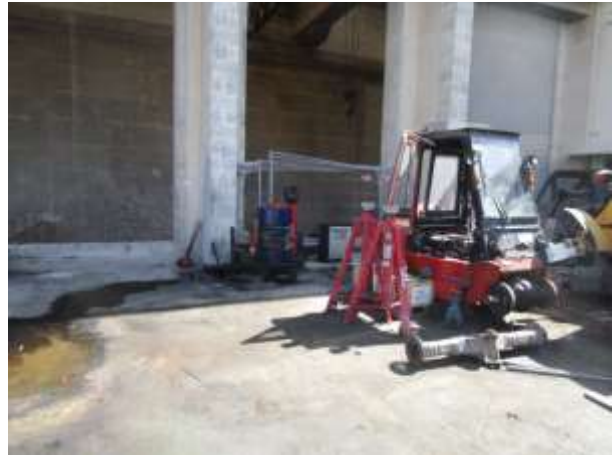
Maintenance of Wasteserv vehicles are maintained on site in an outside work area which is in dire need to upgrading (image 48, 49). This should be resolved once the workshop, currently under construction is complete.

Image 48 – outside mechanical workshop

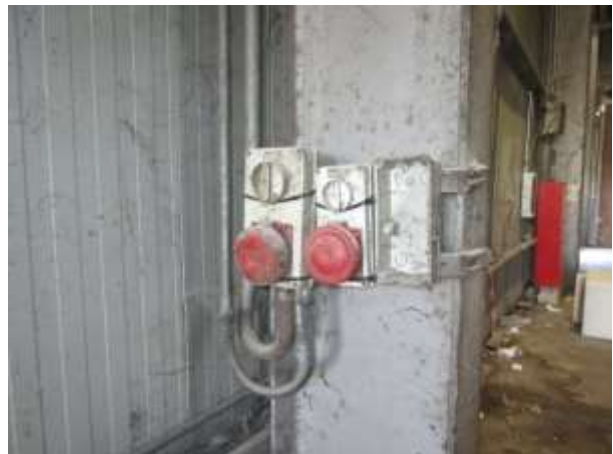
Electrical distribution boards and switchgear appeared to be in a fair condition. Routing of the permanent electrical installation is through or on appropriate cable containment, however the use of temporary extension leads on a permanent basis was noted. Three-phase electrical power sockets installed in the reception exhibited cable ties, thus suggesting that they are damaged. Signage indicating the electrical hazard is generally lacking.

Image 51 – damaged 3-phase power sockets

Item	Suggested Time Frame	Status
<p>maintained on all panels located within the premises.</p> <p>Damaged light fittings, electrical power outlets and the elimination of electrical extension leads shall be addressed as soon as possible.</p>	1 month	
<p>6.1.5 Personal Protective Equipment</p> <p>Enforce use of personal protective equipment protection by visitors and workers. If necessary increase the amount of signage to encourage and inform personnel on the correct type of equipment to be used.</p>	Immediate	
<p>6.1.6 Health surveillance</p> <p>Personnel that are exposed to non-mechanical hazards at the facility are to be included in a health surveillance program. As a minimum, the following arrangements should be in place:</p> <ul style="list-style-type: none">- Pre-employment screening that includes a questionnaire about present or past health conditions - advise new employees about what to look out for and that they should report symptoms;- A questionnaire to be completed for all workers after employment at 6 weeks, 12 weeks (or similar intervals) and at least annually thereafter to enquire about any developing symptoms. The questionnaire must be administered by a responsible, trained person who must understand the purpose of the questionnaire, confidentiality requirements and what records must be kept;- Identify a named occupational health professional or company, who can advise on any adverse findings from the questionnaire and who can make arrangements for further investigation where necessary.	12 months

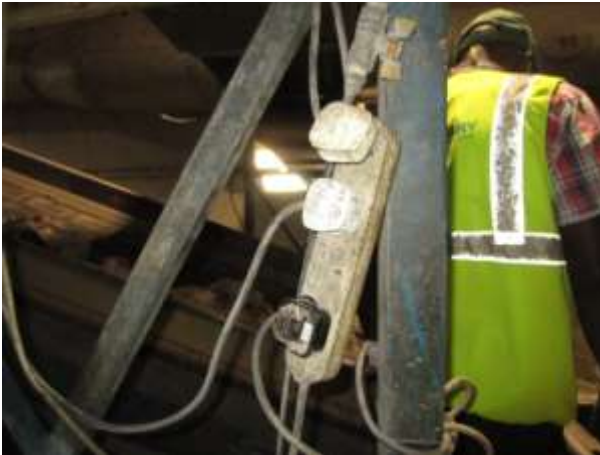
Image 52 – extension leads in use

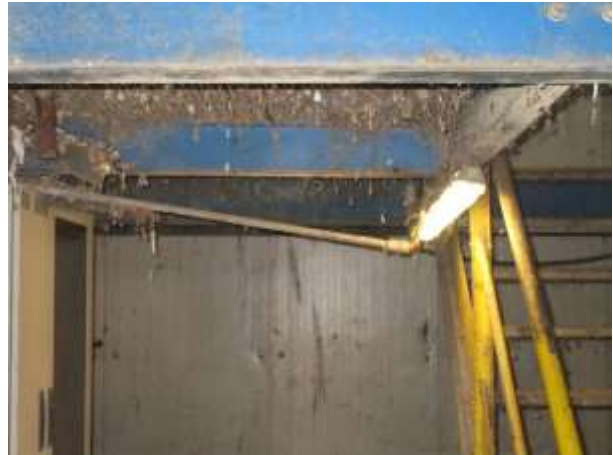
Image 53 – damaged electrical lighting installation

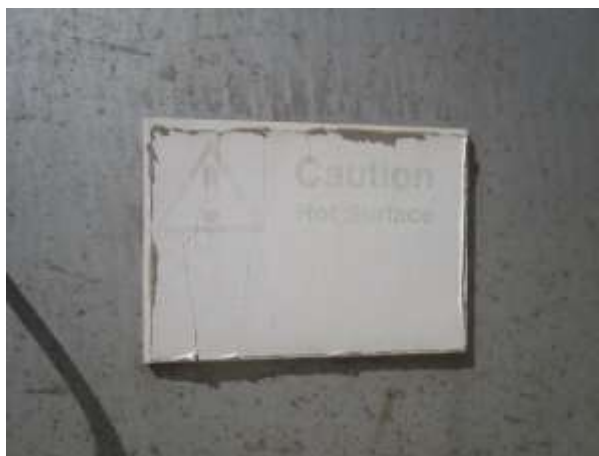
Image 55 – faded signage

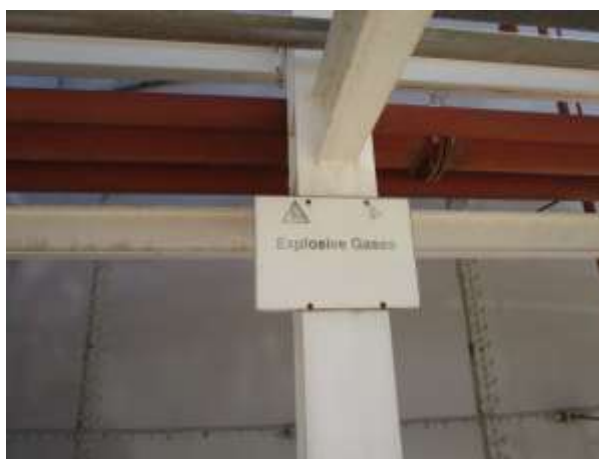
Image 57 – faded signage

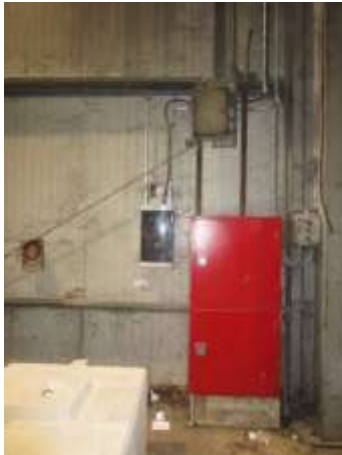
Signage is provided around the premises and is in accordance with local legislation, however some more specific signage is desirable as in the case of emergency stops and trip wires, prohibition notices advising personnel not to climb into conveyors unless they have been locked out, location of hydrants, 'Ex' signage, pipe labelling, confined spaces, permit to work, hazardous chemicals outside dedicated stores, etc. Refer to images 58 to 61.

Image 58 – no signage on fire cabinet or electrical distribution board

6.1.9 Health and Safety Signage		
Maintain current signage and ensure that it is observed. Training on the significance of health and safety signage might need to be considered.	Note	
Review signage based on continuous assessment to ensure that sufficient information is available within the facility.	3 months

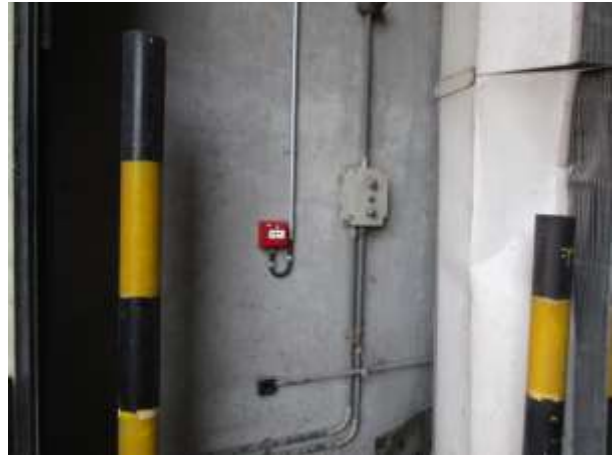
Image 59 – manual call point sign missing

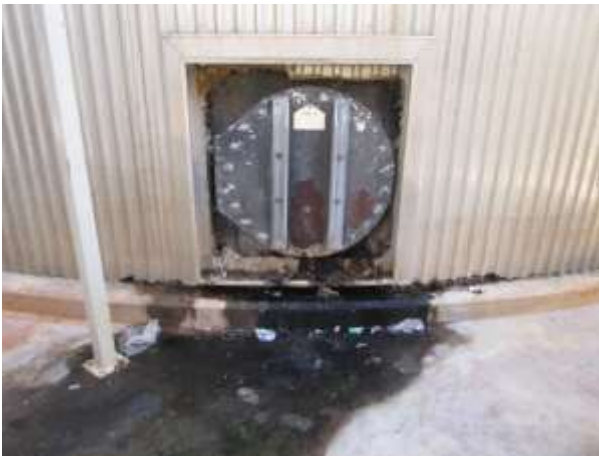
Image 60 – confined space entry, no permit to work signage

Item	Suggested Time Frame	Status
<p>6.1.11 Confined Spaces</p> <p>All the confined spaces within the facility are to be clearly denoted with signage and entry must be controlled.</p> <p>Maintain the confined space hazard assessment and control program should be formally implemented detailing:</p> <ul style="list-style-type: none">- The identification and assessment of all potential hazards that may exist at the beginning of the work as well as those that may develop because of the work activities.- The roles and responsibilities of each person or party involved.- A plan to eliminate or control all identified hazards.- Written work procedures.- Training program for all the workers that will enter into the confined spaces.- The establishment of an entry permit system for each entry into a confined space.- Development of an emergency plan complete with training and equipment in case an unforeseen situation occurs and an emergency response system.- Medical fitness requirements of staff entering confined spaces.- Etc.	<p>3 months</p> <p>Note</p>

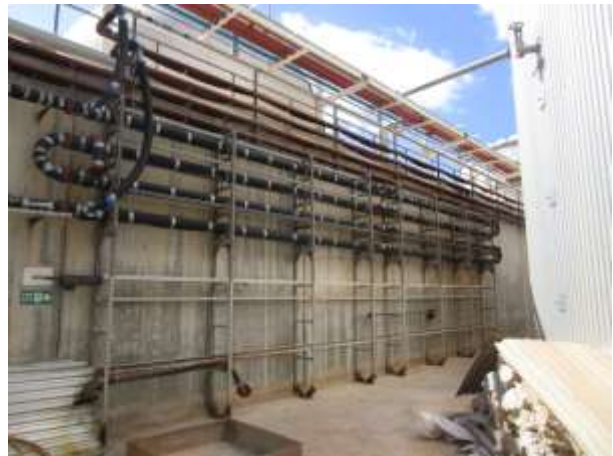
Image 61 – no labelling on pipework

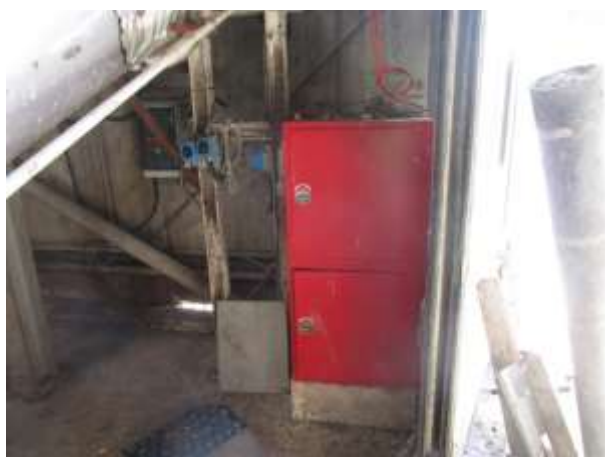
Image 65 – unmarked fire cabinet
