SHIELD CONSULTANTS LTD

Fire Risk Assessment

JAC Steel Ltd.

**Waste Treatment Complex Qasam Industrijali,
Marsa, MRS 1000**

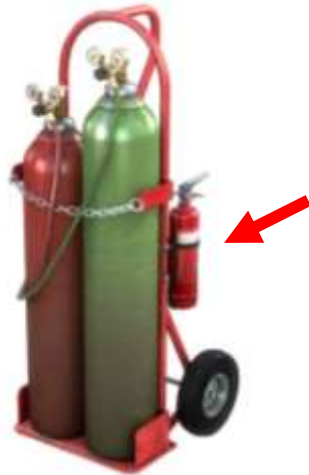
3.2	Fire Extinguishers	Fire Extinguishers have been better positioned and distributed along the facility. These have been installed in accessible areas and mounted on wall brackets that will allow them to be easily accessed by workers. <ul style="list-style-type: none"> • A small (1kg) powder fire extinguisher should be fixed to every oxy-acetylene set.

Image 1 – Oxy-acetylene set with fire extinguisher

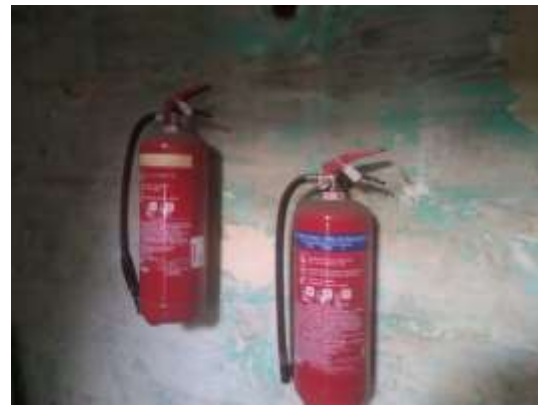
Image 2 – Foam Fire extinguisher

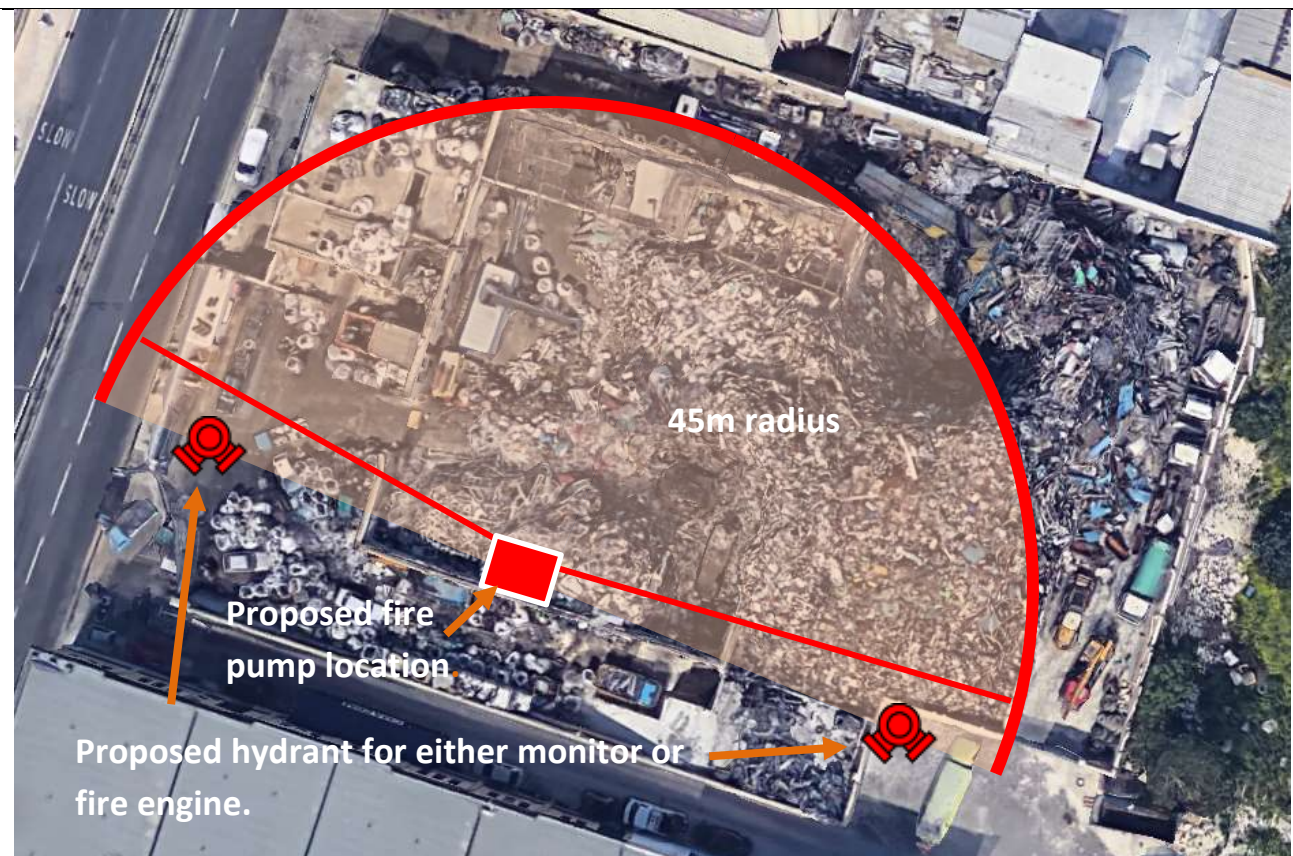
Image 6 – areas covered by water jets from proposed water monitor positions

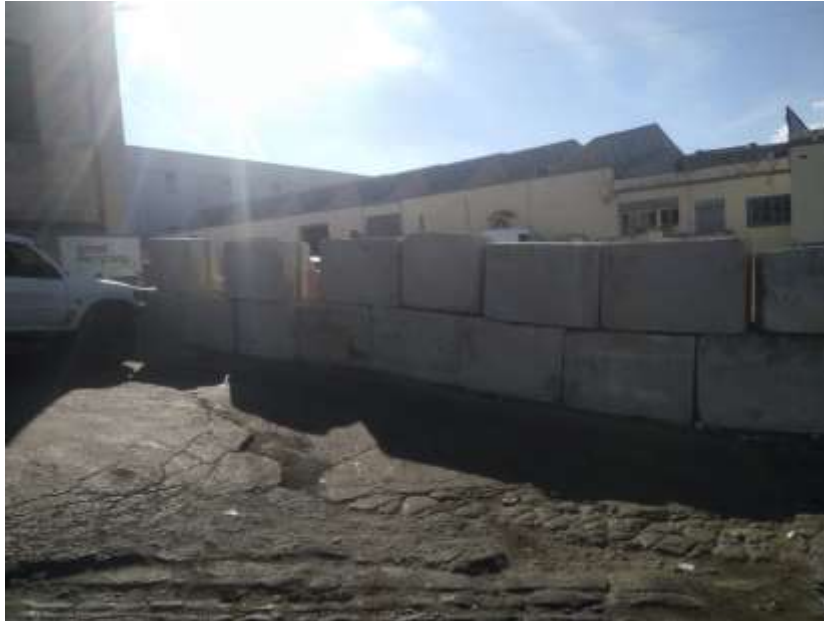
5	Access to the Fire Service
	<p>Since the access to the site directly from Triq Giuseppe Garibaldi is no longer accessible, vehicles need to access the site from the rear passing through the single access road leading to the JAC site. This is not an ideal approach for fire service vehicles as the room for manoeuvrability is very limited.</p> <p>Civil Protection (CPD) vehicles would be forced to remain stationed at a distance and display long stretches of hoses to be able to carry out firefighting efforts. This would take considerable time and would result in a fire having time to grow larger and therefore become more difficult to control.</p>

Image 16 – blocked access to the front of the site

Since the closing of the front road is not up to the management of JAC steel, *they are not at liberty to open it themselves*. It might be necessary to make the request to the relevant authority for the concrete blocks to be replaced with other blocks that are longer and taller in size so that a fewer number would be required to close off the opening. **These would then be able to be removed, only in case of emergency and in case that the CPD need to attend**, by one of the several forklift trucks operating within the facility.

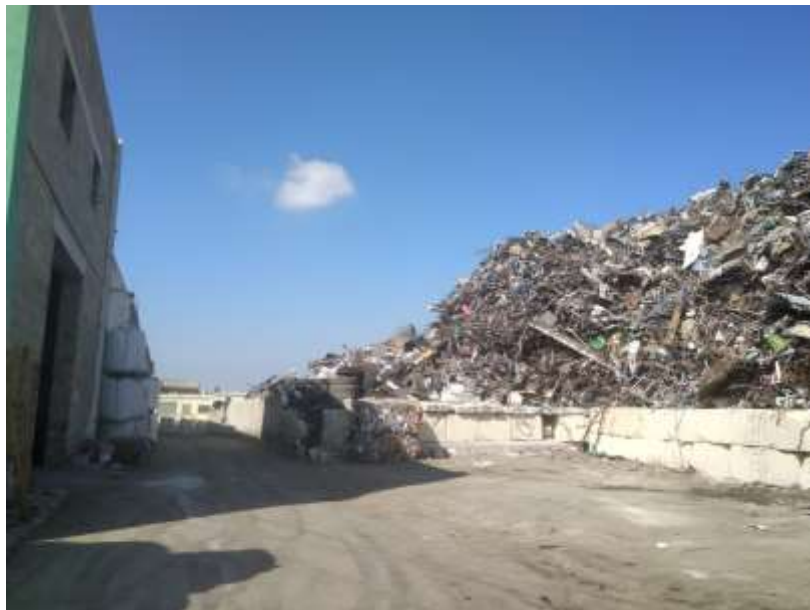
Image 17 – access road to site

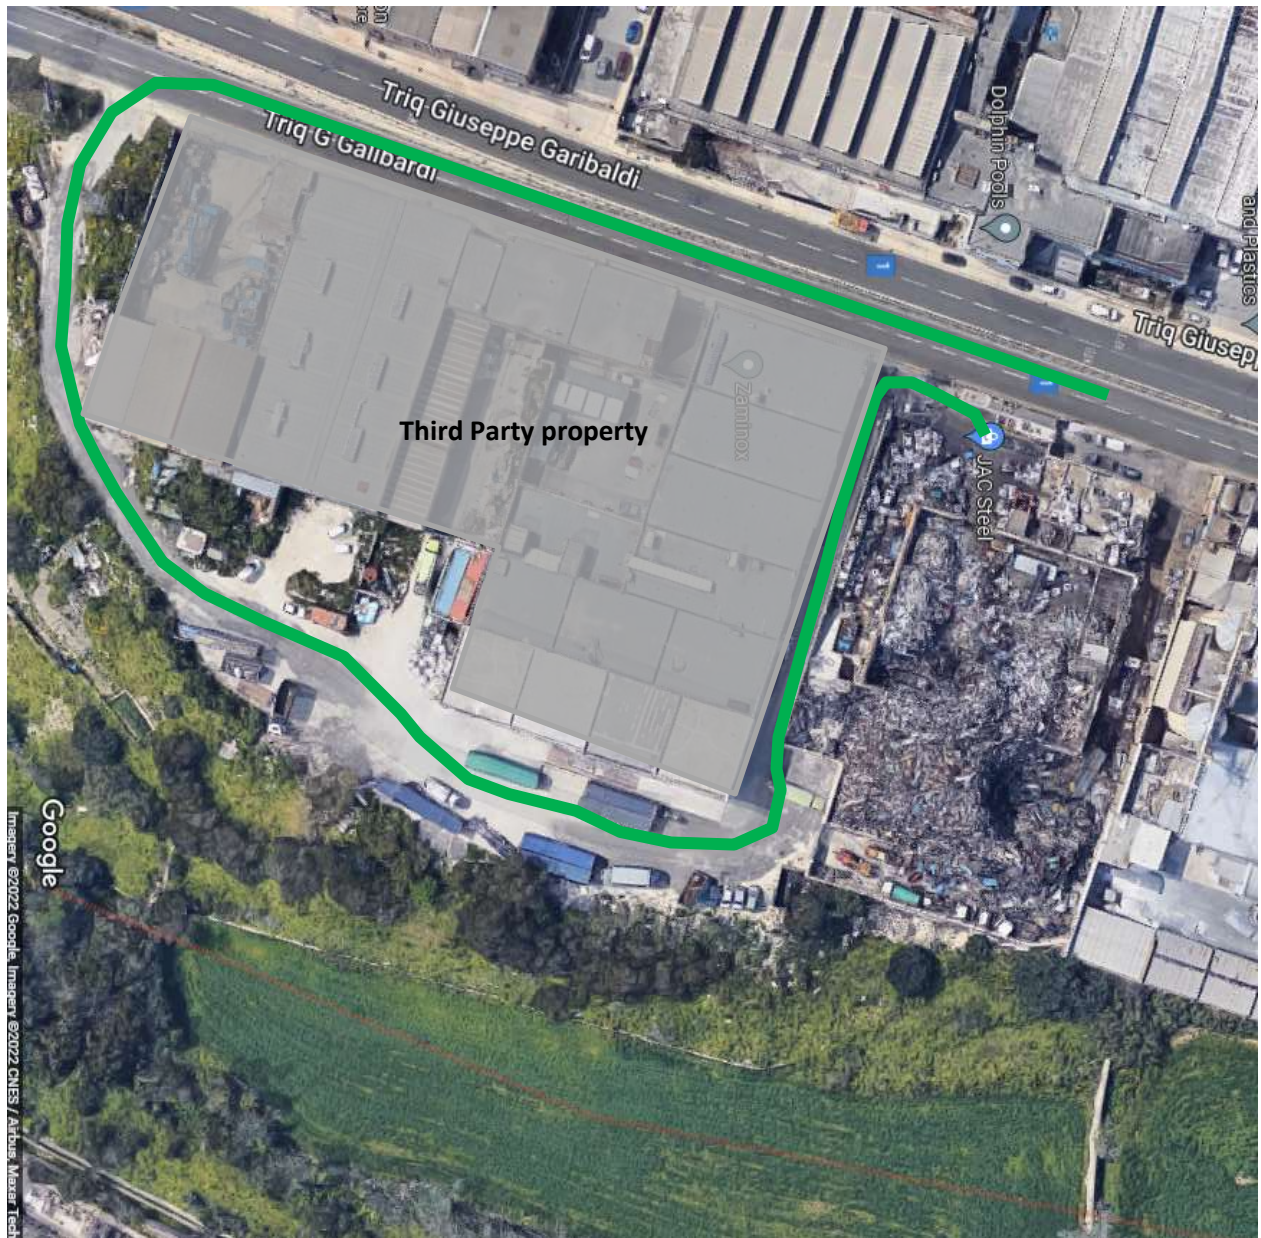
Green line shows access to fire brigade due to closed off access from Triq Giuseppe Garibaldi
