Magħtab Environmental Complex, Malta

New Non-Hazardous Waste Landfill

Stability Risk Assessment

Date: 7 December 2021

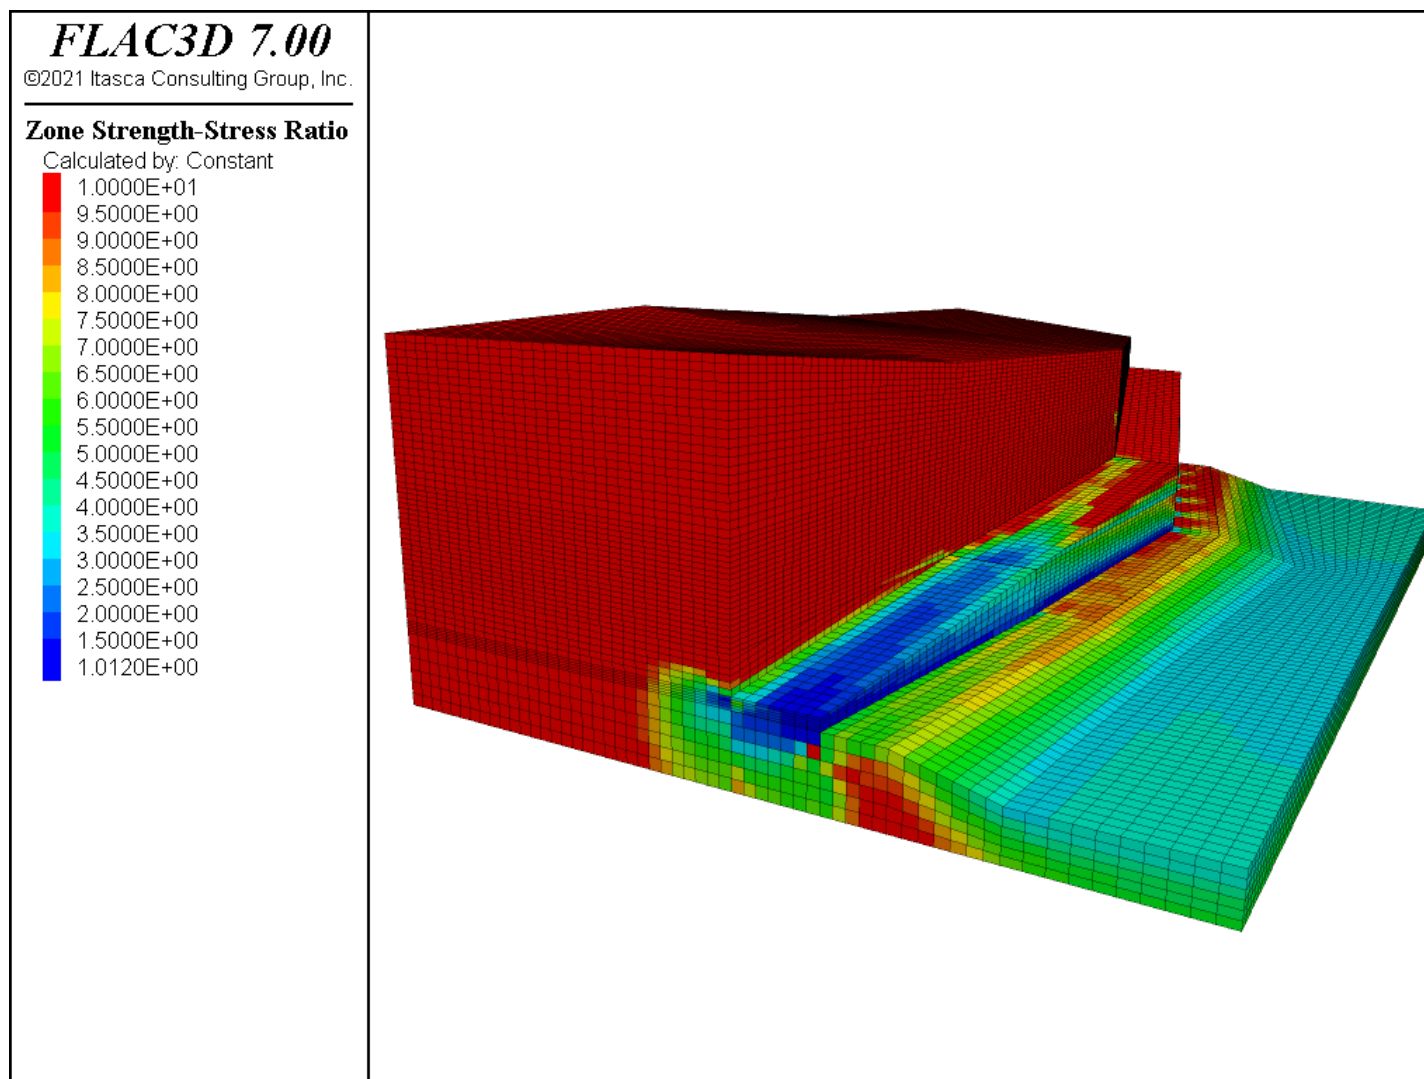
Ratio of rockmass strength to the maximum stress – highest stress at tow of slope but not sufficient to cause failure.

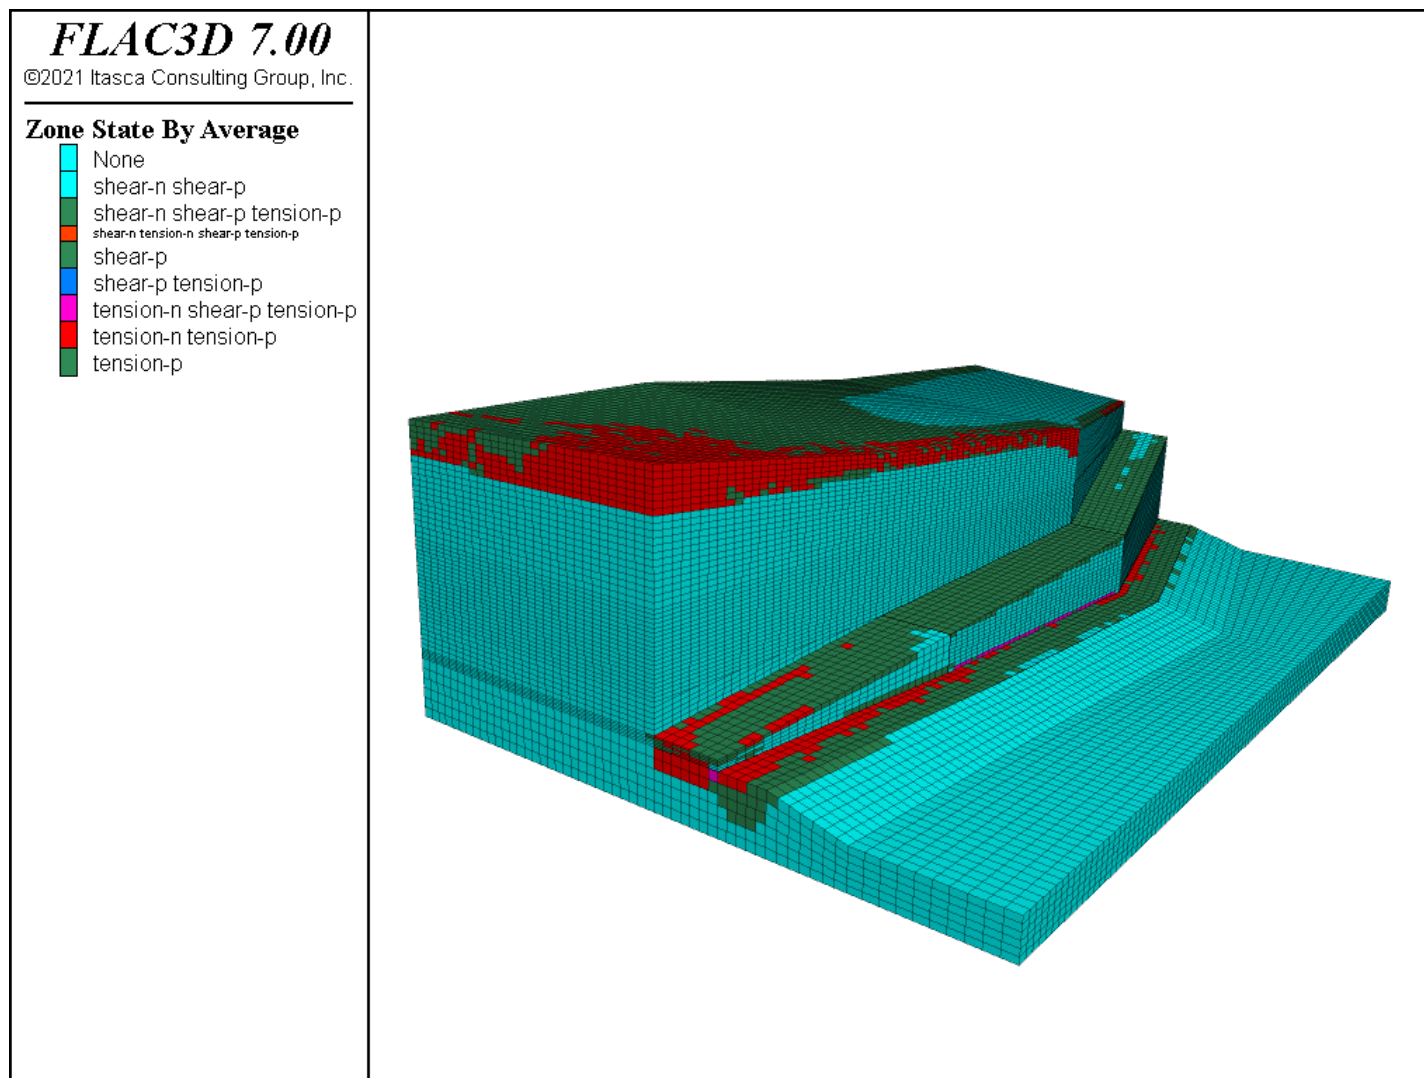
State of finite difference elements at end of simulation – light blue colour state indicates lack of instability.

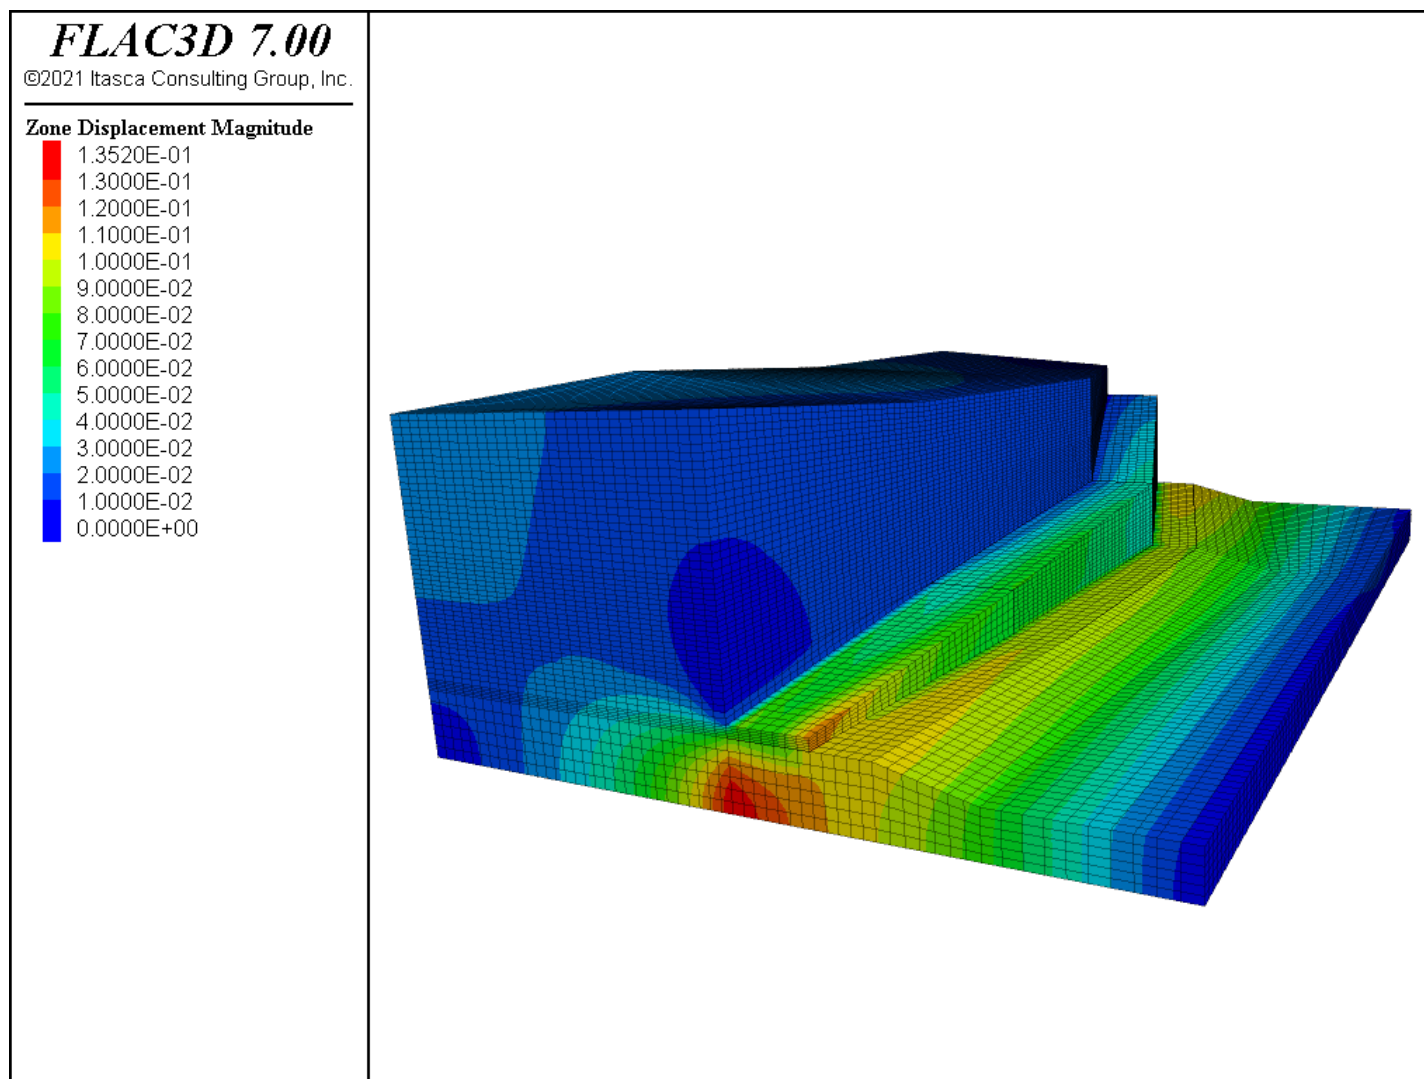
Displacements due to deepest excavation near access road and promontory; movements very small, insufficient to cause issues.

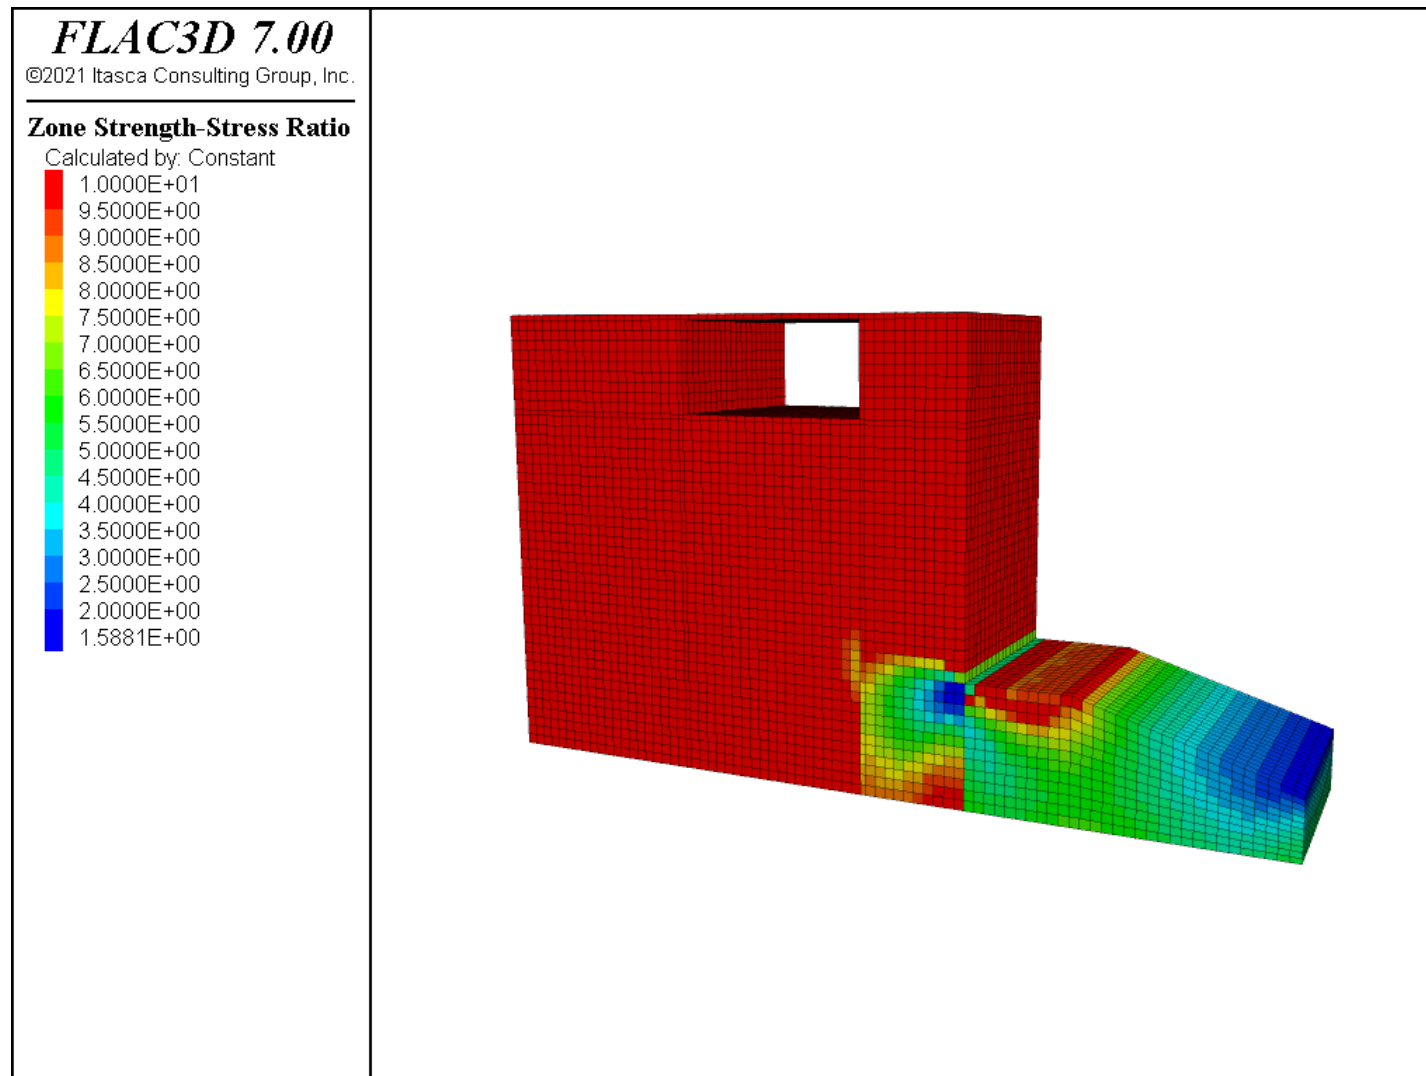
Ratio of rockmass strength to the maximum stress – highest stress at tow of slope but not sufficient to cause failure.

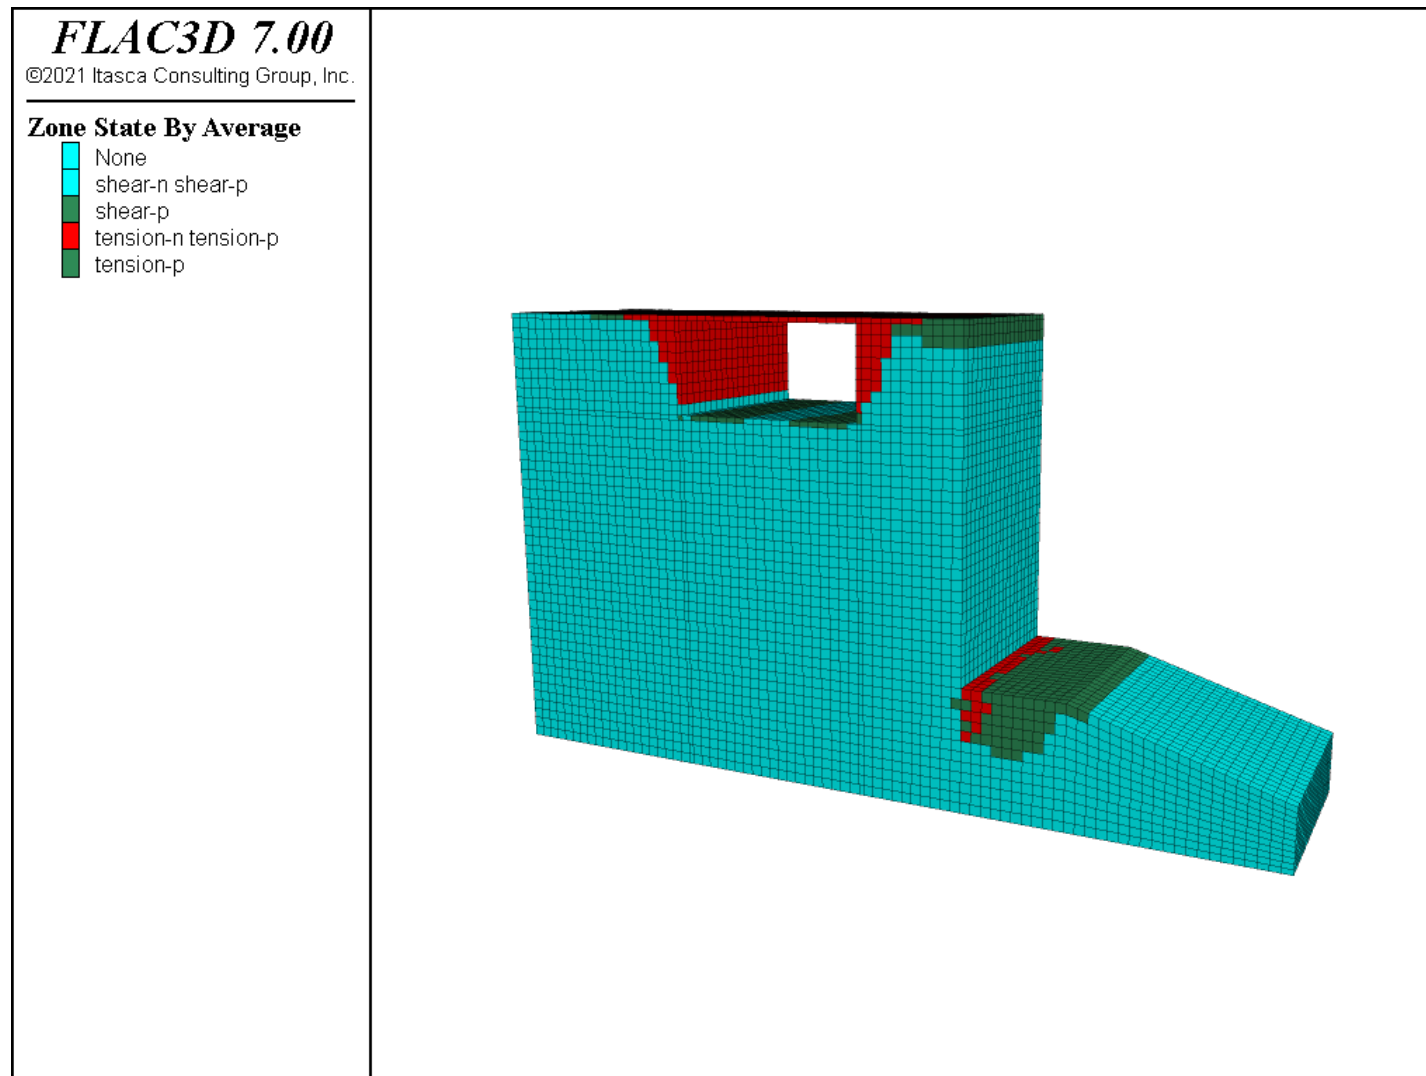
State of finite difference elements at end of simulation – blue indicates lack of instability. Neither tank nor slope are affected.

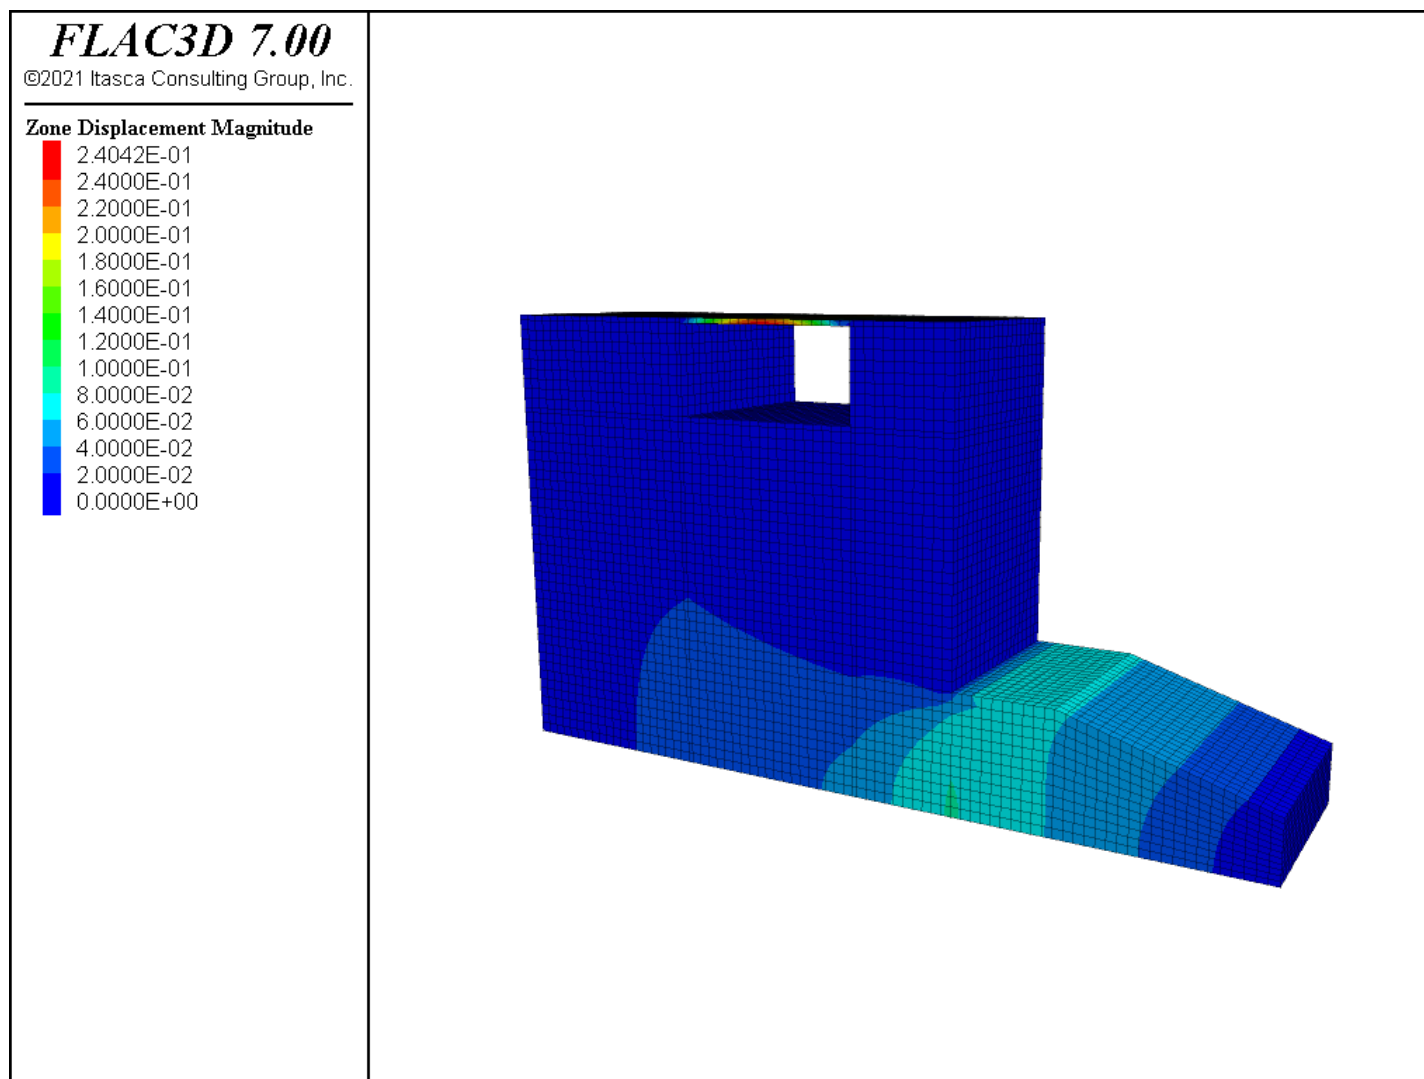
Displacements due to excavation near a reservoir tank; movements very small, insufficient to cause issues.

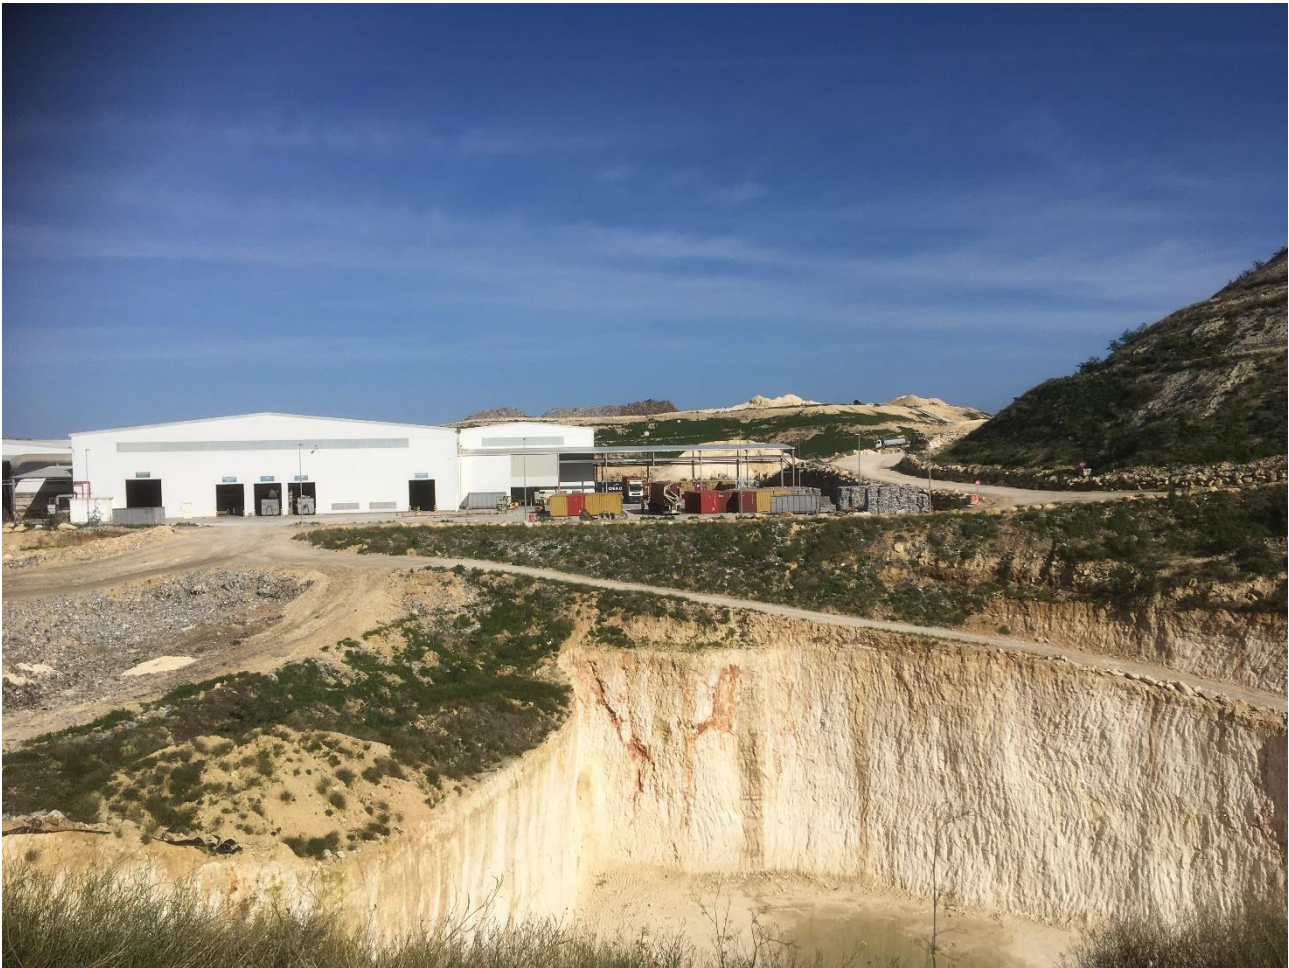
Tile 1

New Landfill rock face beneath MTP, base at formation level.

Discoloured joint or small fault evident in corner of new landfill excavation. Water tank is located under the hardstanding with containers. No instability observed. Anchors / shotcrete to be installed as face extends back towards MTP

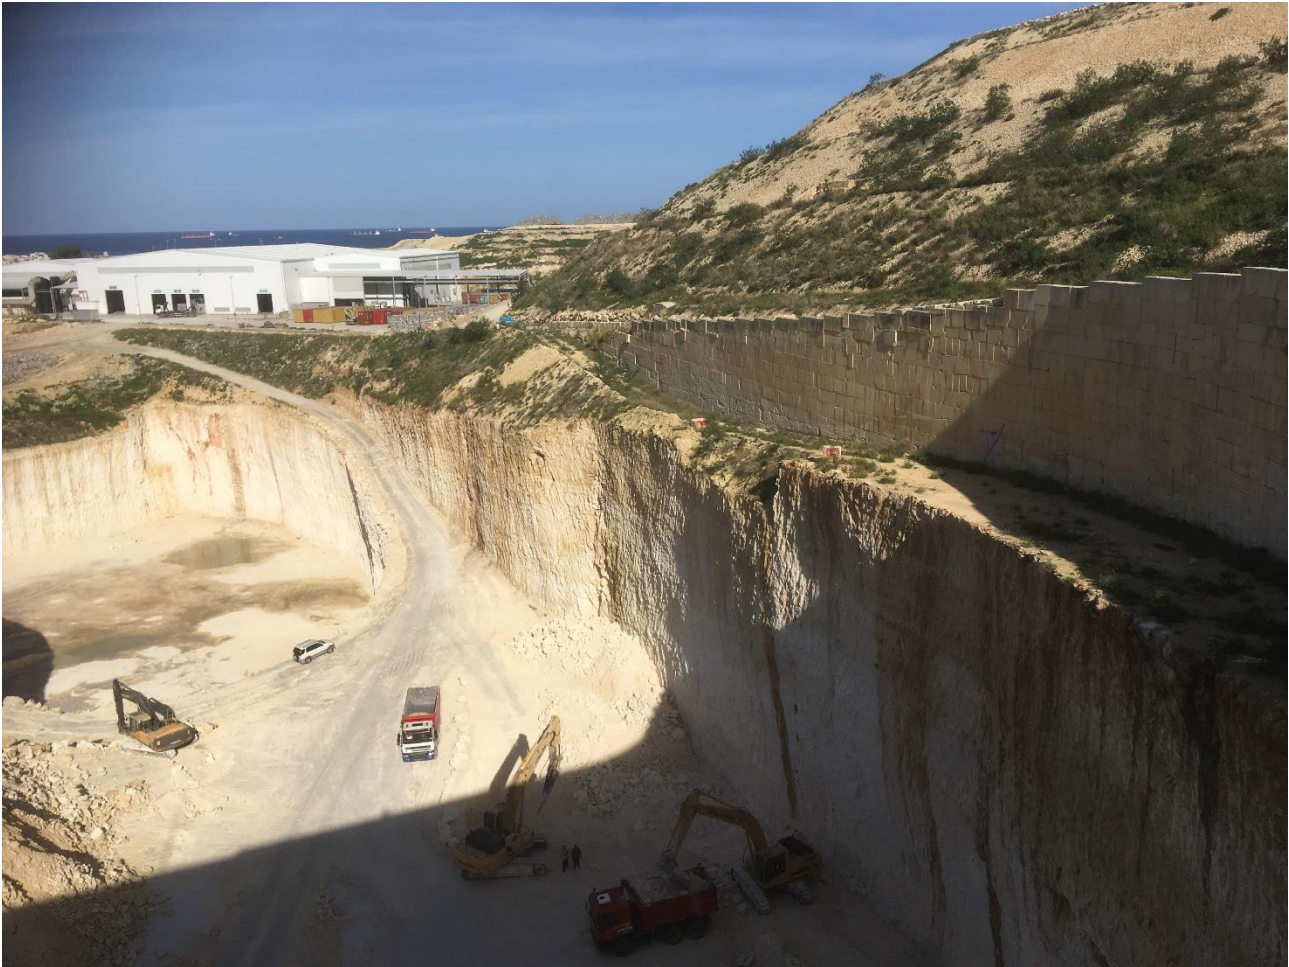
Tile 2

New Landfill rock face beneath Magħtab historic landfill.

Subvertical master joints/ faults extend through face. Some movement locally causing near-face rockfall. Water tanks located behind access ramp. Road to be widened. Stabilisation through rock anchors / shotcrete to be completed.

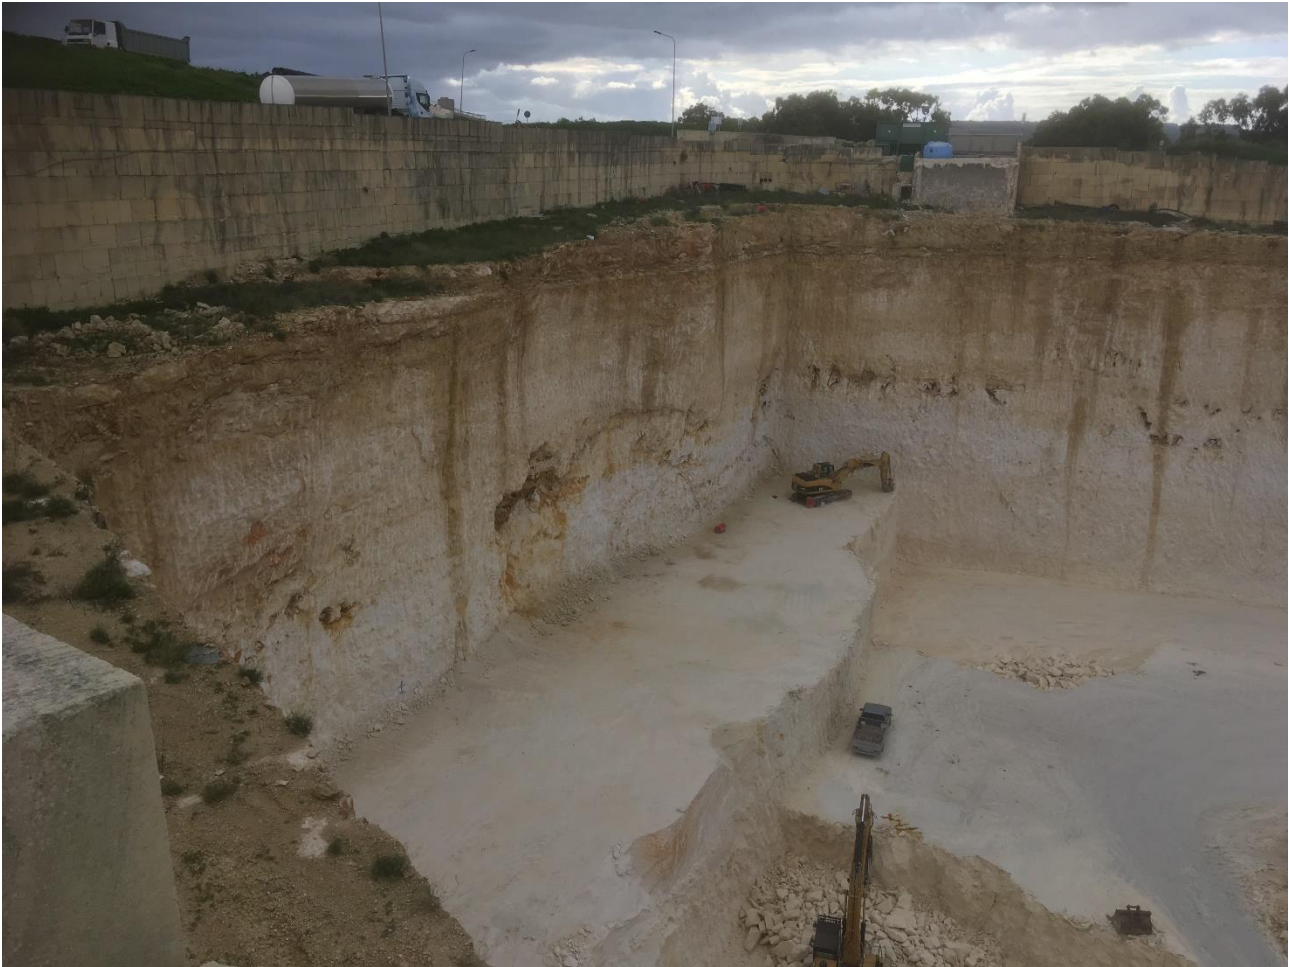
Tile 3

New Landfill rock face beneath Ta'Żwejra historic landfill.

Solution features – voids with brown staining - occur in the wall of the middle bench above a low-permeability horizon. Bench to be left in place to provide support to the southern face.
