Green Skip Services
Administration Building
Maghtab NXR08

LEAK TIGHTNESS TESTING

Project Title: Leak tightness testing
Sub-Title: As-above
Project No: C/42913
File Location: y:\projects\qms - design jobs\green skip services ltd\c42913 - drainage testing\design\technical reports\c42913 leak-tightness survey report 14.01.2013.docx
Status: Final
Client Contact Name: Ondine Gaerty
Client Company Name: Green Skip Services
Project Co-ordinator: Clinton Spiteri
Document Controller: Vanessa Buttigieg
Issued By: MEDITERRANEAN TECHNICAL SERVICES LTD
Central Complex, Level 2
Triq in-Naġġar
Mosta MST1761

LEAK TIGHTNESS SURVEY REPORT

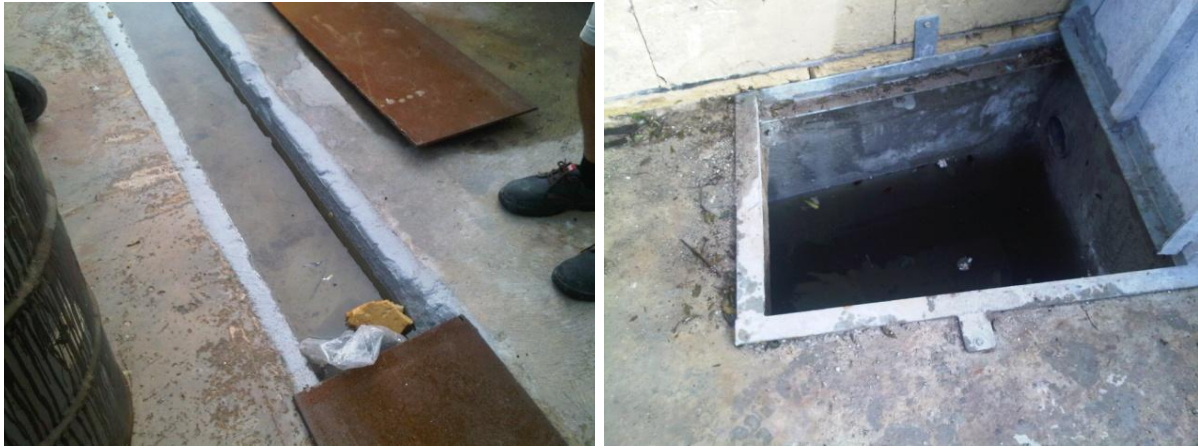
On 19/11/2012 at 15:00 the spill channel, associated reservoirs and cesspit were completely filled with water.

Photo 1: Charging spill channel and cesspit with water

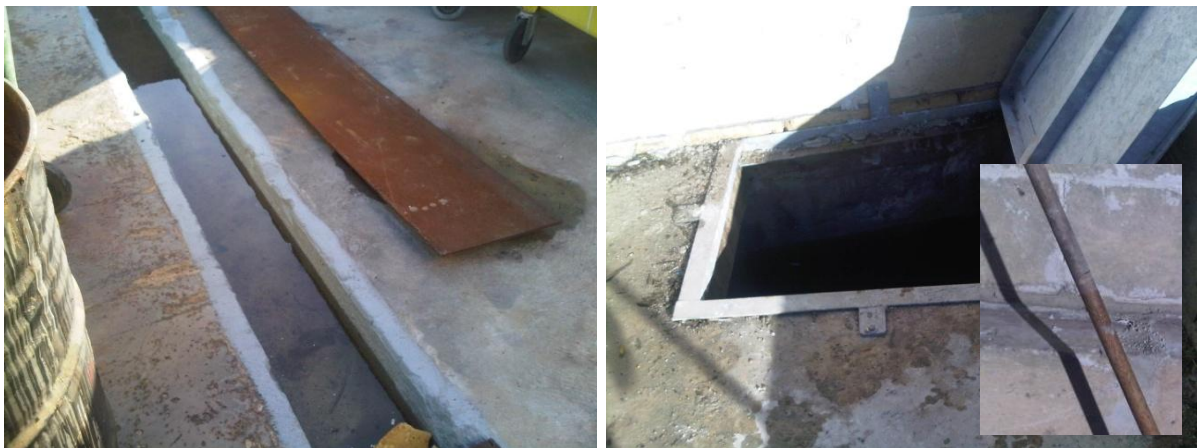
On 20/11/2012 at 15:00 it was observed that the spill channel and cesspit retained the water, with only a minor change in volume.

From the results obtained it can be concluded that the spill channel, associated reservoirs and cesspit are all water tight. It is important that these tests are repeated from time to time to ensure they always retain their water tightness.

Photo 2: Spill channel and cesspit (with dipstick insert) after 24 hrs
