Job ref: **MPS-MS-Turbine Hall
8 – internal concrete
structure**Issue date: **23/06/2017**

Works Method Statement	R01	Area	Zone 05		
Description of Works	Scarifying of surface concrete and subsequent demolition of concrete structure

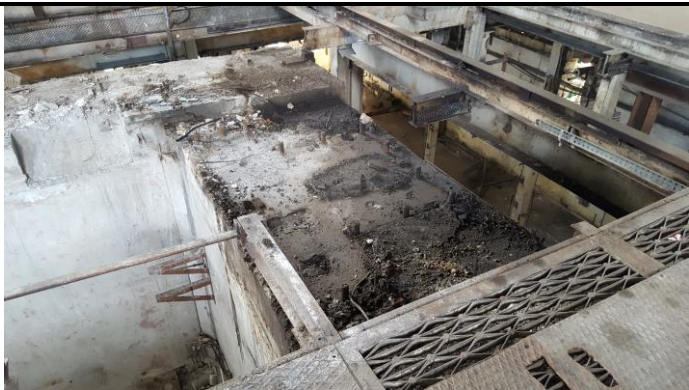
5	
	Horizontal platform

3.0	WORKS METHODOLOGY		
	Works will be carried out using light weight machinery, possibly a hand held scarifier / chaser.		
	Scarifying will be carried out up to 20mm depth from the existing surface.

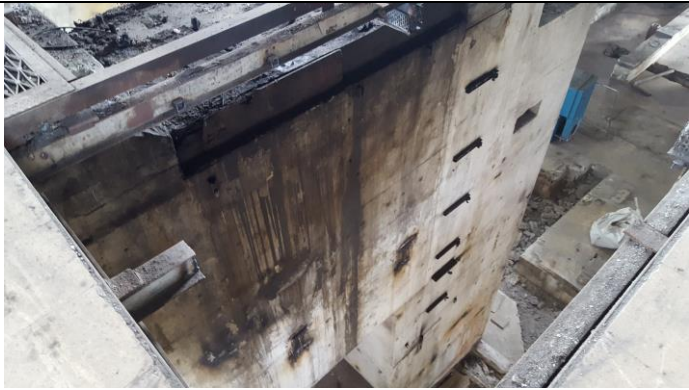
5	
	Vertical wall
