Government of Malta  
Ministry for Resources and Infrastructure

# **Development of Rehabilitation Strategies Magħtab, Qortin and Wied Fulija Landfills**

Stage II Report

February 2003

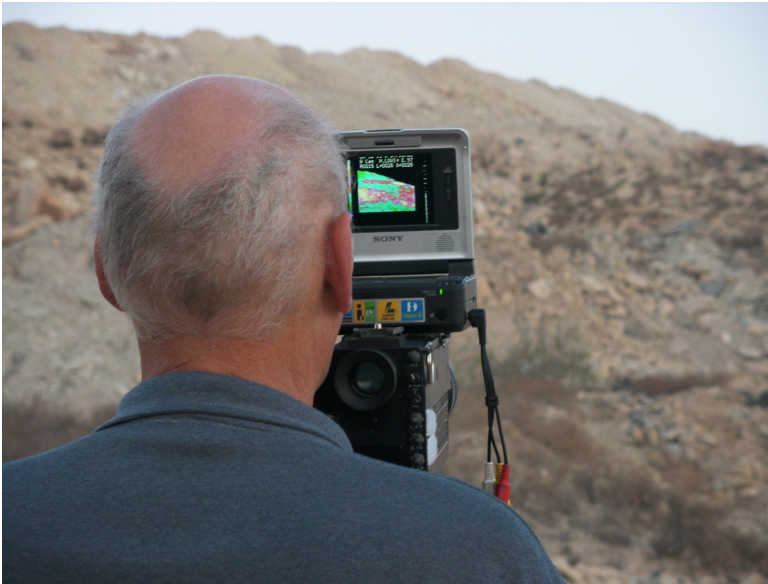
**Plate 2.1: Thermal Surveying with Infrared Camera**

Aerial thermal imaging using a thermal camera coupled with a digital video camera was undertaken using a light aircraft to identify general areas of heating on each landfill. This was supplemented with 'walkover' imaging surveys using the thermal camera to obtain specific measurements of surface temperature (Plate 2.1). The aerial thermal and visual imaging of each landfill is reproduced as a digital video file (MPEG format) on the appended CD-ROM. The results from the thermal survey were verified by physical measurement of surface temperatures using a hand held temperature probe on a notional 50 m grid pattern across each site. In addition temperature measurements were recorded at 1m depth intervals in the boreholes drilled through the waste mass at each site (see below).

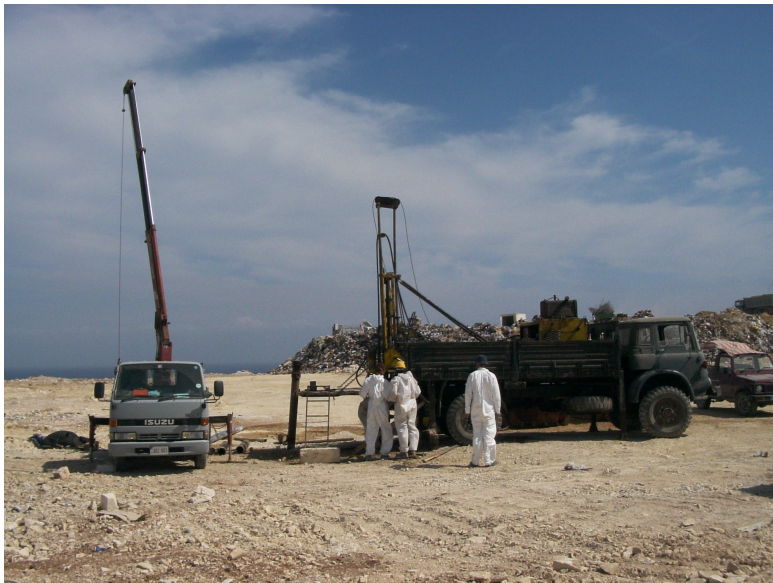
**Plate 2.3: Surface Gas Monitoring – Maghtab**

Landfill gases were monitored in monitoring wells within the wastes by direct connection to a gas tap mounted on the monitoring well. Gases emitted from the landfill surface were also monitored on a notional 50 m grid over the surface of each site using a hollow stainless steel probe (Plate 2.3).

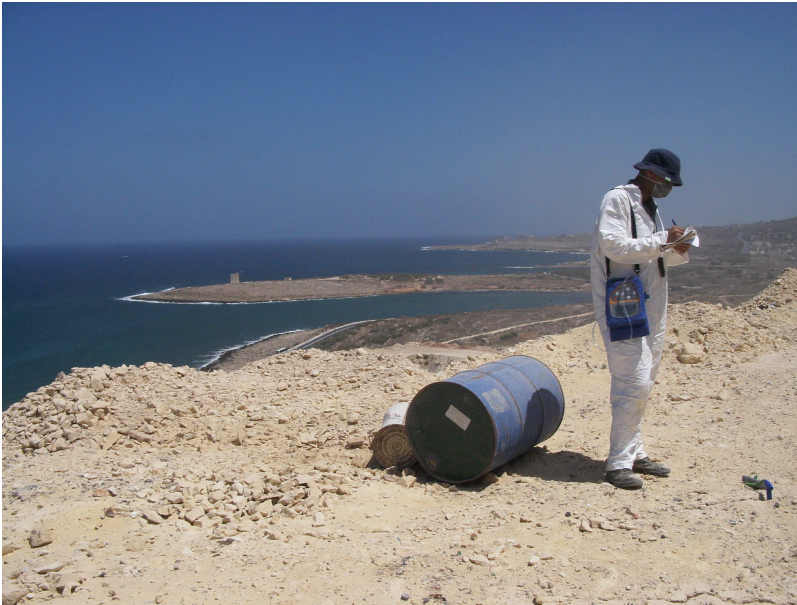
**Plate 2.4: Off-site Soil Sampling – Maghtab**

Samples of surface soil (to 5 cm depth) were taken from around each of the three sites using a stainless steel trowel and stored in appropriate sample containers (Table 2.1 and Plate 2.4). Sampling equipment was cleaned with hexane between samples. Representative samples of waste and cover materials on the surfaces of each site were taken using the same method.

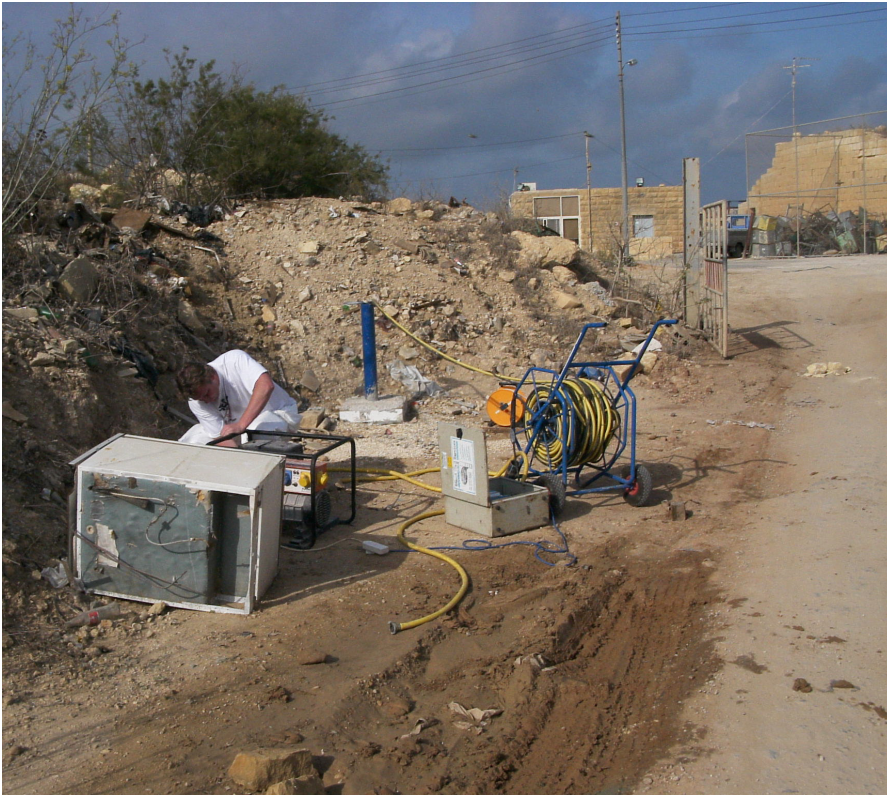
**Plate 2.6: Groundwater Sampling from Agricultural Abstraction – Qortin**

Samples from existing agricultural abstractions were sampled using existing pumping equipment (electrical powered) where present (Plate 2.6). In two locations, it was necessary to lower a stainless steel bucket into the well to sample. The public water supply at Wied-il-Għasel was sampled from the dedicated sampling point within the pumping station. Samples were taken directly from the spring at Qortin.

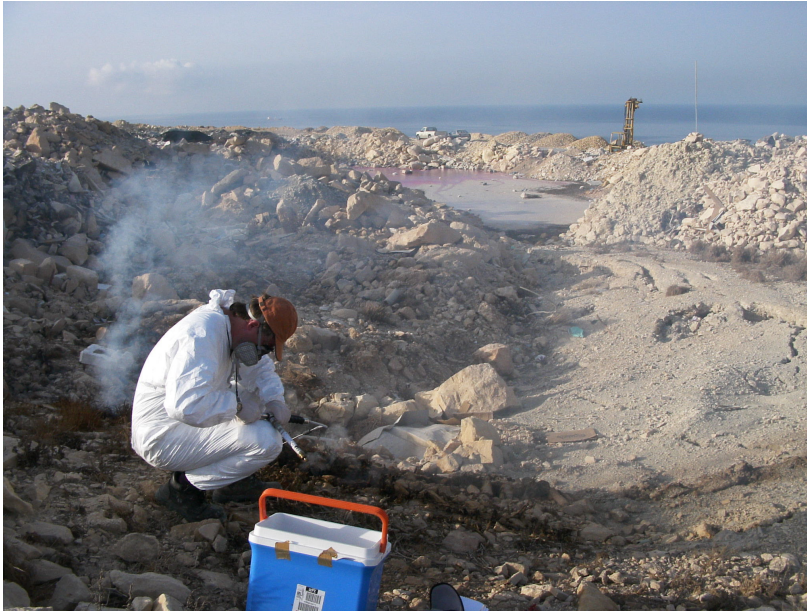
**Plate 2.7: Gresham Sampling – Magħtab**

Landfill gases from monitoring wells within wastes and from selected locations of surface gas venting were sampled with Gresham tubes (Plate 2.7). Each Gresham tube was purged three-times with borehole gas before the sample was taken.

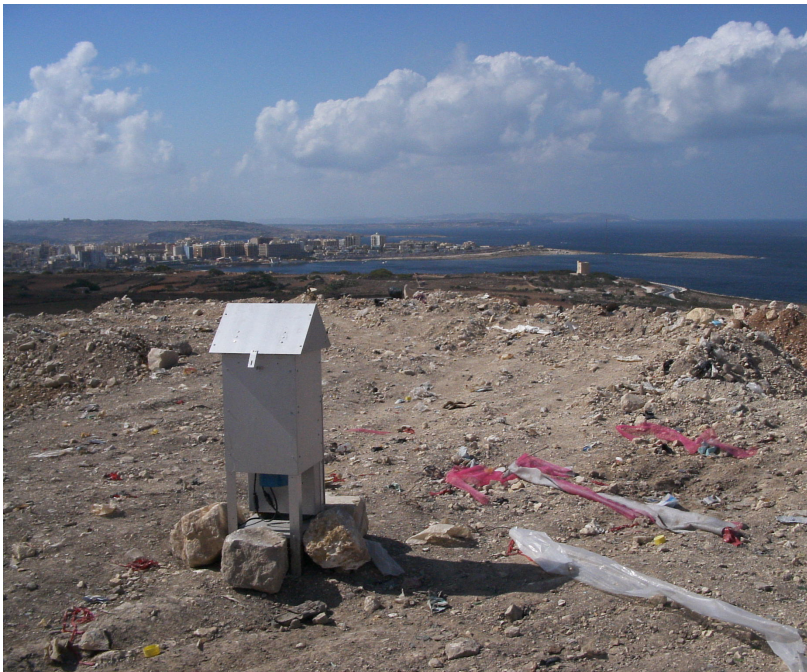
**Plate 3.1: Combustion venting and waste settlement – Magħtab north face**

The entire waste mass is likely to be undergoing settlement as a result of self-weight consolidation (with burial i.e. the newer layers of waste compressing the underlying materials). Generally combustible and decomposable wastes have been placed as discrete zones within the waste body surrounded by largely inert material. There is evidence of significant differential surface settlement occurring as a result of waste decomposition and combustion. Numerous tension cracks exist, frequently in areas showing either surface staining or direct evidence of subterranean combustion. Surface depressions from settlement of waste are found associated with areas of combustion (Plate 3.1) and there is anecdotal evidence that some of these surface movements are sudden.

Areas where combustion gases vent to the ground surface are typically stained brown and a brown-black, viscous condensate is often found immediately surrounding the vent (Plates 3.1 and 3.2). This condensate typically contains a wide range of volatile and semi-volatile organic compounds resulting from combustion of wastes:

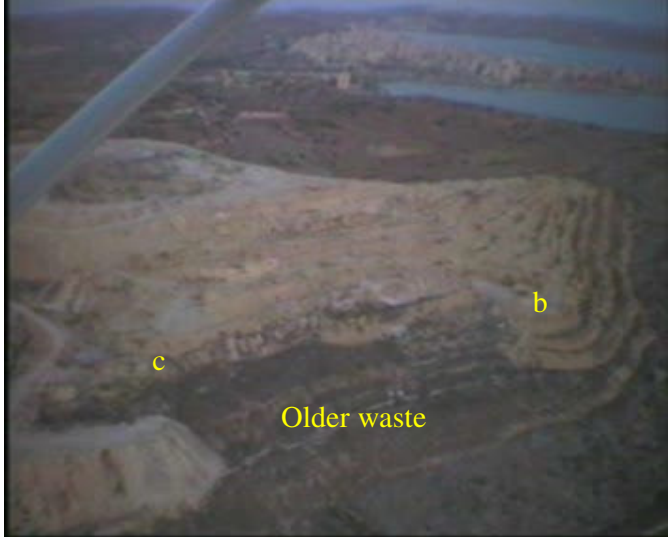
**Plate 3.3: Thermal Survey North Face of Maghtab**

<p>a) Aerial view of north face showing locations of photos b) and c)</p>

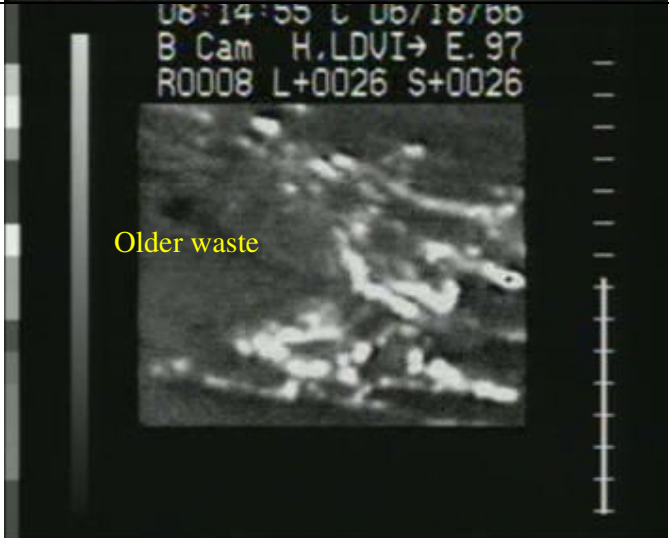
<p>b) heating on western side of north face extending to low levels. Note lack of heating in older waste at base.</p>

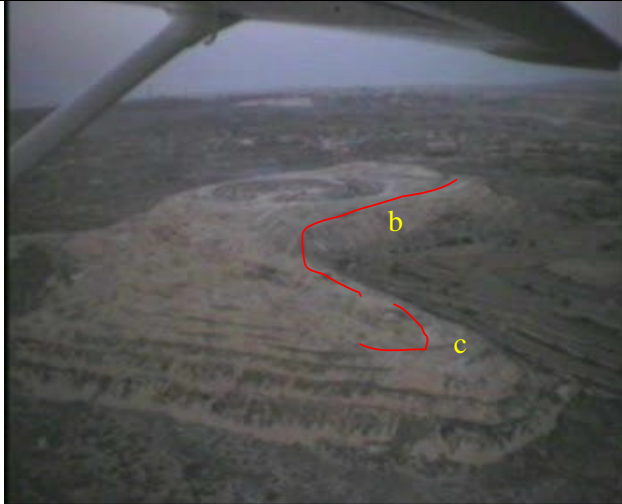
**Plate 3.4: Thermal Survey West Side of Maghtab**

<p>a) Aerial view of west side of Maghtab showing locations of photos b) and c)</p>

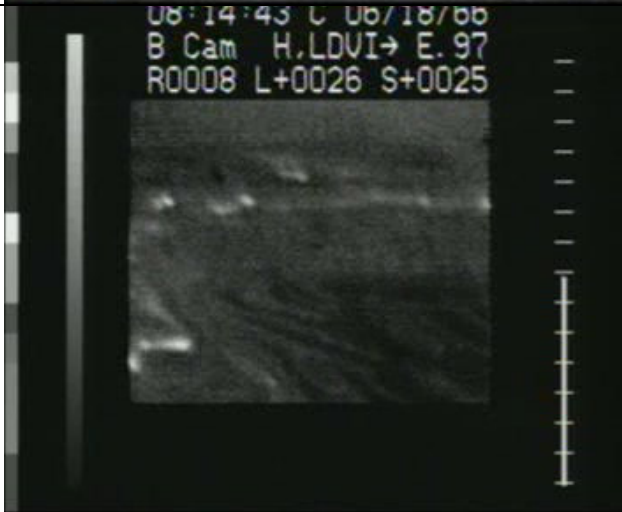
<p>b) heating on upper layers of western side</p>

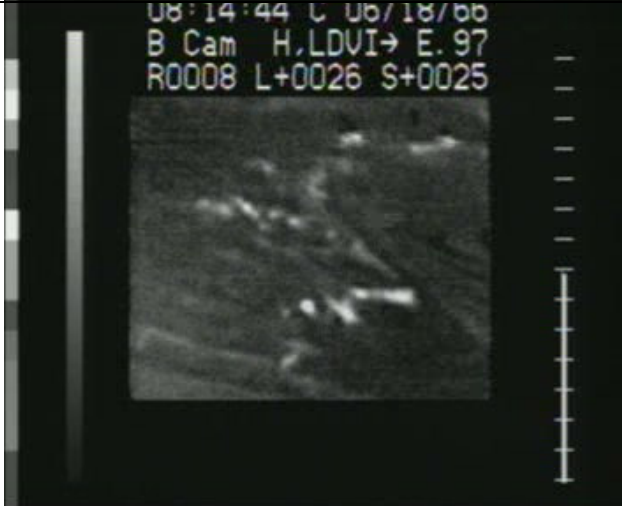
<p>c) heating on upper layers of north-west (Ghallis) ridge</p>

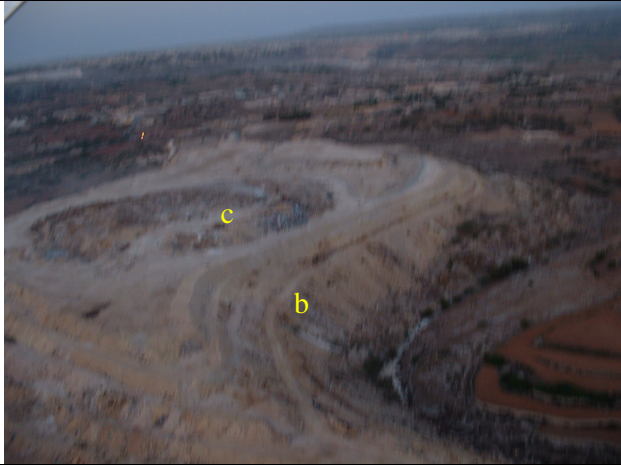
**Plate 3.5: Thermal Survey Top of Maghtab**

<p>An aerial photograph of a large, irregularly shaped landfill site. The terrain is a mix of brown, tan, and dark grey, indicating different layers of waste and vegetation. Two yellow letters, 'b' and 'c', are placed on the image to indicate specific locations of interest. 'b' is located in the lower-middle part of the landfill, and 'c' is located in the upper-middle part.</p>	<p>a) Aerial view of top of Maghtab showing locations of photos b) and c)</p>

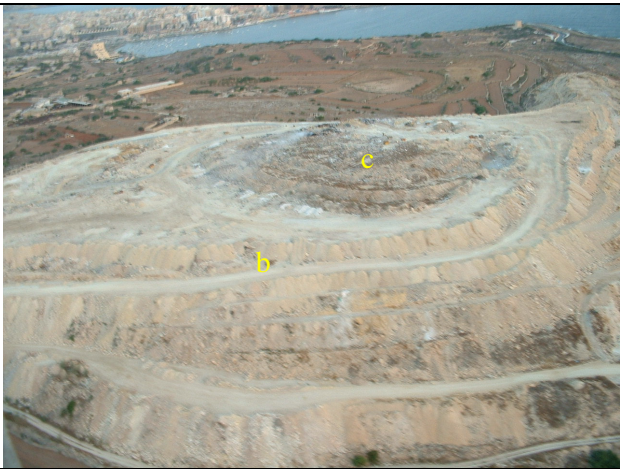
**Plate 3.6: Thermal Survey East Side of Maghtab**

<p>a) Aerial view of eastern side of Maghtab showing locations of photos b) and c)</p>

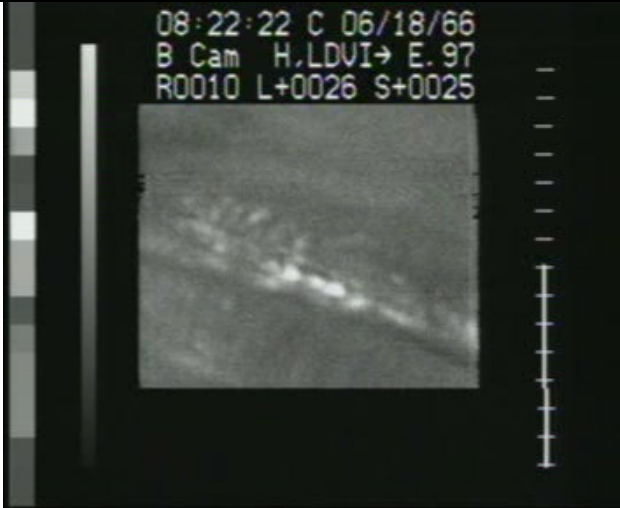
<p>b) heating along side of main haul road on eastern side of landfill</p>

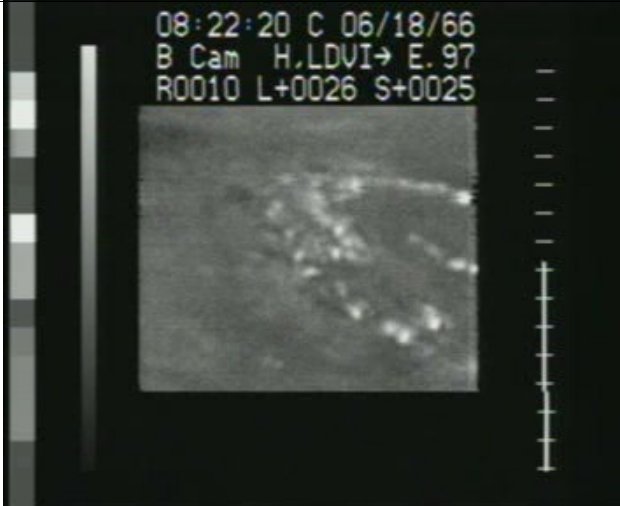
<p>c) heating under area of recent waste deposition on top of Maghtab. Note curved lines of heat corresponding to areas of waste buried as waste deposition front moves.</p>

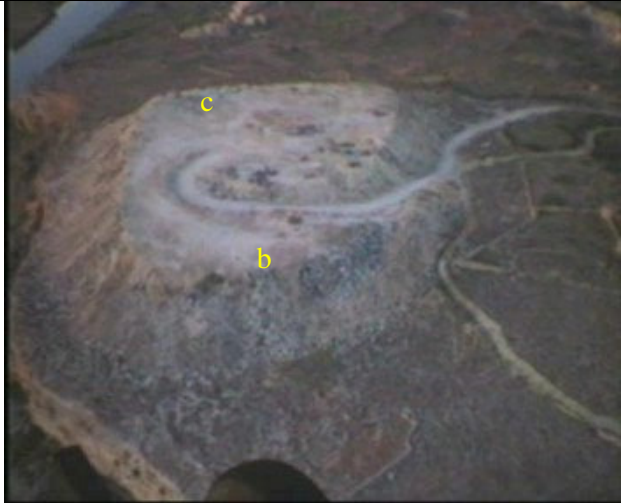
**Plate 4.1: Thermal Survey Qortin**

<p>a) Aerial view of Qortin showing locations of photos b) and c)</p>

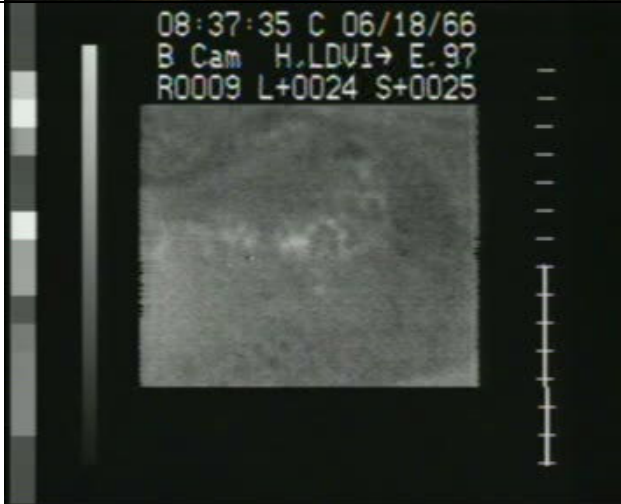
<p>b) very limited heating along north-western crest of Qortin (site of some cracking and minor venting)</p>

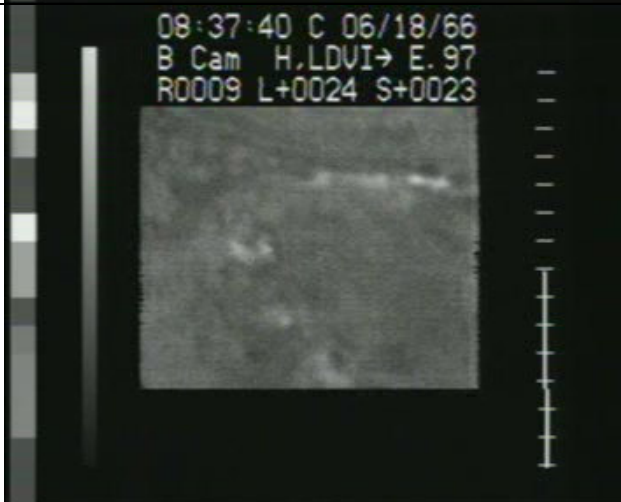
<p>c) limited heating under north-eastern crest of Qortin (site of cracking and venting).</p>

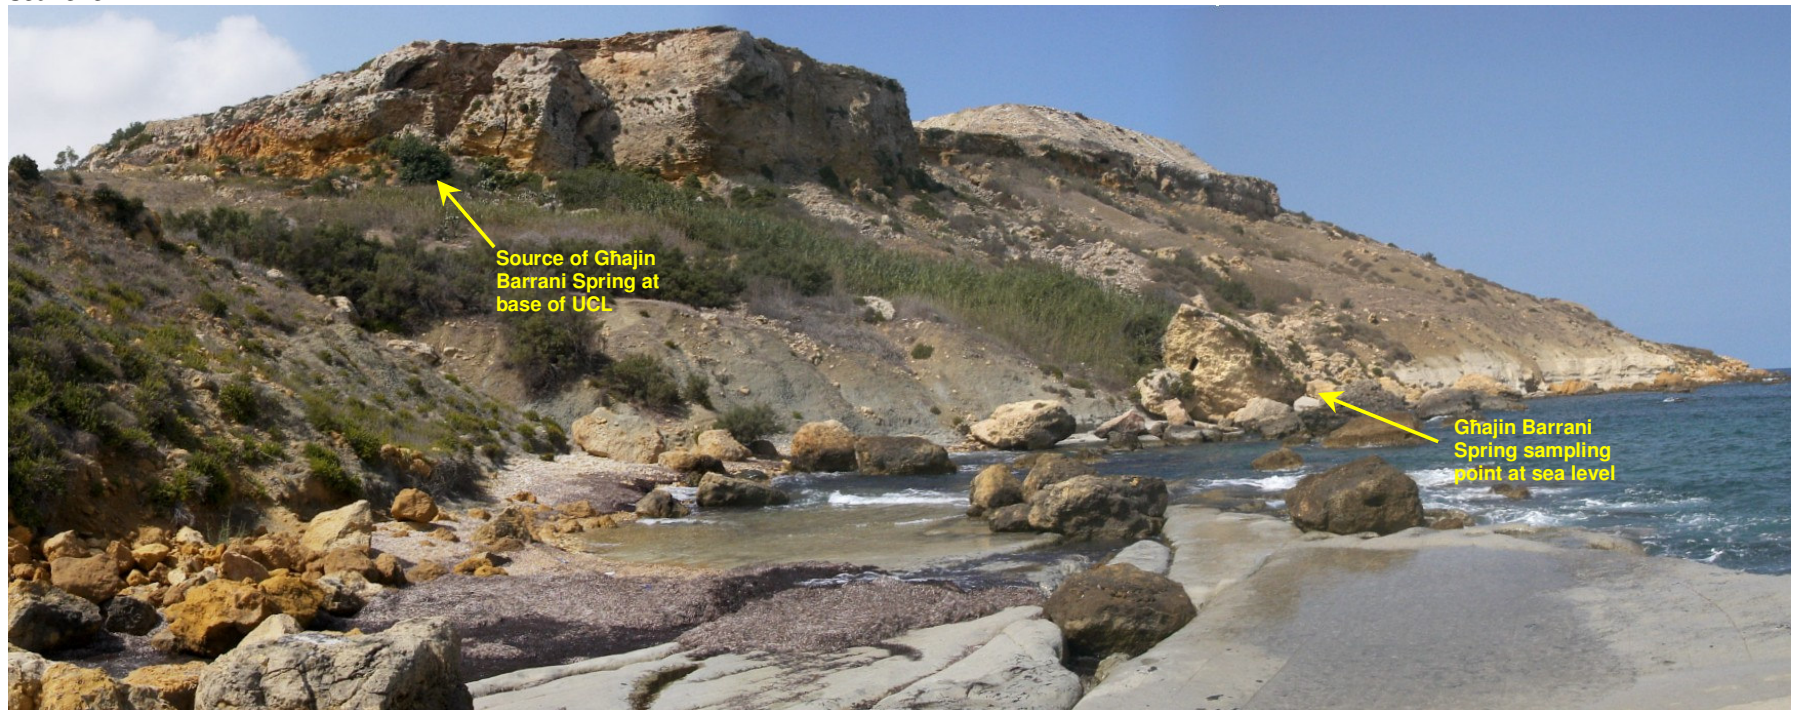
**Plate 4.2: Qortin from Ghajn Barrani showing Upper Coralline Limestone overlying Blue Clay with Globigerina Limestone at sea level.**

At Qortin and Wied Fulija the waste masses have encroached of to within a few metres of the crests of precipitous cliffs. There is historical evidence of failure of sections of these cliffs and such occurrences will inevitably occur in the future (although the timescale over which such events will occur is unknown at present). Should localised cliff failure occur the potential exists for waste materials to be deposited onto the foreshore and possibly into the sea.

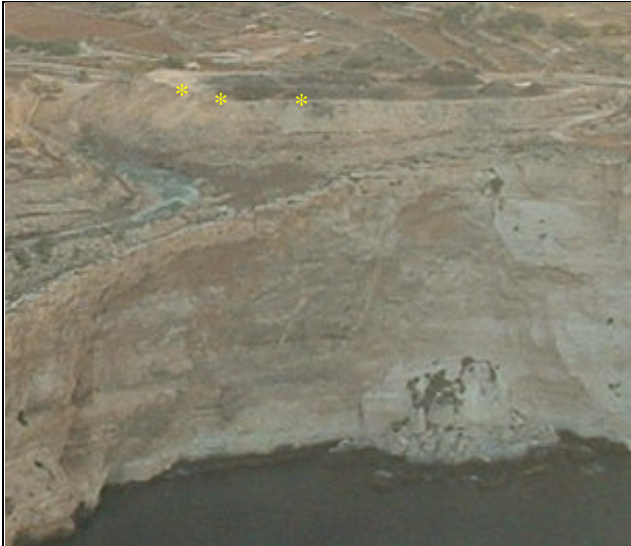
**Plate 5.1: Thermal Survey Wied Fulija – East Mound**

There is evidence of previous cliff failure where significant blocks have fallen into the sea beneath the eastern waste mound (Plate 5.1).

<p>a) Aerial view of east mound at Wied Fulija. Asterisks show locations of heating in photo b).</p>

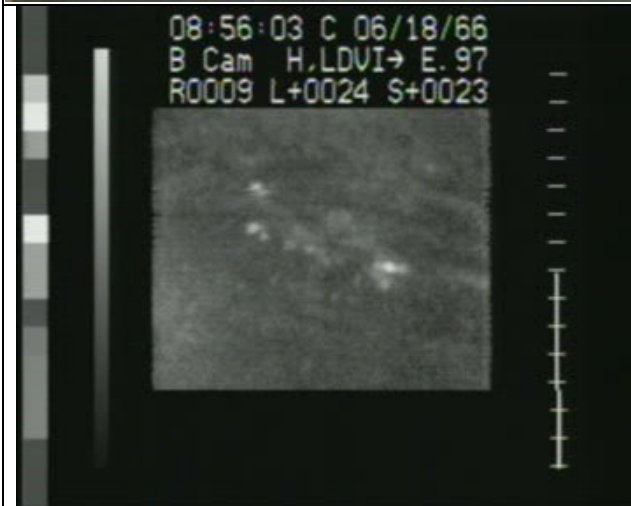
<p>b) limited heating along southwestern crest of east mound (site of some cracking and minor venting)</p>

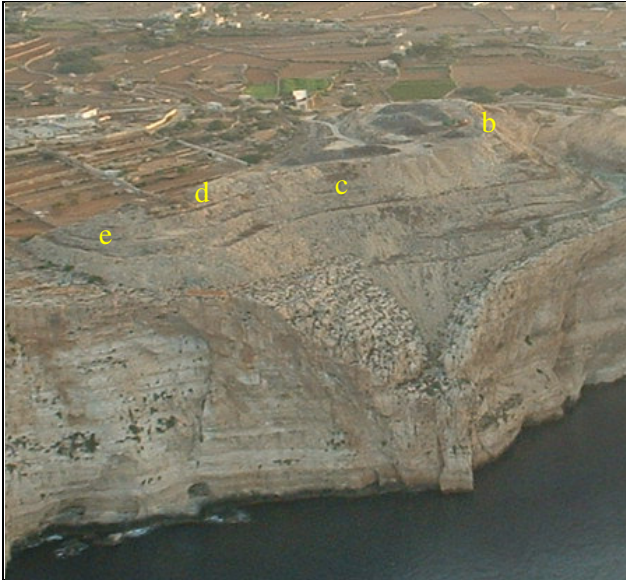
**Plate 5.2: Thermal Survey Wied Fulija - West Mound**

The two waste mounds encroach to within a few metres of the crest of vertical or overhanging sea cliffs approximately 100m high. Waste also infills the line of the former Wied Hallelin valley and forms a large, sloping, wedge-shaped face where this is exposed above the cliff (Plate 5.2). The near horizontally bedded rock in the cliffs comprises strata of the Lower Coralline Limestone Formation.

<p>a) Aerial view of Qortin showing locations of photos b) - e). Note cliff overhang and infilled valley of Wied Hallelin.</p>

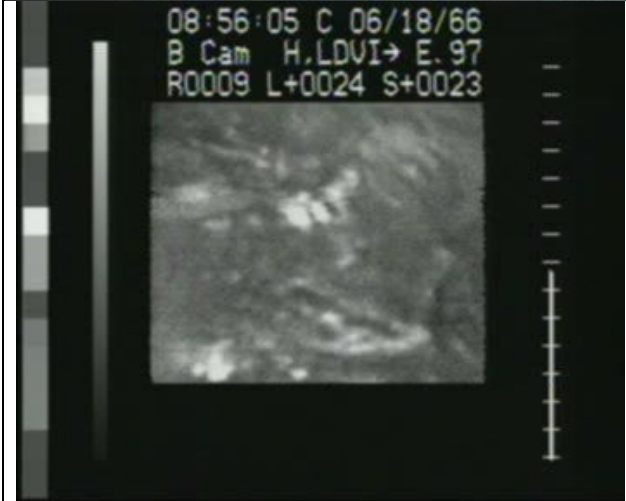
<p>b) heating on crest and on base of south-eastern corner of west mound.</p>

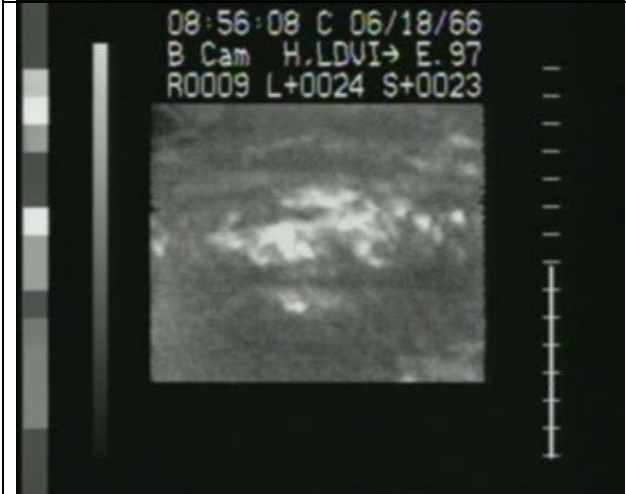
<p>c) heating on centre of west mound.</p>

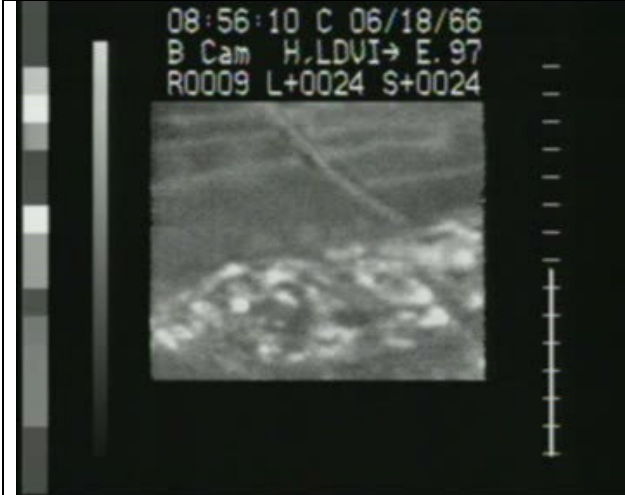
d) Top of western end of west mound

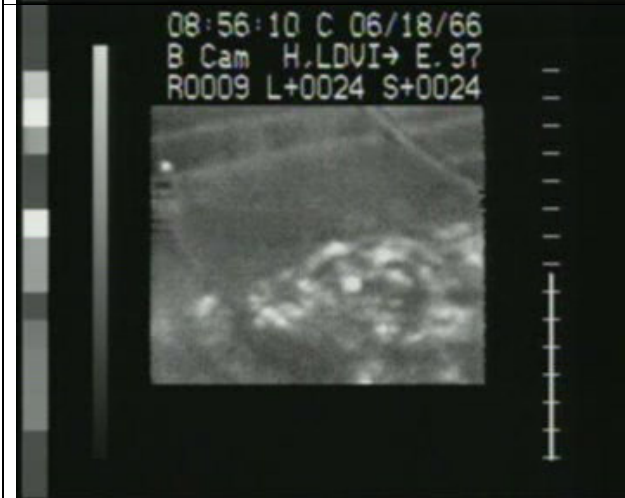
e) western end of west mound

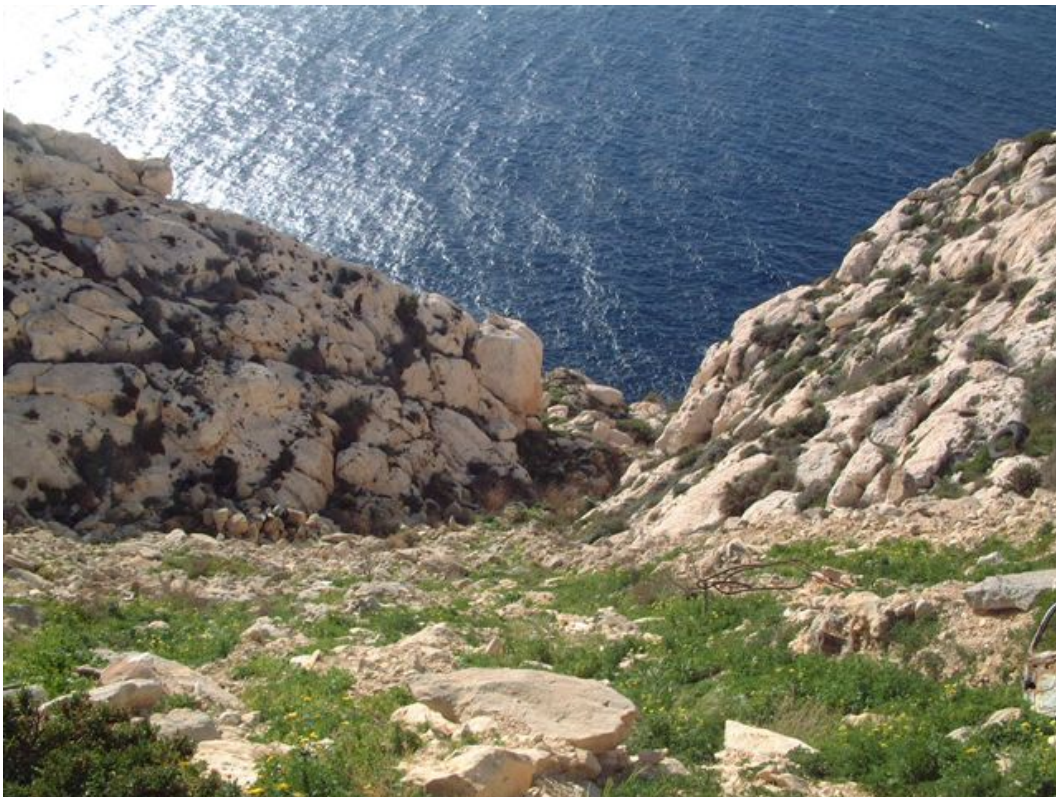
**Figure 6: Mouth of Wied il-Hallelin, with vertical sides colonised by rupestral vegetation.**  
**Much of the mouth has been infilled by construction debris.**
