***Ta' Żwejra Non-hazardous Engineered Waste  
Management Facility I/o Naxxar***

**Application for Renewal of IPPC permit IP 0001/05/B**

# ANNEX 2: ERA inspection report

## Routine Inspection Report

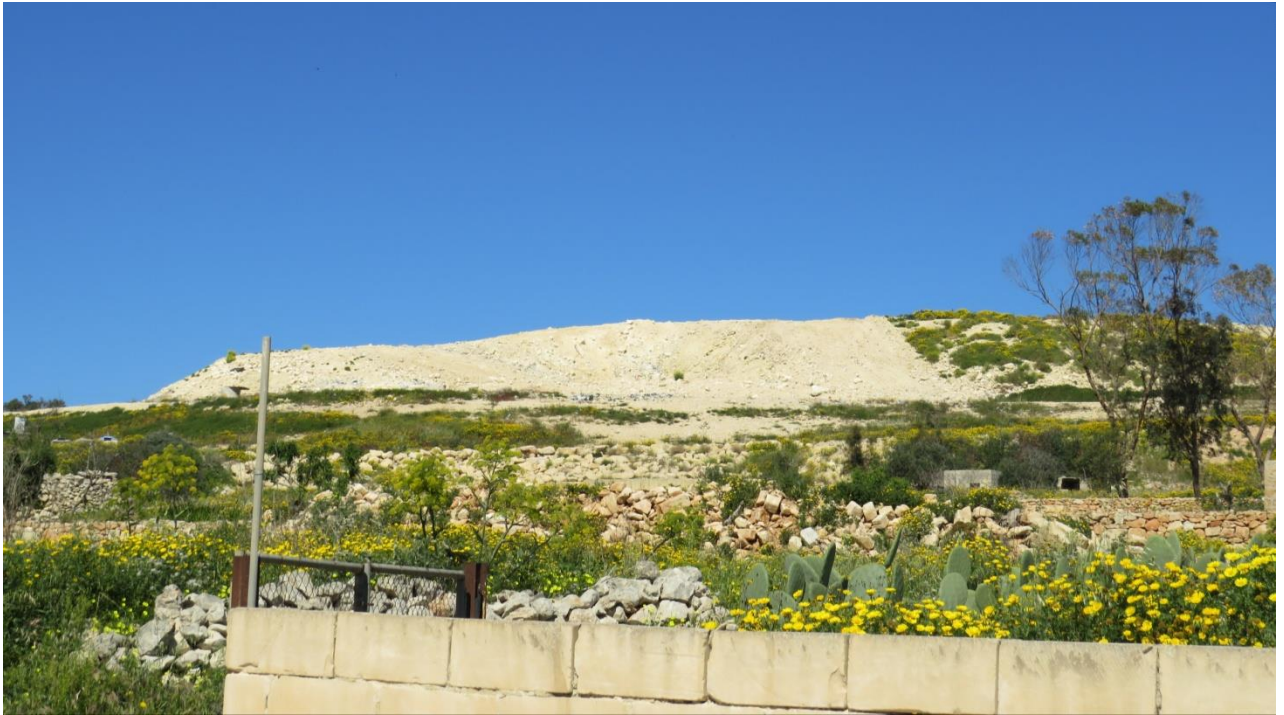
**Photo 1** – Fresh inert material deposited in an area previously used to stockpile grey bags

Aspect	Detailed Observations	Actions Required by Operator
Site Security	The undersigned officers approached the complex from the back gate. The gate was found to be open and the guardhouse unmanned.	Operator is to ensure that the site is secured as per IP Condition 3.10.1.5 which states that the operator shall ensure that the landfill is secured to prevent free access to the site.
Operations on Site during Inspection	<p>No grey bags were noted in the area covered by the Ta' Zwejra Permit. An area previously being used for stockpiling of grey bags was noted to be covered with fresh inert material <b>(see Photo 1)</b>.</p> <p>No information has been received regarding the backlog of grey bags awaiting processing which had been observed stored next to MBT North and which had also been transferred to Ta' Zwejra.</p>	Operator is to provide ERA with details of the total capacity of grey bag waste that was stockpiled therein and what has happened to these stockpiles. A target timeframe during which the total backlog of grey bags is envisaged to undergo treatment at the MBT facility should also be submitted <b>within 2 weeks</b> of the date of the covering letter of this report.

Aspect	Detailed Observations	Actions Required by Operator	WSM Reply
Site Security	The undersigned officers approached the complex from the back gate. The gate was found to be open and the guardhouse unmanned.	Operator is to ensure that the site is secured as per IP Condition 3.10.1.5 which states that the operator shall ensure that the landfill is secured to prevent free access to the site.	Manning of security gate is being reviewed to ensure that gate is adequately manned.
Operations on Site during Inspection	No grey bags were noted in the area covered by the Ta' Zwejra Permit. An area previously being used for stockpiling of grey bags was noted to be covered with fresh inert material (see Photo 1). No information has been received regarding the backlog of grey bags awaiting processing which had been observed stored next to MBT North and which had also been transferred to Ta' Zwejra.	Operator is to provide ERA with details of the total capacity of grey bag waste that was stockpiled therein and what has happened to these stockpiles. A target timeframe during which the total backlog of grey bags is envisaged to undergo treatment at the MBT facility should also be submitted within 2 weeks of the date of the covering letter of this report.	Stockpile of bags is being maintained as feedstock to Malta North plant; data on inputs is being compiled.

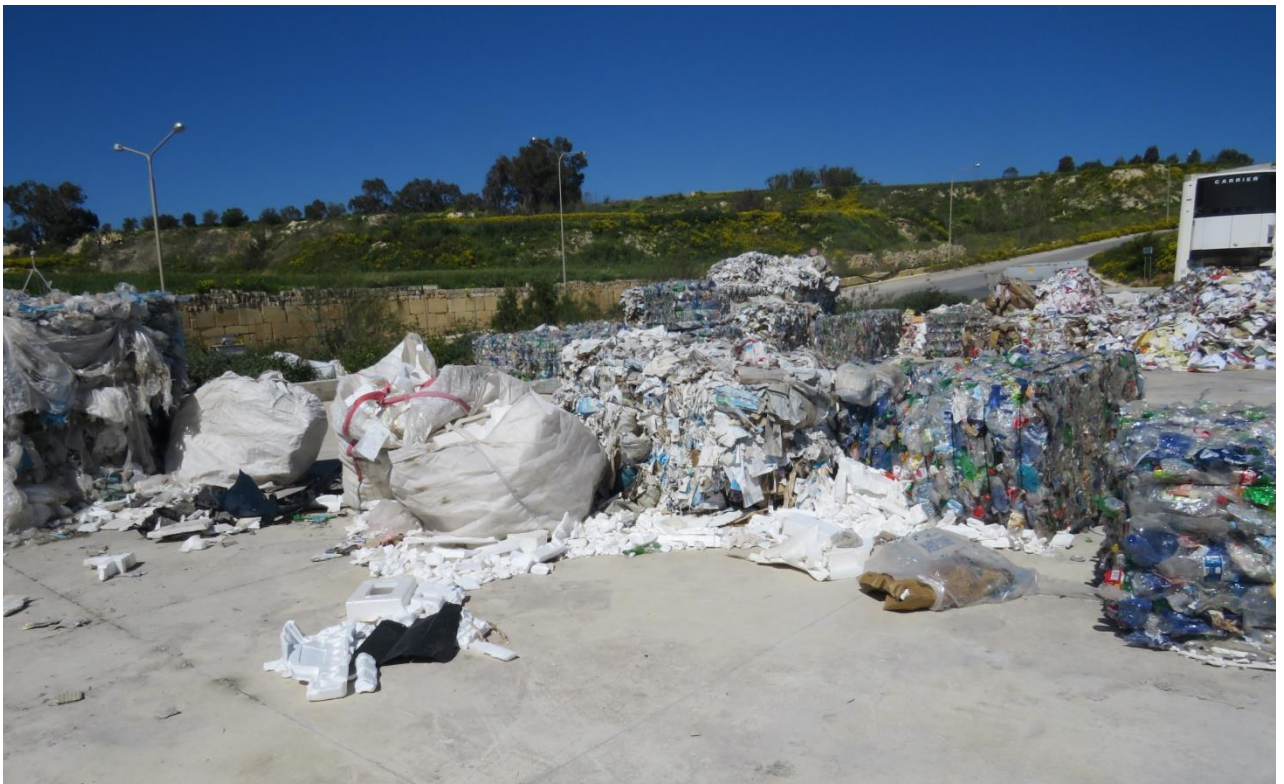
Area Above Water Reservoir	The area above the water reservoir was noted to be full of Jumbo bags of expanded polystyrene, bales of PET and loose car bumpers. Expanded polystyrene, both loose and bagged, was noted to be wind-blown around the site <b>(see Photos 2 and 3)</b> .	Operator should clear the area and provide ERA with details of the end disposal of this waste <b>within 2 weeks</b> of the date of the covering letter of this report.

**Photo 2** – Some of the material stored in the area above the water reservoir

Area Above Water Reservoir	The area above the water reservoir was noted to be full of Jumbo bags of expanded polystyrene, bales of PET and loose car bumpers. Expanded polystyrene, both loose and bagged, was noted to be wind-blown around the site (see Photos 2 and 3).	Operator should clear the area and provide ERA with details of the end disposal of this waste within 2 weeks of the date of the covering letter of this report.	Efforts are being undertaken to catch up with backlog of material to be exported.

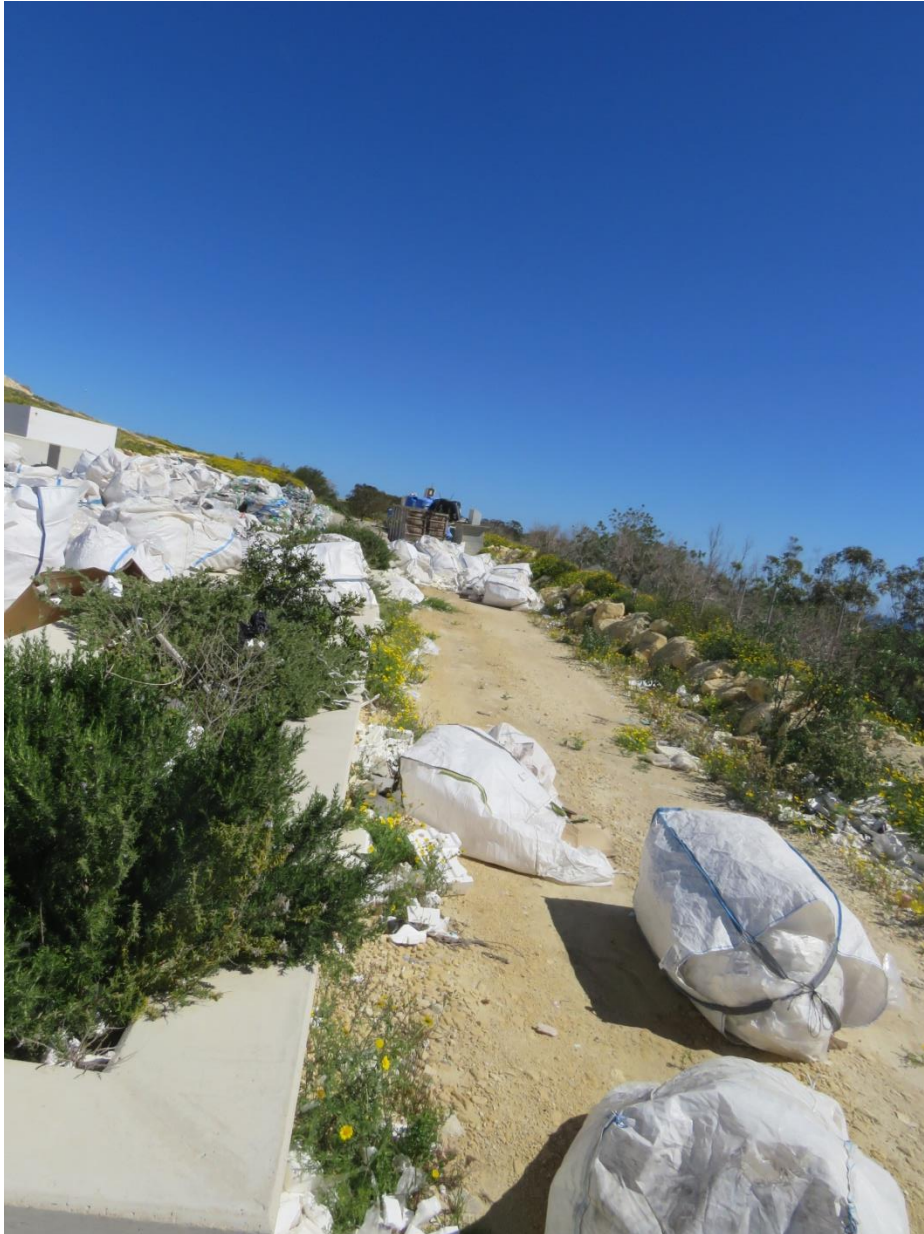
**Photo 3** – Expanded polystyrene being wind blown out of the area
