**PA/05908/23 & EA/00007/18**

**PROPOSED CONVERSION FROM A TEMPORARY TO A PERMANENT TUNA FARMING AREA AS ESTABLISHED IN PA/02175/18; RETAINING THE APPROVED TOTAL BIOMASS OF FISH AND ALL RELATIVE CONDITIONS**

**ENVIRONMENTAL IMPACT ASSESSMENT UPDATE REPORT  
VOLUME I: COORDINATED REPORT**

**Version I: January 2025**

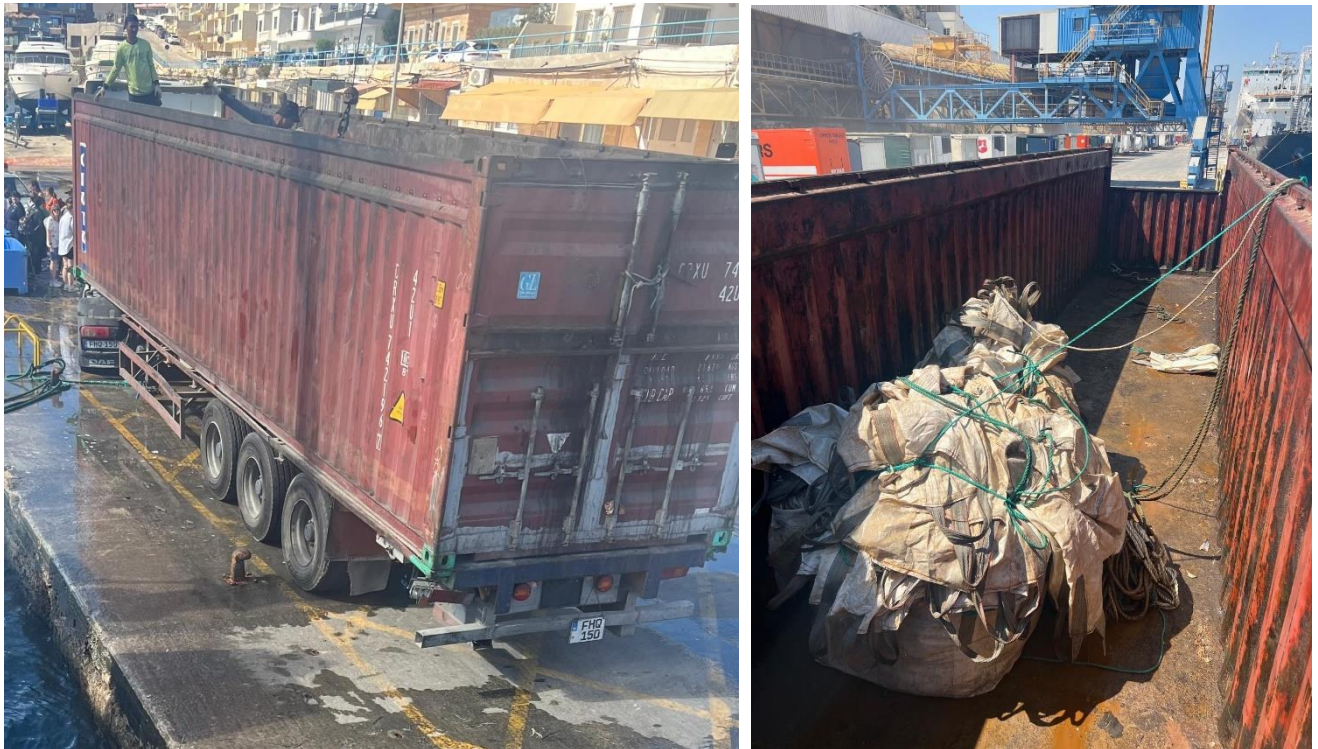
**Figure 2.4: Truck with feed in jumbo bags left to partially defrost**

- 2.12. In order to optimise feeding efficiency it is necessary to ensure that when fed to the tuna the baitfish are not completely defrosted so that the high calorific oils are ingested too and not lost from the feed. Nonetheless, the process does involve the development of an oily slick originating from the semi-frozen feed. In order to address this issue, a number of measures have been taken throughout the past years. These include:

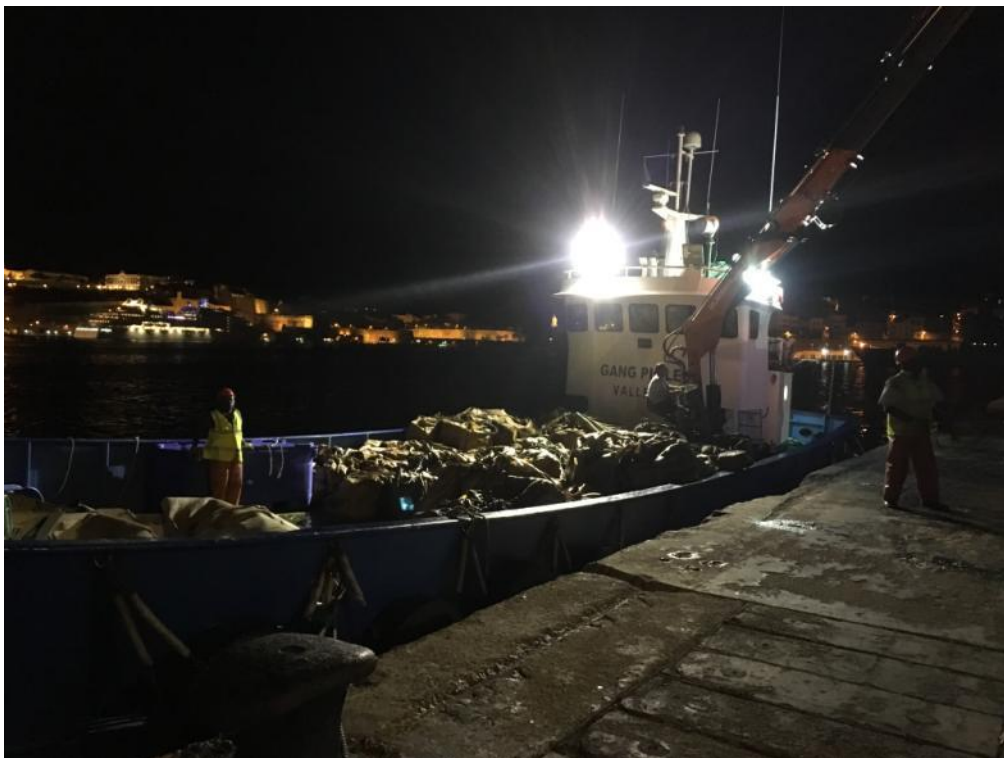
**Figure 2.5: Feed being loaded on to feeder vessel early in the morning**

- 2.10. Early the next day (around 4:00 hrs), the baitfish are transferred to the Grand Harbour where they are delivered alongside and loaded onto a feeder vessel (**Figure 2.5**). Once loaded, the vessel sets sail towards the farm. The thaw water in the trucks is drained into IBCs and collected by a licensed waste contractor.

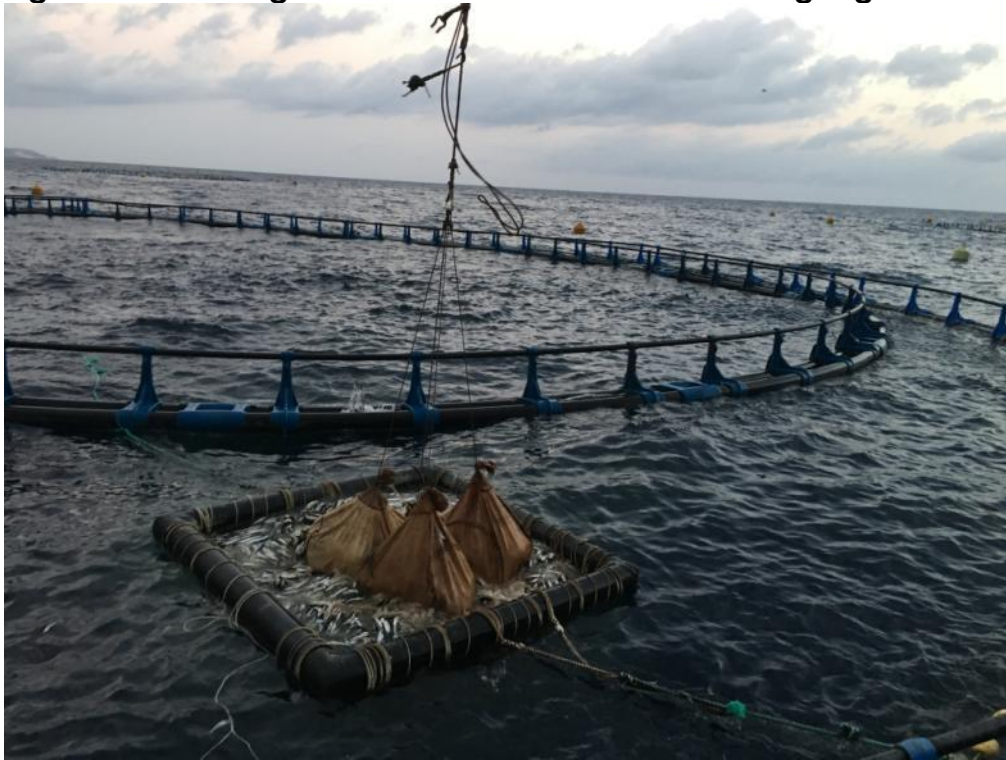
**Figure 2.6: Loading of semi-frozen baitfish into feeding cage**

- 2.11. The tuna are fed once a day, at dawn. Semi-frozen baitfish<sup>7</sup> are normally placed in small feeding cages floated at the centre of the pen (**Figure 2.6**), and once they have been thawed enough, the central cage is opened by divers and the fish dispensed into the pen. The divers monitor the tuna and control the amount of feed released into the pen to minimise wastage. Once the tuna are satiated, the diver stops feeding. The process may be repeated two hours later; however, if the tuna are satiated, any remaining fish can be lifted from the pen and transferred to other cages.

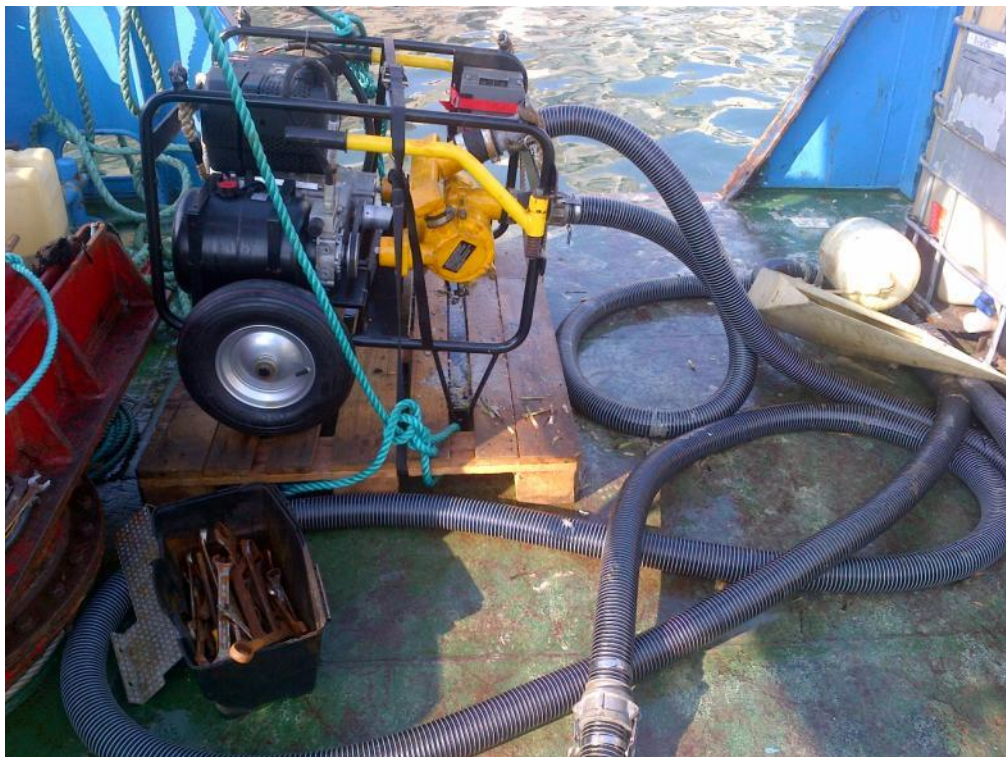
**Figure 2.7: Skimmer**

<sup>8</sup> This would depend on the state of the sea. Under calm conditions, the surface slick is mostly retained inside the cage; on the other hand, strong swell could result in overtopping of the oily slick outside of the cage containment. In this case, external oil spill containment / spill collection vessels would need to be deployed.

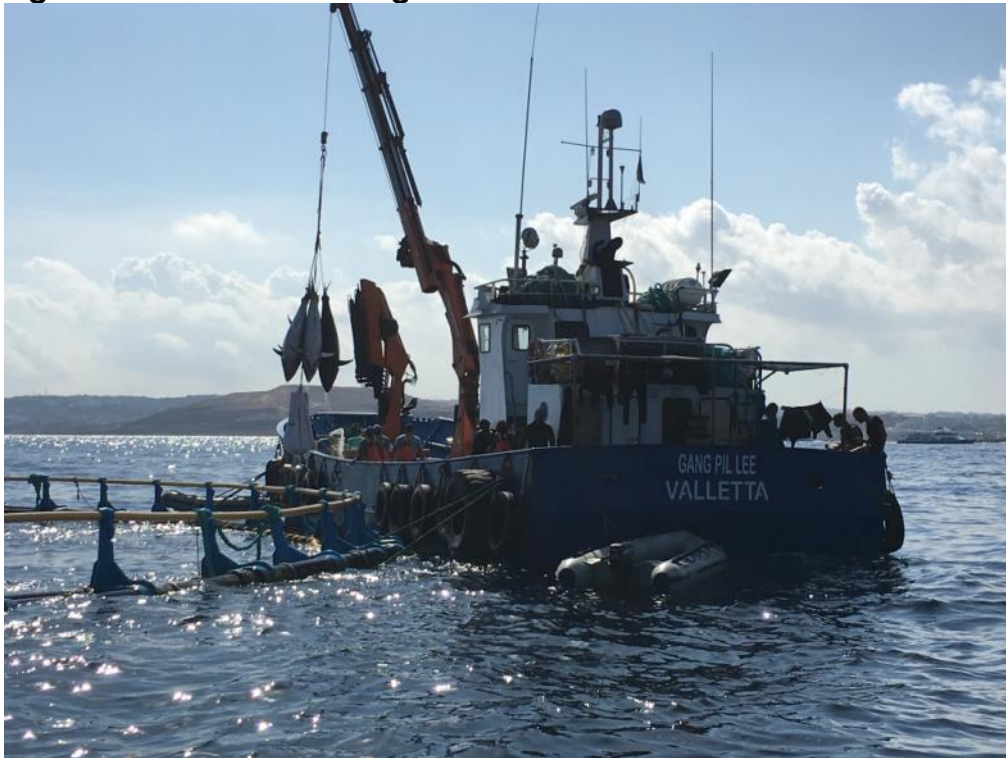
**Figure 2.8: Tuna harvesting**

- 2.16. The tuna are transferred to a service vessel by crane (**Figure 2.8**) from where they are then quickly transported by service boats (**Figure 2.9**) to a waiting processing vessel anchored further out at sea (**Figure 2.10**). Onboard the ship, the tuna are weighed, heads and tails are cut off and the guts removed. The head, tails and guts of the tuna, which amount to approximately 30% by weight, are a waste by-product of the industry. These used to be disposed of at sea beyond the 12 nautical mile limit as directed by the Veterinary and Phytosanitary Regulation Department. However, following the establishment of Aquaculture Resources Ltd by the Federation of Maltese Aquaculture Producers and the construction of a rendering plant in Hal Far, this waste by-product is being collected and transformed into valuable products, including protein-rich fish meal and Omega-3 and Omega-6 fish oils. These materials are essential for the cosmetic, pharmaceutical, and agricultural industries (Aquaculture Resources Ltd, 2024<sup>11</sup>). The operation typically generates approximately 8-10 tonnes of offal per day during the peak fattening period.

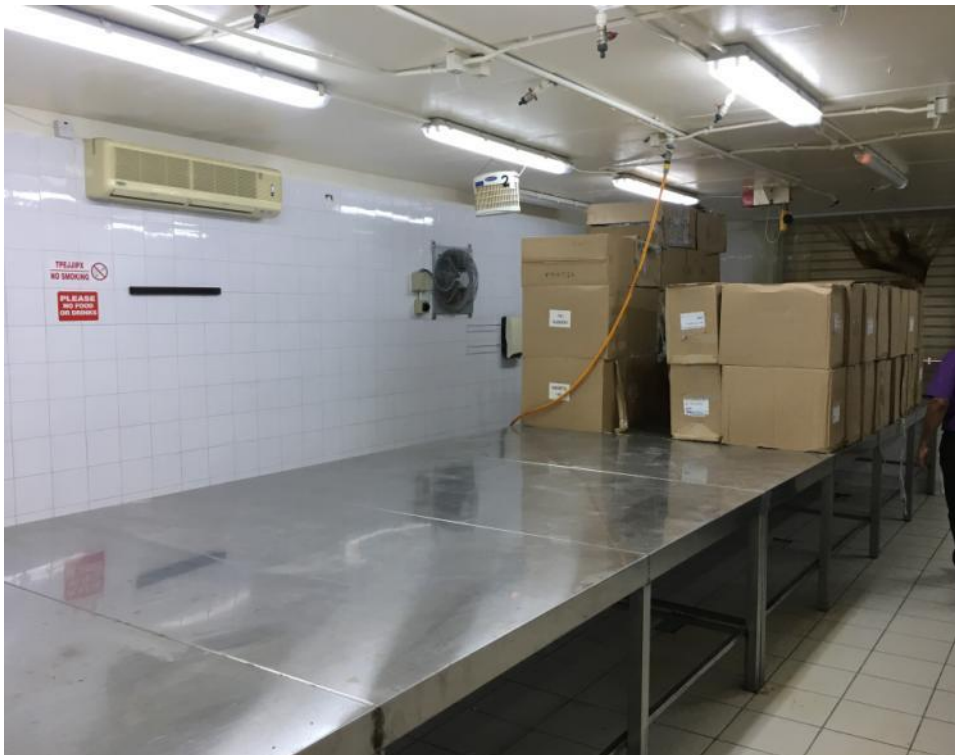
**Figure 2.11: Marfa land-based facility**

- 2.18. If the harvested fish are to be sold to the fresh fish market, they are normally processed onboard the service boats (not the processing vessels / freezer ships) and at the land base facility in Marfa or the Azzopardi fish shop in St Paul's Bay (**Figure 2.11**). In this case, processing has to take place in a short time interval in order to minimise the length of time that the fish remain at ambient temperatures. The fish are processed in the same manner as described above, except that rather than blast frozen, the fish are cooled in an ice and salt mixture to the desired temperature and packed in purposely designed carton boxes for export.

- 2.24. The Applicant operates two land bases (see **Figure 2.12**). One land base is situated in Marfa and is used for packing and processing of fresh fish for export by air freight. The second land base is located at the Kordin industrial estate and is used to receive and prepare the bait fish as well as for the washing and storage of crates. A third site in Maghtab is used to store cage materials, nets, and ancillary farm materials.

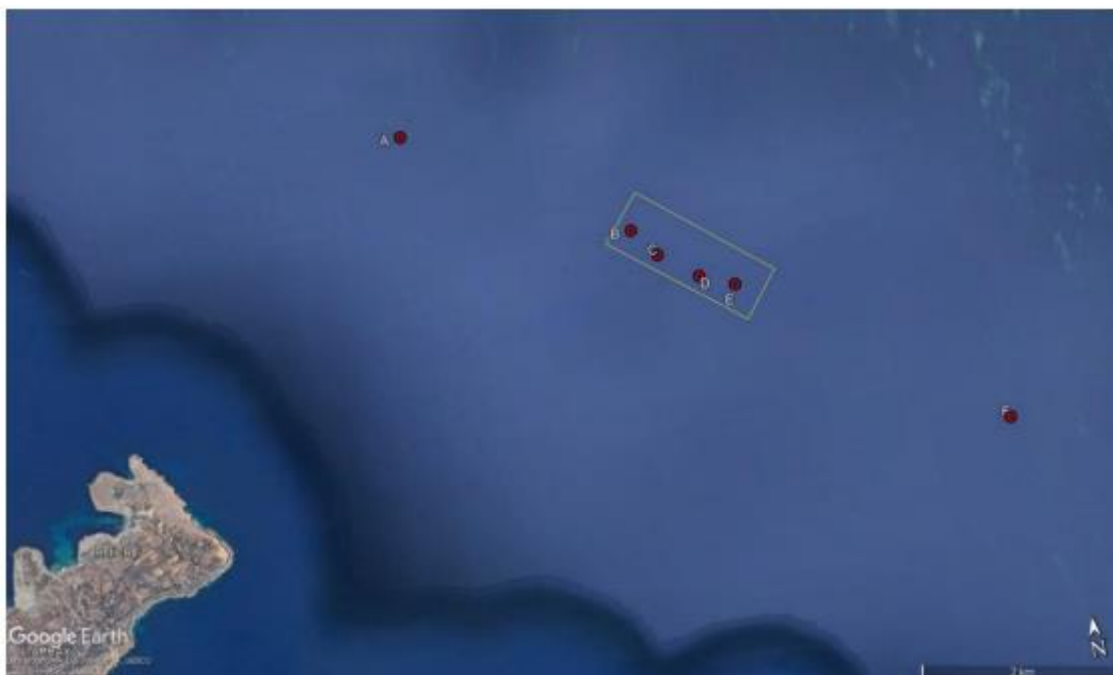
**Figure 4.2: Aerial image showing the locations of water quality monitoring stations A - F.**

- 4.26. Analysis of the findings of the monitoring data for water quality (2019 – 2023) and seabed sediments (2023) have been reviewed and assessed against the baseline conditions reported in the original EIA. **Tables 4.5** and **4.6** provide a summary of the findings of the water quality and sediment monitoring, respectively.

Monitoring session	Summary of Findings
March 2019	<p>Values of temperature, salinity, dissolved oxygen, turbidity and Secchi Disc depth recorded from the four water quality monitoring stations were similar, overall, during both spring and summer 2019 sessions.</p> <p>No floating material, surface oil slicks, tarry residue, surface foam/bubbles or odours were detected on the sea surface during this survey. This was corroborated by aerial photographs of the survey area.</p> <p>Of the 8 cages used by AJD Tuna Ltd, two cages had a net and appeared to hold tuna; likewise, of the 8 cages used by Malta Mariculture Ltd, two cages had a net and appeared to hold tuna.</p> <p>Mean values of pH, Total Nitrogen, Total Phosphorous, Chlorophyll a, total organic carbon (TOC) and total suspended solids (TSS) in seawater recorded from the four stations were similar, overall, during both spring and summer 2019 sessions.</p> <p>The findings of the present water quality monitoring session indicate that AJD's and MML's tuna farming activities have not resulted in appreciable alteration of water quality in terms of the monitored attributes.</p>

September 2019	<p>Values of temperature, salinity, dissolved oxygen, turbidity and Secchi Disc depth recorded from the four water quality monitoring stations were similar, overall, during both spring and summer 2019 sessions.</p> <p>Some oil slicks and foam were observed on the surface during fieldwork. Such patches were dispersed and recorded close to the boundary line of the tuna farms, in the vicinity of the western station.</p> <p>No floating material, surface oil slicks, tarry residue, surface foam/bubbles or odours were detected</p>
