PROPOSED CONVERSION FROM A TEMPORARY TO A PERMANENT TUNA FARMING AREA AS ESTABLISHED IN PA/02175/18; RETAINING THE APPROVED TOTAL BIOMASS OF FISH AND ALL RELATIVE CONDITIONS

**ENVIRONMENTAL IMPACT ASSESSMENT UPDATE REPORT
VOLUME 2: TECHNICAL APPENDICES**

REMOTE SENSING SURVEY REPORT 2018

Malta Environmental Baseline: Acoustic and Camera Surveys April / May 2018

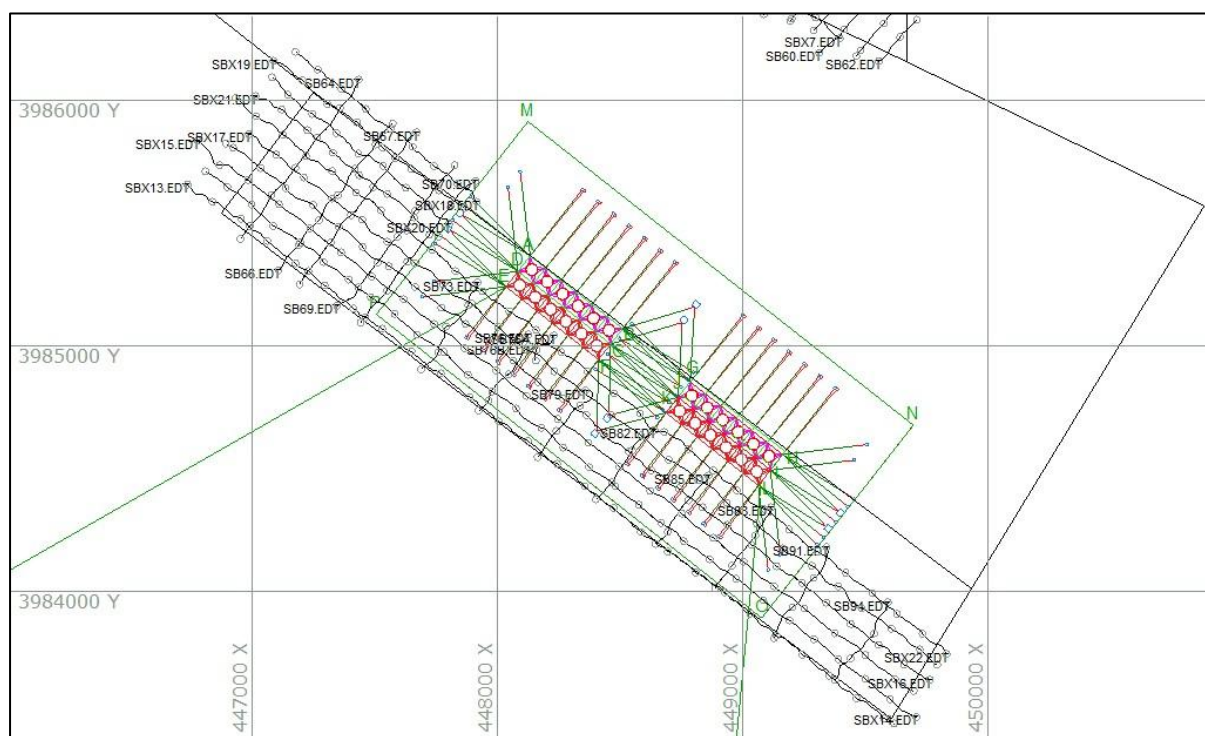
Figure 2.4: Bathymetric survey track plots for all successful survey lines in area 2

In area 2 a total of 23 lines of good quality data were achieved. The survey plan for this area had to be altered during the fieldwork due to the prevailing wind and sea conditions. This meant fewer NE-SW main lines were run, but additional cross lines were added. Figure 2.4 shows the track plot for the achieved bathymetric survey lines in area 2.

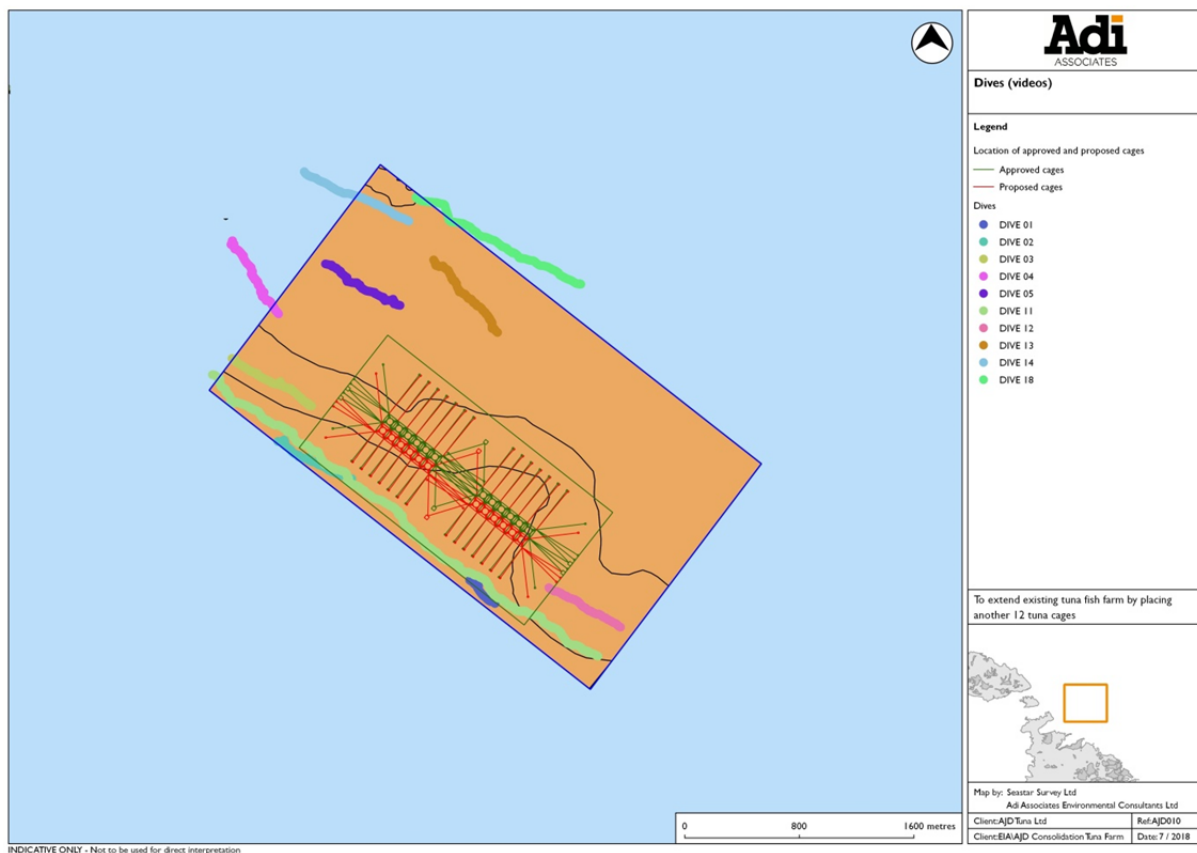
Figure 4. Map showing the survey area (blue boundary) and locations of the ten video transects (referred to as 'Dives' in the figure key) that were used to survey the marine benthic habitats present in the area of interest. Map source: Seastar Survey Ltd (UK) and Adi Associates Environmental Consultants Ltd.

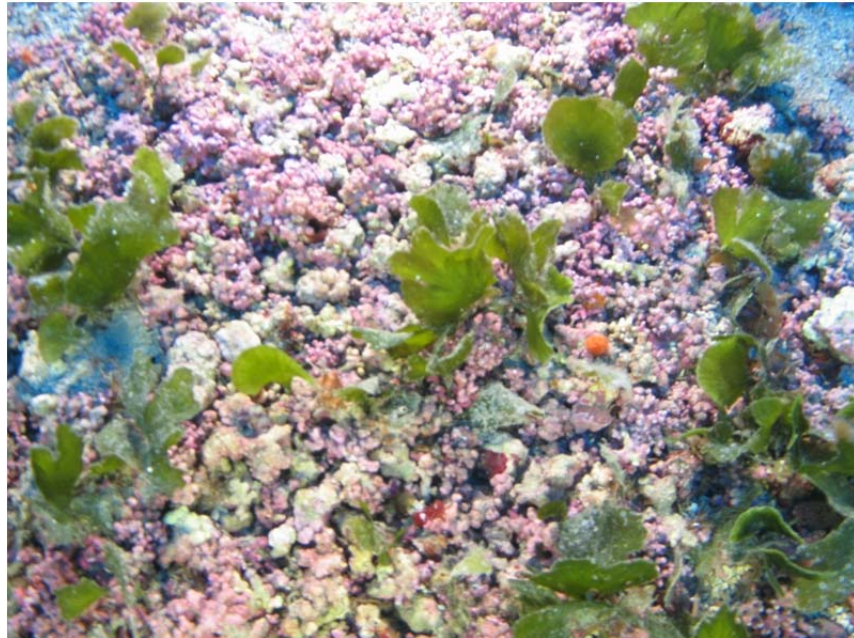
Figure 6. Photograph of the seabed taken at a point along Transect 5, showing a close-up of a dense rhodolith bed. The green alga visible in the photo is *Flabellia petiolata*.

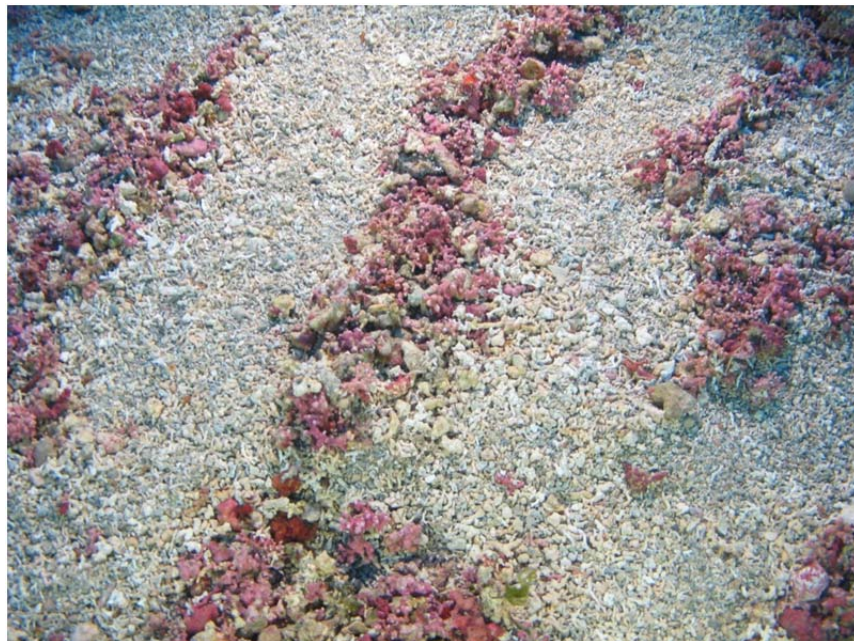
Figure 7. Photograph of the seabed taken at a point along Transect 12, showing a close-up of a sparse rhodolith bed.

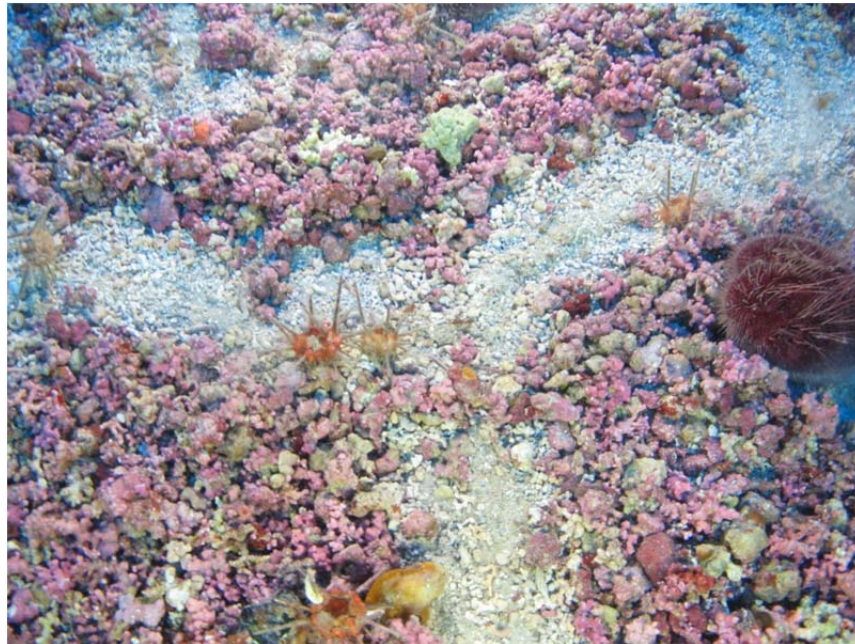
Figure 8. Photograph of the seabed taken at a point along Transect 5, showing a close-up of a rhodolith bed intermixed with bare sediment. The five orange coloured long-spined urchins visible in the photo are individuals of *Stylocidaris affinis*. The large purple coloured urchin on the right hand side of the photo is an individual of the Purple Heart Urchin *Spatangus purpureus*.

33. The most abundant megafaunal species that were recorded from this association are the cidariid sea urchin *Stylocidaris affinis* and the Purple Heart Urchin *Spatangus purpureus* (Figure 8); other megafaunal species that were recorded during the survey included several species of sponges and bryozoans (including *Sertella* sp.), the Long-spined Urchin *Centrostephanus longispinus* (Figure 9), the Red Seastar *Echinaster sepositus* (Figure 10), the crinoid *Antedon mediterranea*, the crab *Inachus* sp., and the seastar *Luidia ciliaris*. Furthermore, the presence of openings to numerous burrows in places indicated an associated rich infauna.

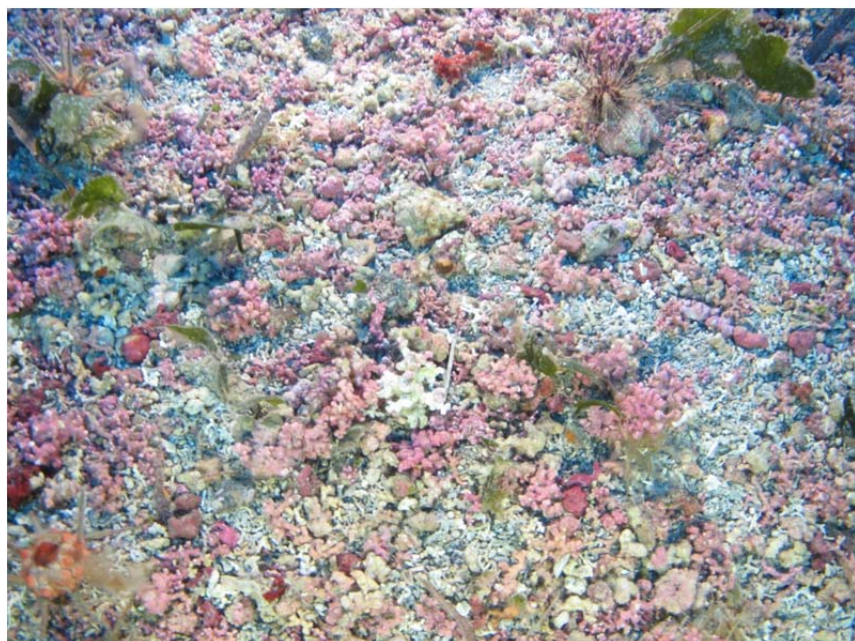
Figure 9. Photograph of the seabed taken at a point along Transect 3, showing a close-up of a rhodolith bed. An individual of the Long-spined Urchin *Cenrostrephanus longispinus* is visible at the top right hand corner of the photo adjacent the alga *Flabellia petiolata* (green).

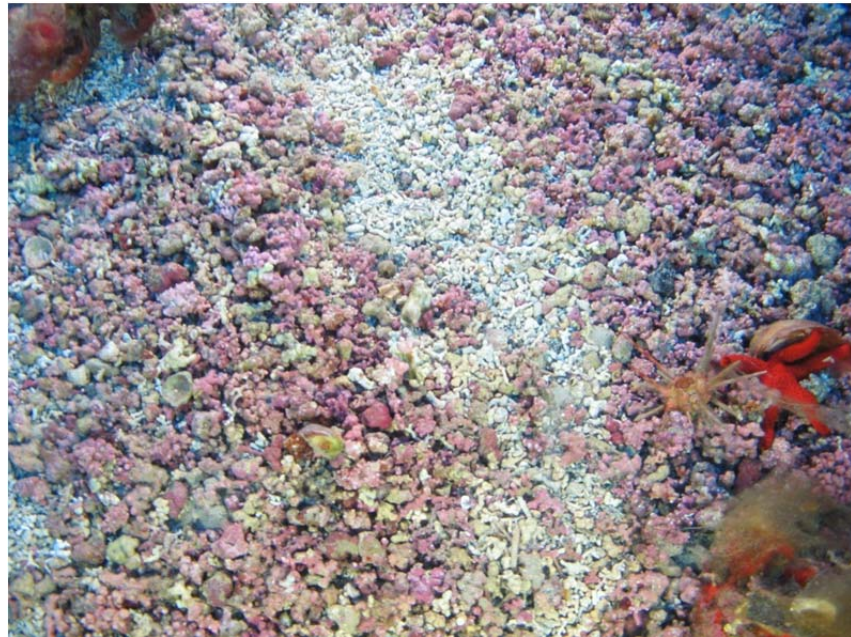
Figure 10. Photograph of the seabed taken at a point along Transect 5, showing a close-up of a rhodolith bed. An individual of the urchin *Stylocidaris affinis* and another of the Red Seastar *Echinaster sepositus* are visible on the right side of the photo.

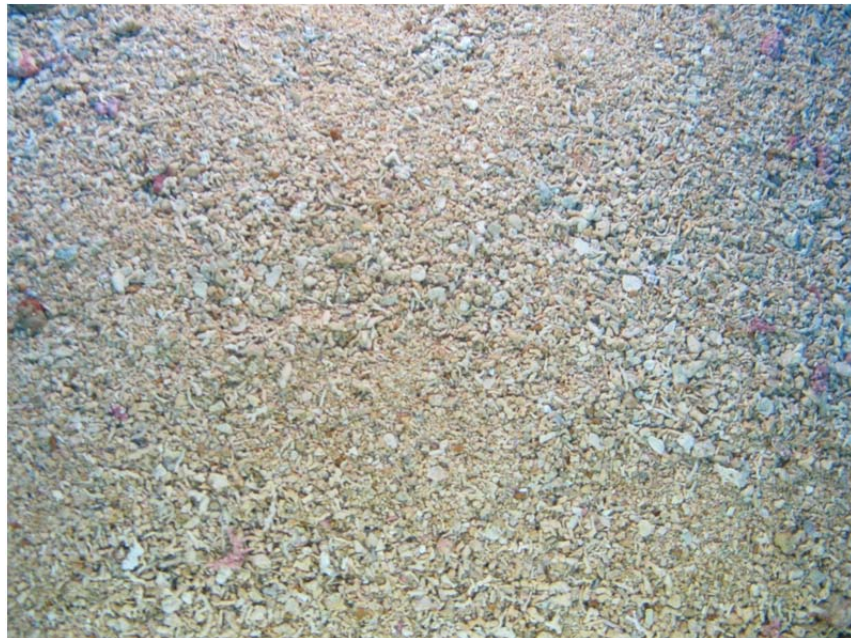
Figure 11. Photograph of the seabed taken at a point along Transect 2, showing a close-up of an assemblage of infralittoral coarse sediment.

20% (see Figures 11 - 14). Detached algal and plant (seagrass) material was present in places on the seabed where this assemblage occurred but no attached fleshy algae or seagrasses were present. The epifauna associated with this assemblage was impoverished; the most abundant macrofaunal species was the Purple Heart Urchin *Spatangus purpureus* (Figure 15) and groups of the Purple Urchin *Sphaerechinus granularis*. However, the presence of openings to burrows present in many places indicated the presence of a rich infauna.

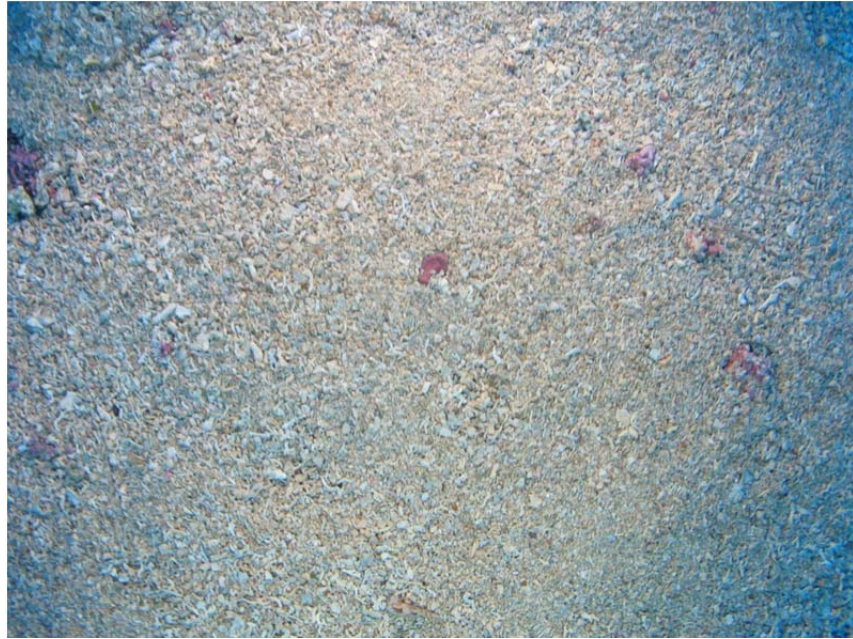
Figure 12. Photograph of the seabed taken at a point along Transect 2, showing a close-up of an assemblage of infralittoral coarse sediment. An individual rhodolith is visible at the centre of the photo.

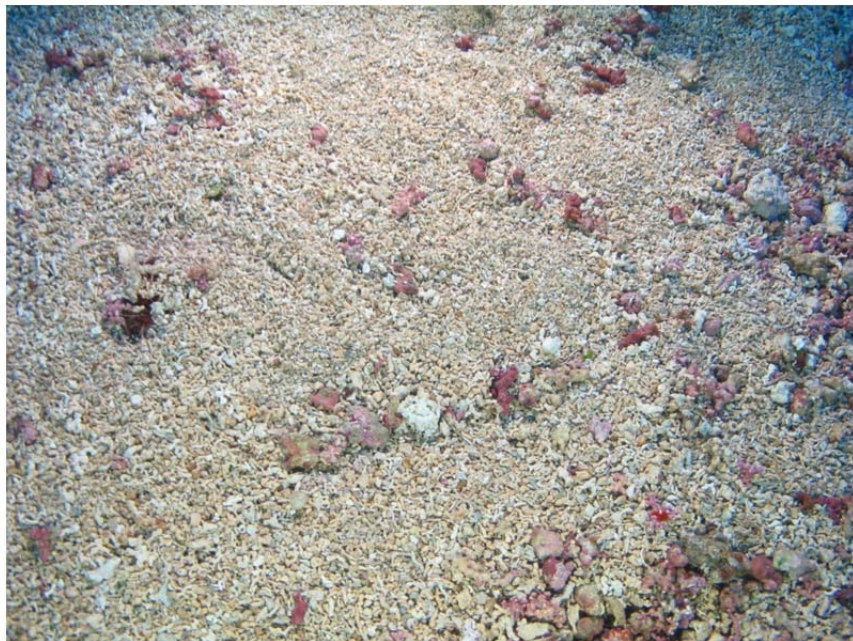
Figure 13. Photograph of the seabed taken at a point along Transect 11, showing a close-up of an assemblage of infralittoral coarse sediment. Individual rhodoliths are visible in places in the photo.

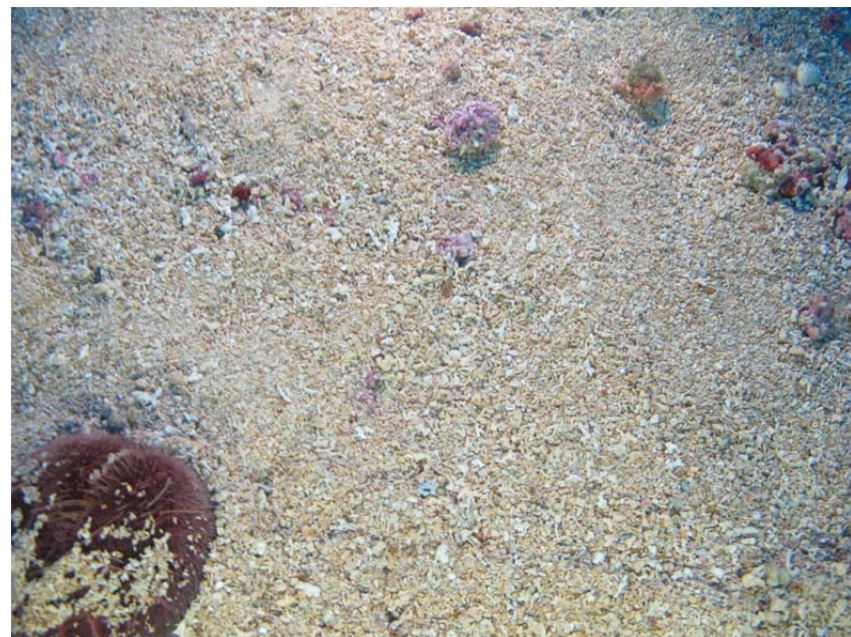
Figure 15. Photograph of the seabed taken at a point along Transect 11, showing a close-up of an assemblage of infralittoral coarse sediment. A few individual rhodoliths (Purple colour) – most of them having a very small size (few mm) – and an individual of the Purple Heart Urchin *Spatangus purpureus*, are visible in the photo.

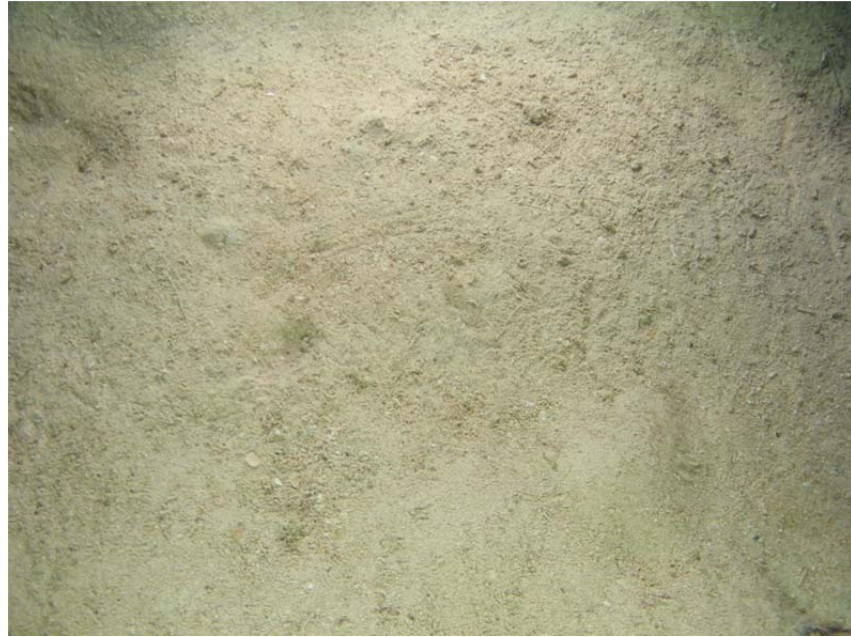
Figure 16. Photograph of the seabed taken at a point along Transect 21, showing a close-up of a Mediterranean community of muddy detritic bottoms.
