Malta International Airport

Method Statement for the Processing and Reuse of Contaminated Material in C15 Concrete

Revision 2.0
12th November 2025

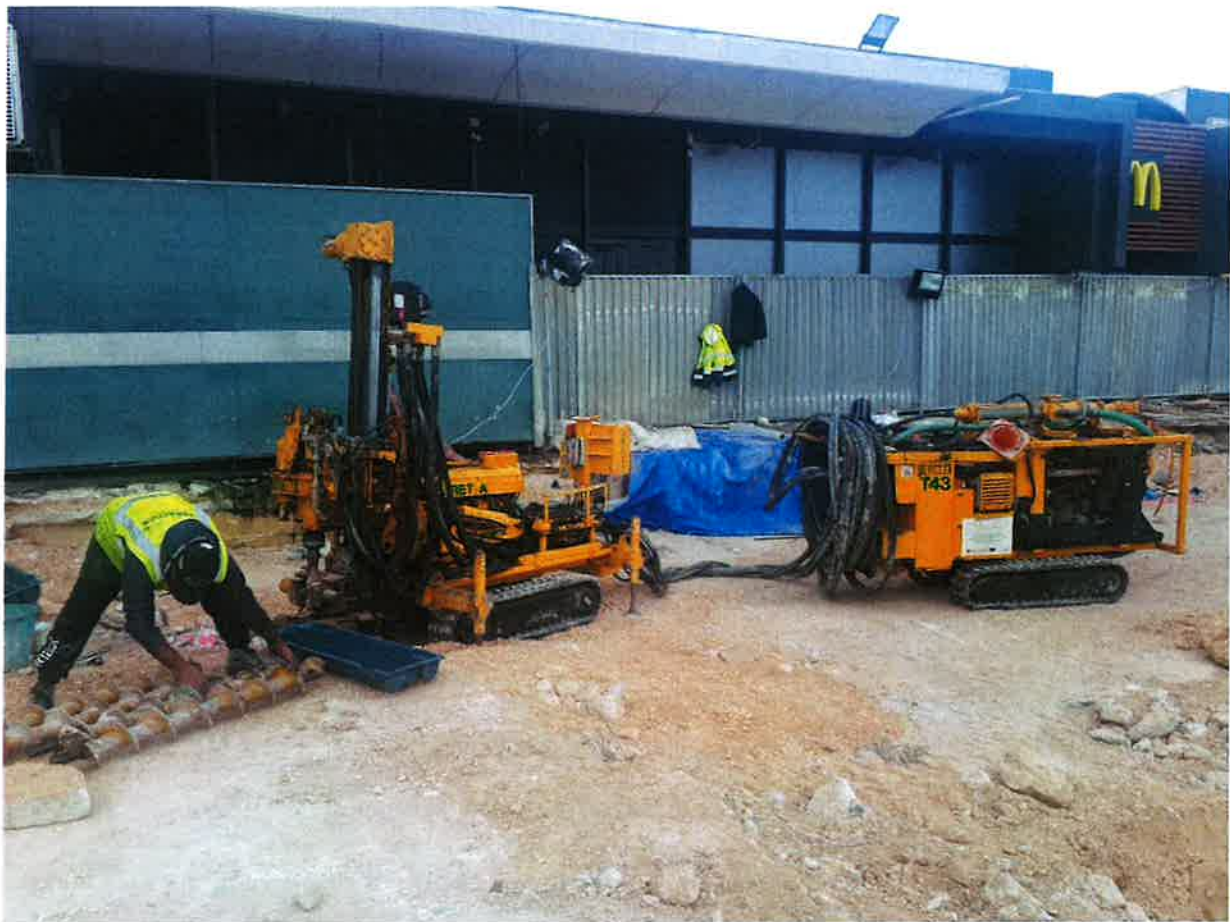
Figure 2: Beretta T43 drill rig fitted with an auger for dry drilling

Dry core sampling was done using a Beretta T43 drill rig fitted with an auger, as shown in **Figure 2**. Samples were placed into appropriate amber glass bottles and septum-capped vials, tightly sealed, stored and maintained in the dark at 4°C – 8°C upon immediate extraction from the ground to prevent any potential losses of volatile substances until delivery to the analysing laboratory. At least 2 kg per sample were collected, whereby 1 kg was designated to be sent to the laboratory while the rest was kept cool locally to serve as a counter-sample.

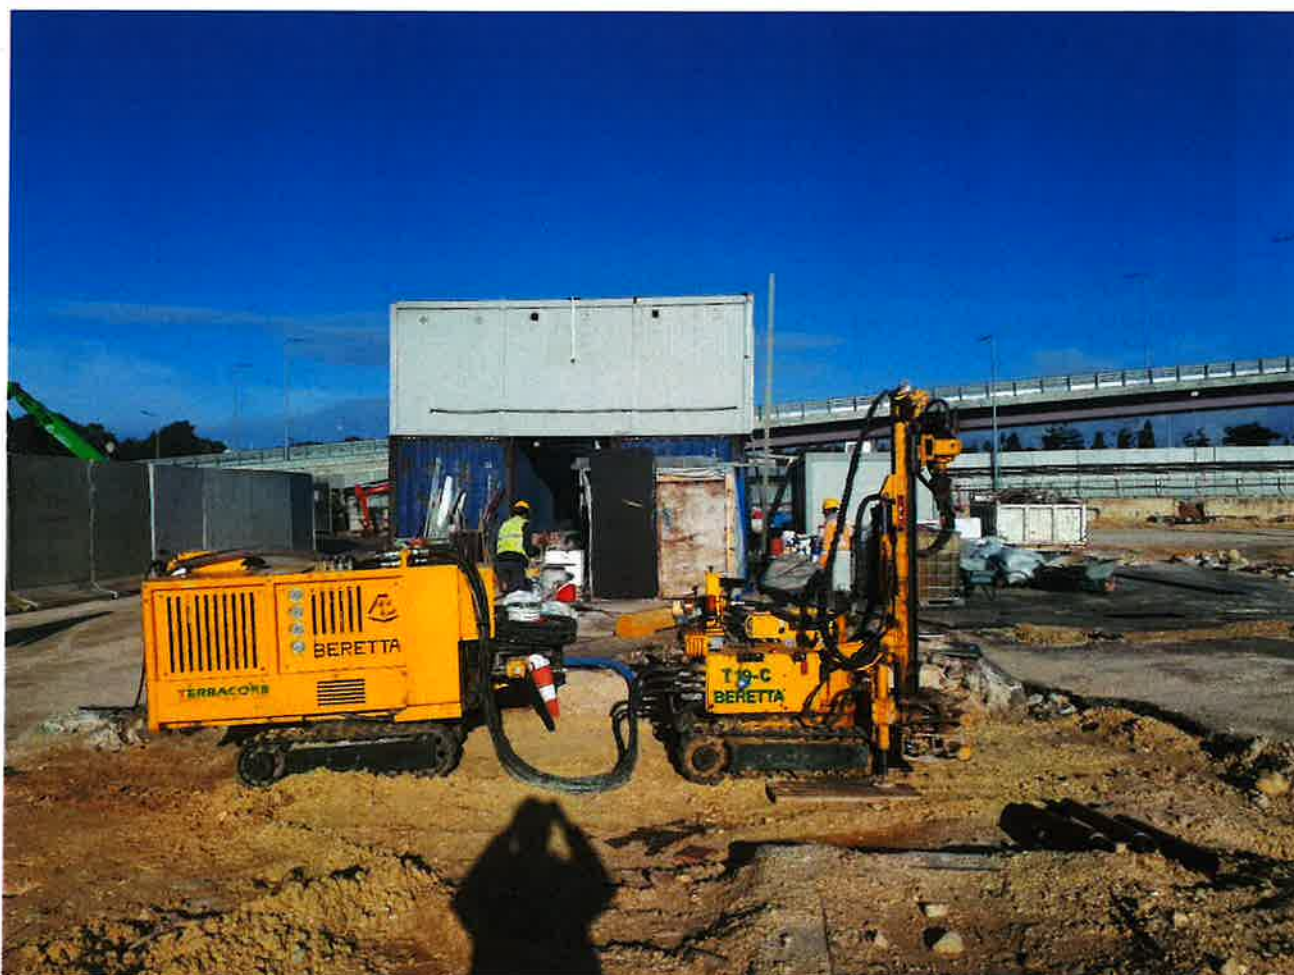
Figure 4: Beretta T19-C drill rig fitted with a hollow corer for wet drilling

Wet core sampling was done using a Beretta T19-C drill rig fitted with a hollow corer as shown in **Figure 4** and **Figure 5**. Samples were placed into appropriate amber glass bottles and septum-capped vials, tightly sealed, stored and maintained in the dark at 4°C – 8°C upon immediate extraction from the ground to prevent any potential losses of volatile substances until delivery to the analysing laboratory. At least 2 kg per sample were collected, whereby 1 kg was designated to be sent to the laboratory while the rest was kept cool locally to serve as a counter-sample.

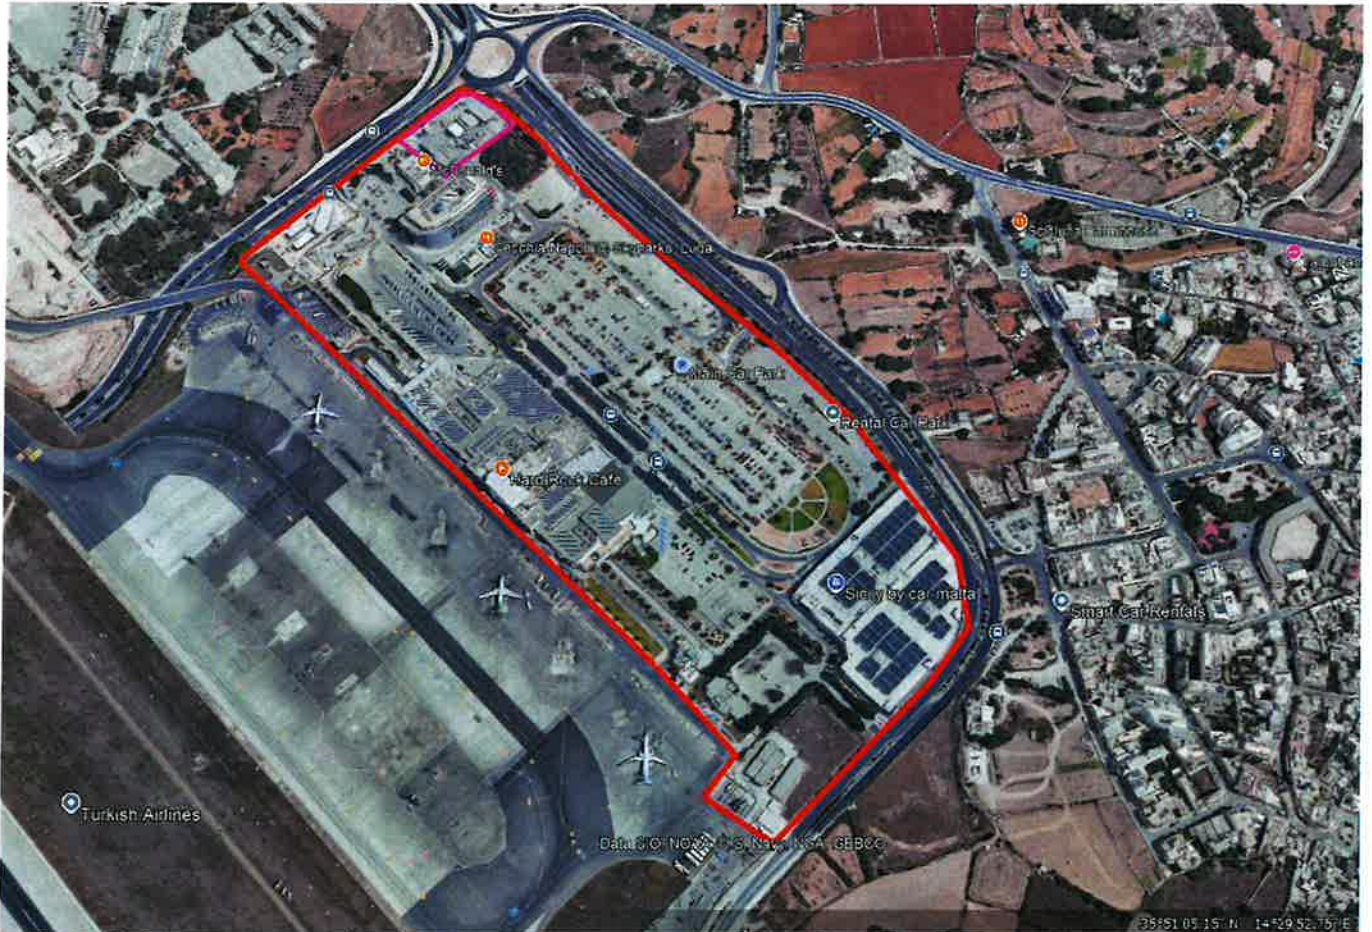
Figure 1: Google Image showing the Skyparks 2 Site. The Purple line shows the location of the Service Station

The Malta International Airport (MIA) had submitted a Development Planning Application (PA 05548/10) for the proposed Master Plan for the Malta International Airport Site known as Skyparks 2 (**Figure 1**).

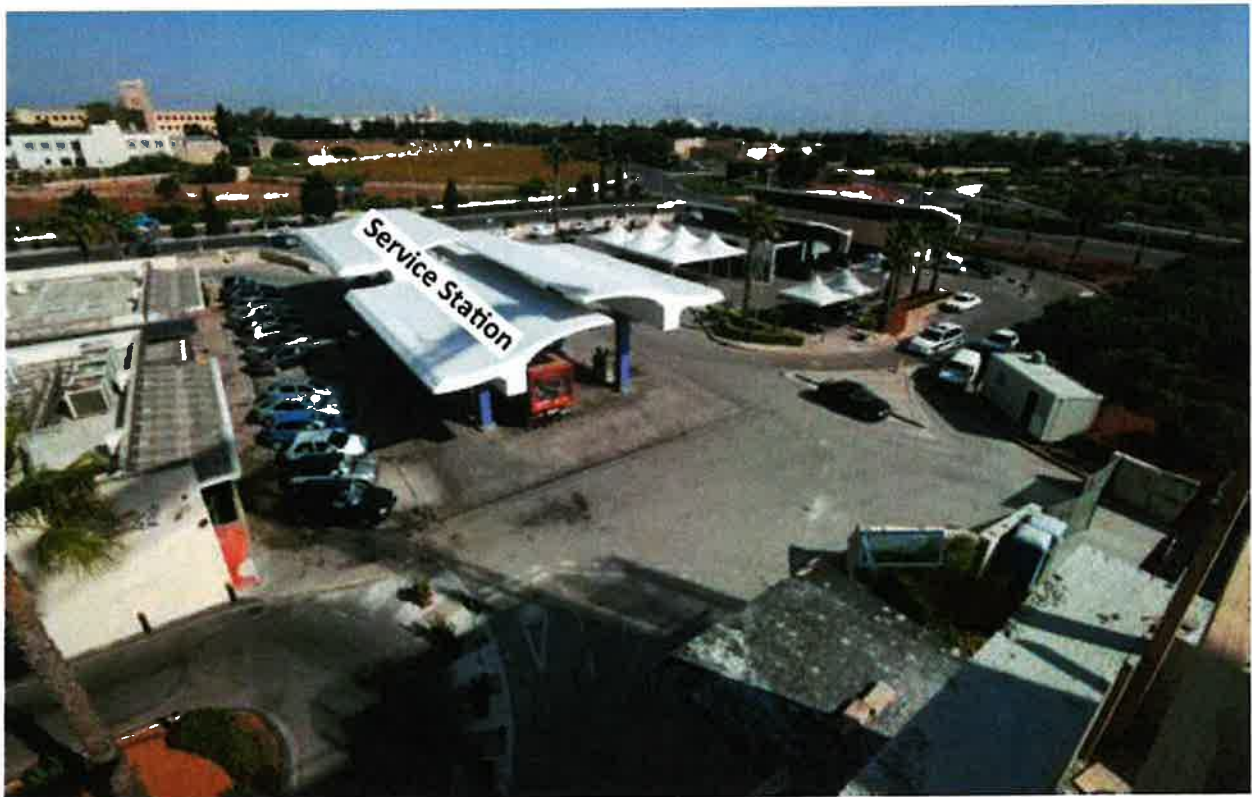
Figure 3: View of the Service Station and Carwash as once seen from the Skyparks Building

- The Skyparks Building
- Public and private service car parks
- Catering facilities - the McDonalds Drive Through, restaurant and cafeteria
- A Service Station and adjoining car and coach wash (**Figure 2, Figure 3, Figure 4**)

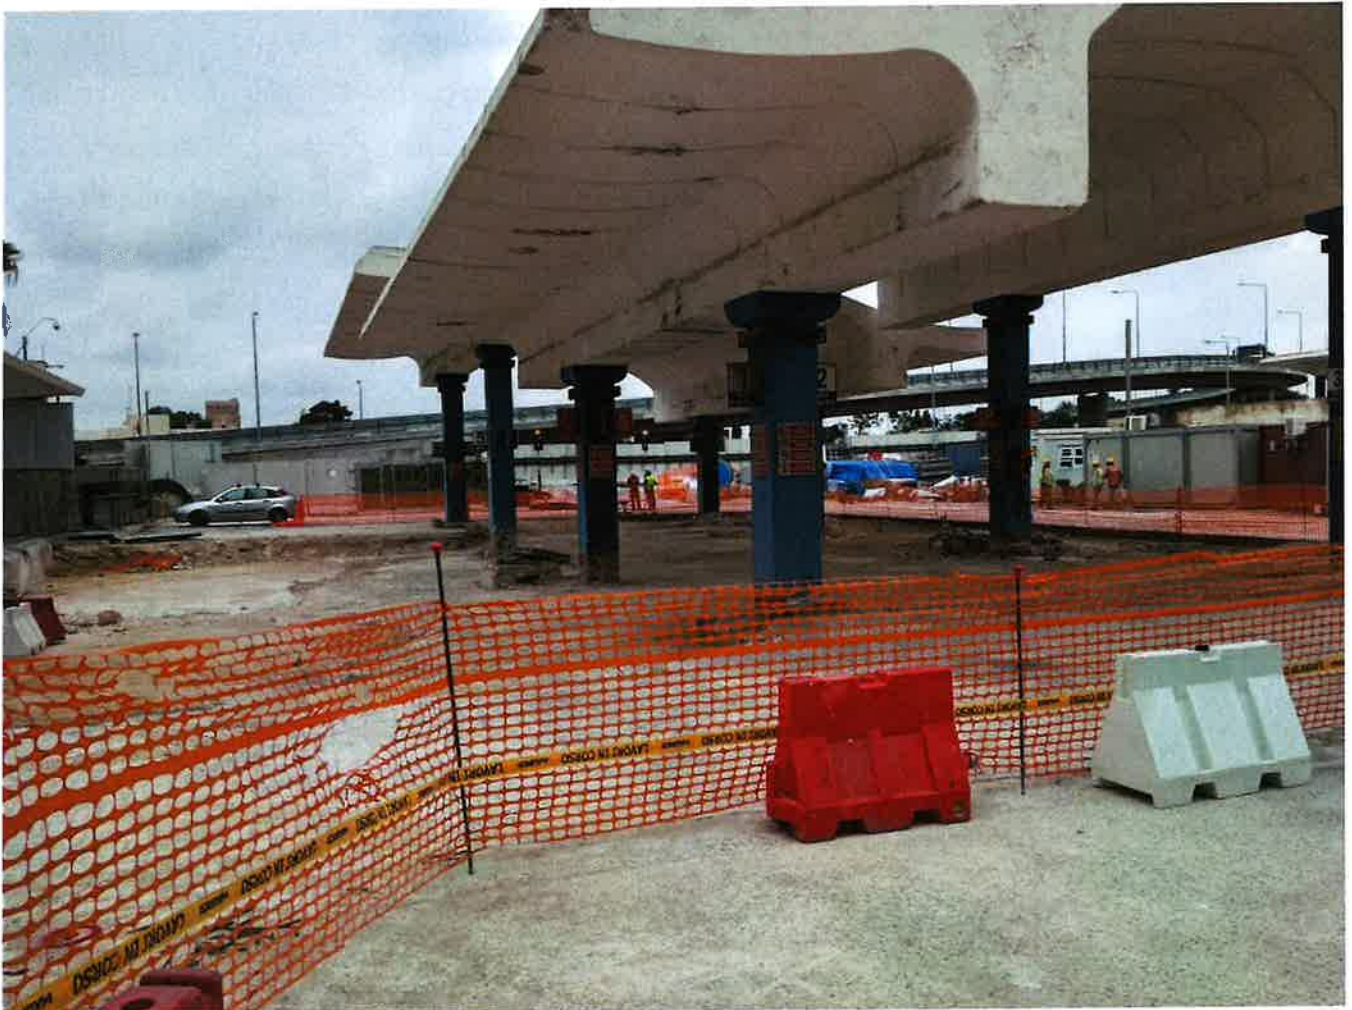
Figure 5: Photograph showing the present conditions at the Service Station

The site was inspected by the undersigned Geologist Dr. Saviour Scerri on the 31 October 2024 (**Figure 5, Figure 6, Figure 7**). At that time excavation works were under way in some parts of the site. The Service Station had already been decommissioned and a decommissioning report Dated October 2022 has been drawn up.

The underground fuel tanks (8 in total), dispensers and fuel lines had already been removed – no fuel contamination was determined at the time. Once excavation works commenced in the forecourt area, a concrete platform was found ~40cm below surface level, and fuel contamination was first noted beneath this platform once it was broken into.

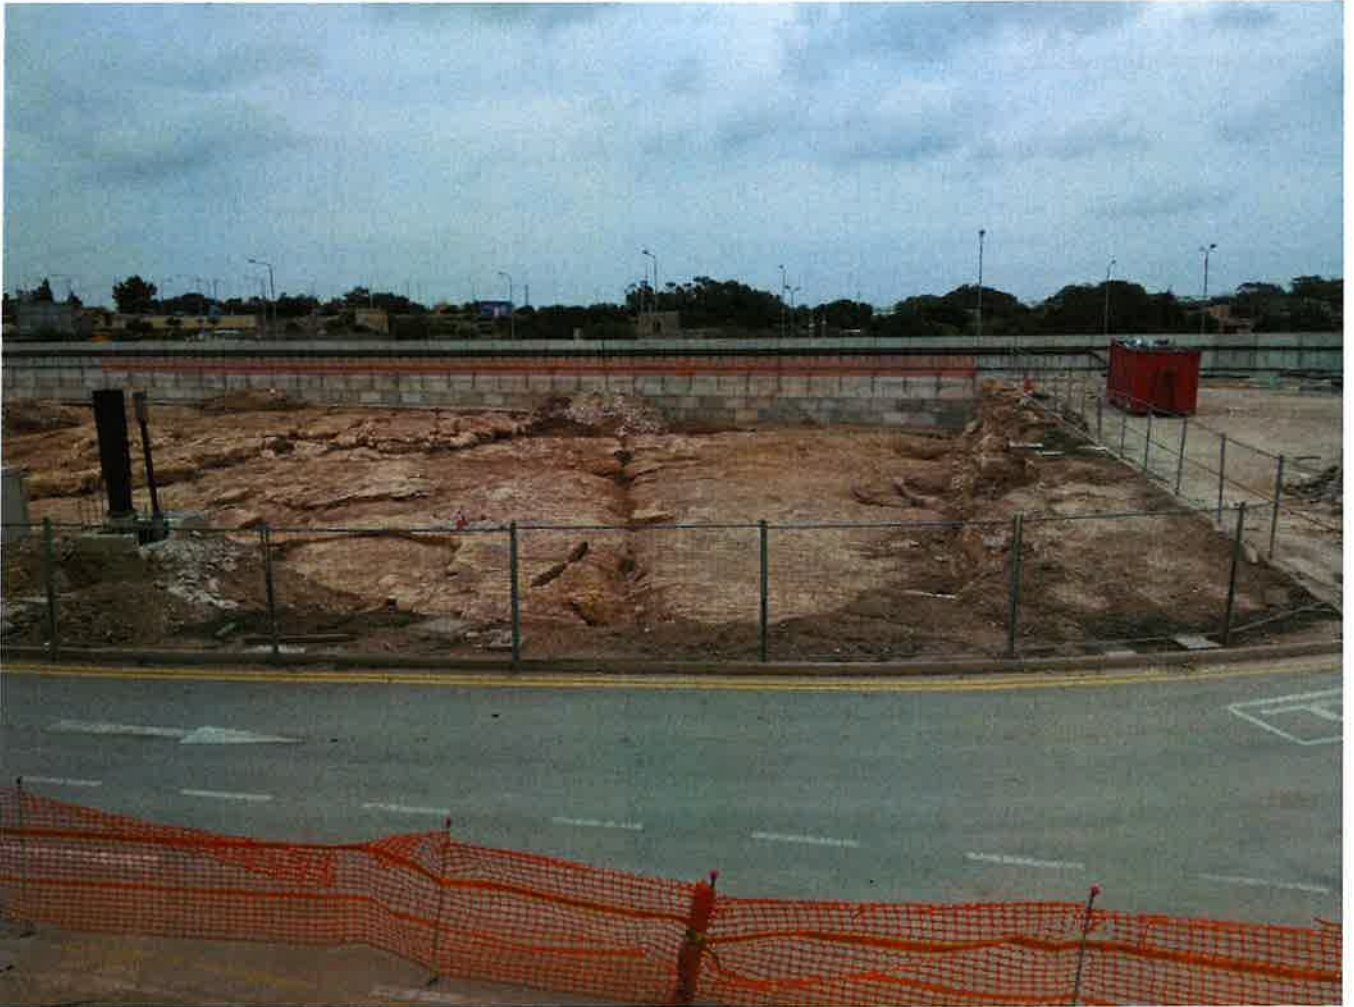
The rock is bedded. Bed dip at about 2° to 4° to the northeast. No faults appear to pass across the site or close to the site. Vertical fractures, often widened by solution, can be seen on the exposed rock surface. Beds can be seen to be about 30cm thick (Figure 10, Figure 11).

Figure 10: Photograph showing ongoing excavation at the Skyparks 2 site, exposing bedded Lower Globigerina Limestone. Straight Vertical fissures can be seen in the middle ground.

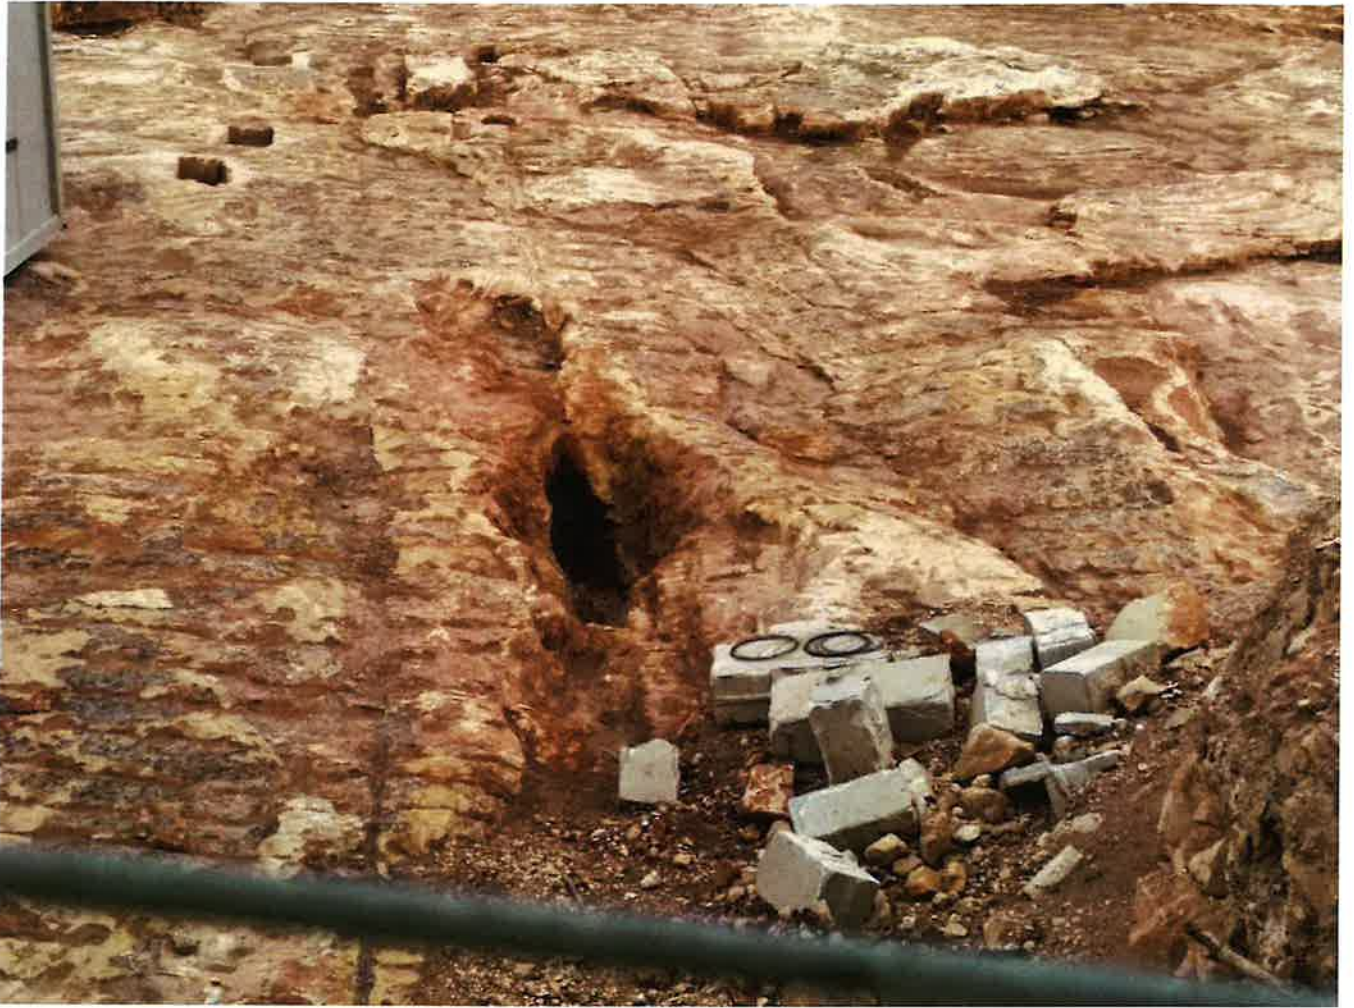
Figure 11: Photograph showing ongoing excavation. Photograph shows bedded Lower Globigerina Limestone and vertical joint widened by solution and partly filled with brown soil

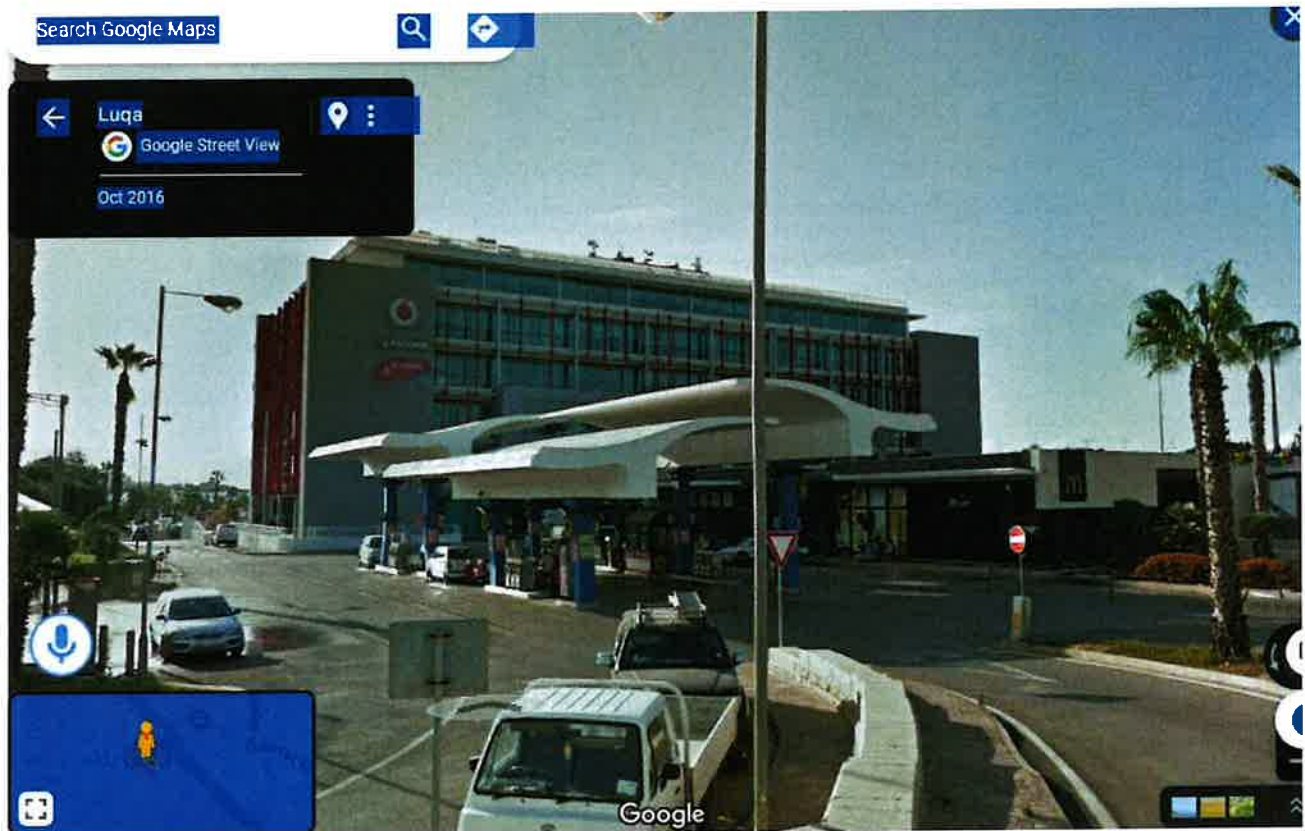
Figure 14: Google Street View (2016) showing extent of the Service Station

The activities undertaken at the Service Station are as follows (**Figure 14**):

1. Loading of petrol fuel into underground storage tanks (USTs) by fuel bowser
2. Loading of diesel fuel into underground storage tanks (USTs) by fuel bowser
3. Petrol refueling of motor vehicles
4. Diesel refueling of motor vehicles
5. Car wash services for motor vehicles

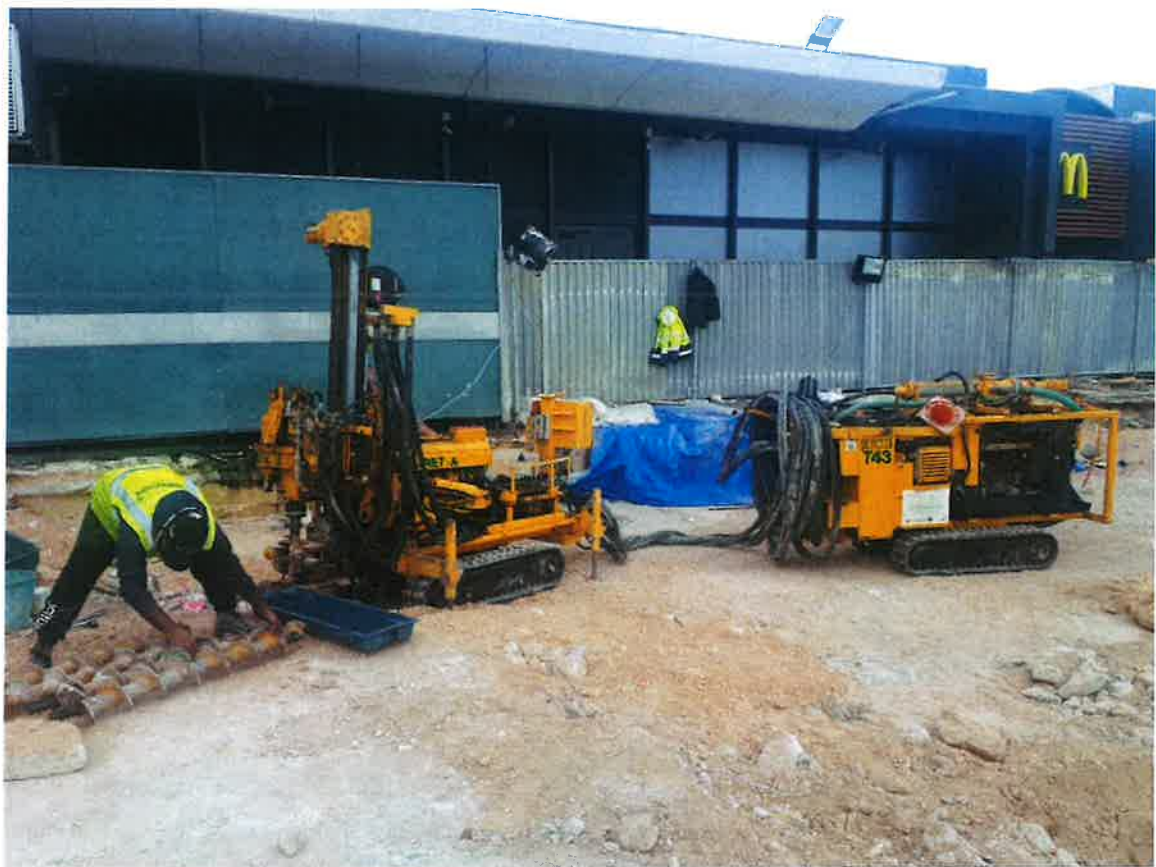
Figure 19: Beretta T43 drill rig fitted with an auger for dry drilling

Dry core sampling was done using a Beretta T43 drill rig fitted with an auger, as shown in **Figure 19**. Samples were placed into appropriate amber glass bottles and septum-capped vials, tightly sealed, stored and maintained in the dark at 4°C – 8°C upon immediate extraction from the ground to prevent any potential losses of volatile substances until delivery to the analysing laboratory. At least 2 kg per sample were collected, whereby 1 kg was designated to be sent to the laboratory while the rest was kept cool locally to serve as a counter-sample.
