# Architectural, Archaeological, Historical & Cultural Heritage and Related Material Assets Study for the proposed Materials Recovery Facility (MRF)

WASTESERV MALTA LIMITED

SERVICE TENDER FOR THE ENGINEERING, PROCUREMENT  
AND CONSTRUCTION OF A NEW MATERIALS RECOVERY  
FACILITY

AIS REF. NO: PRJ-ENV483  
EIGHTH VERSION  
PUBLICATION DATE  
13 JULY 2026

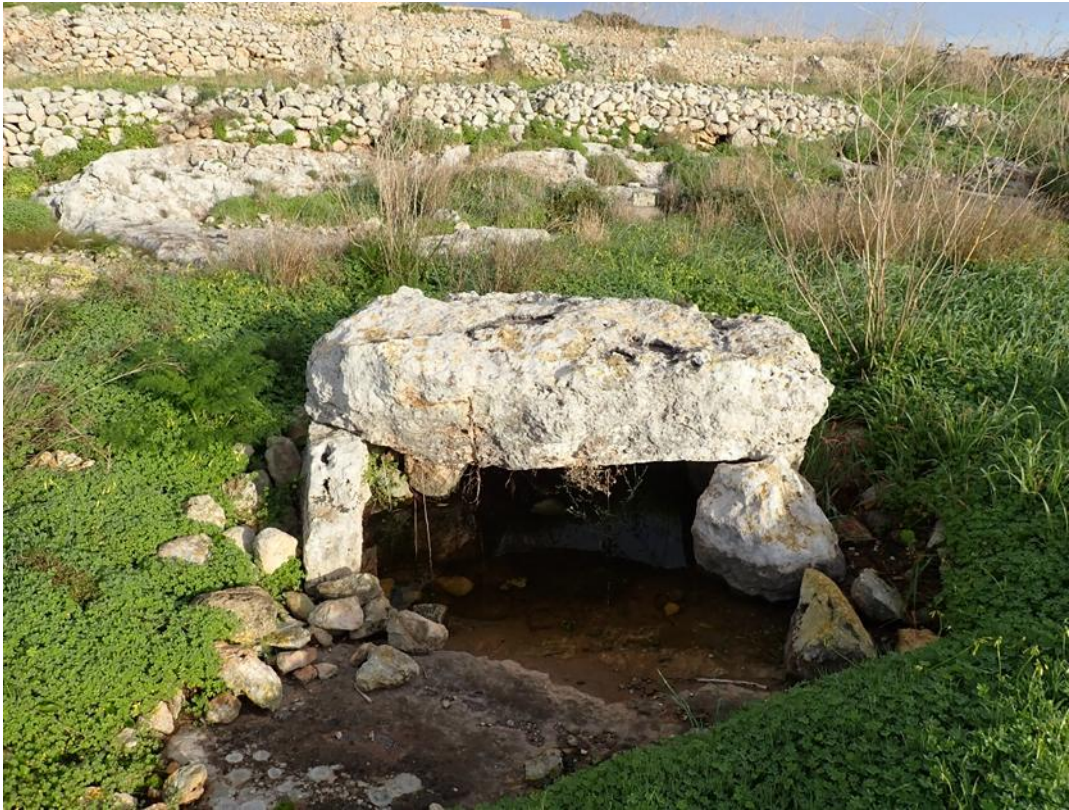
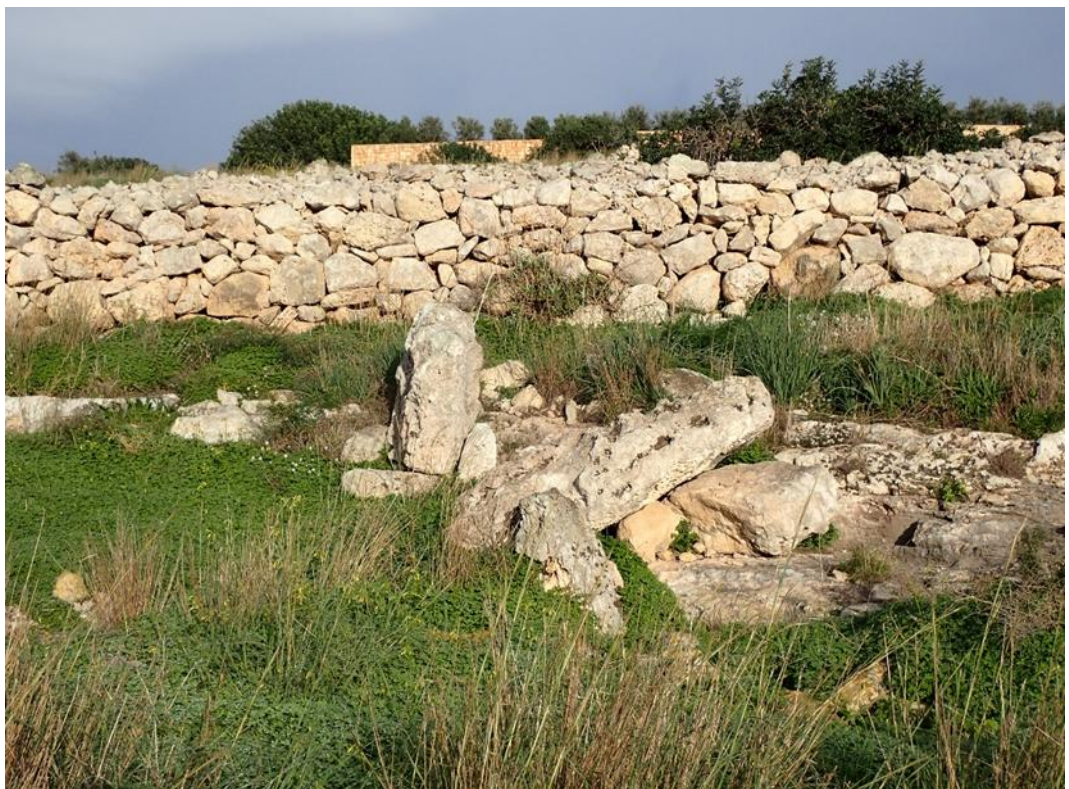
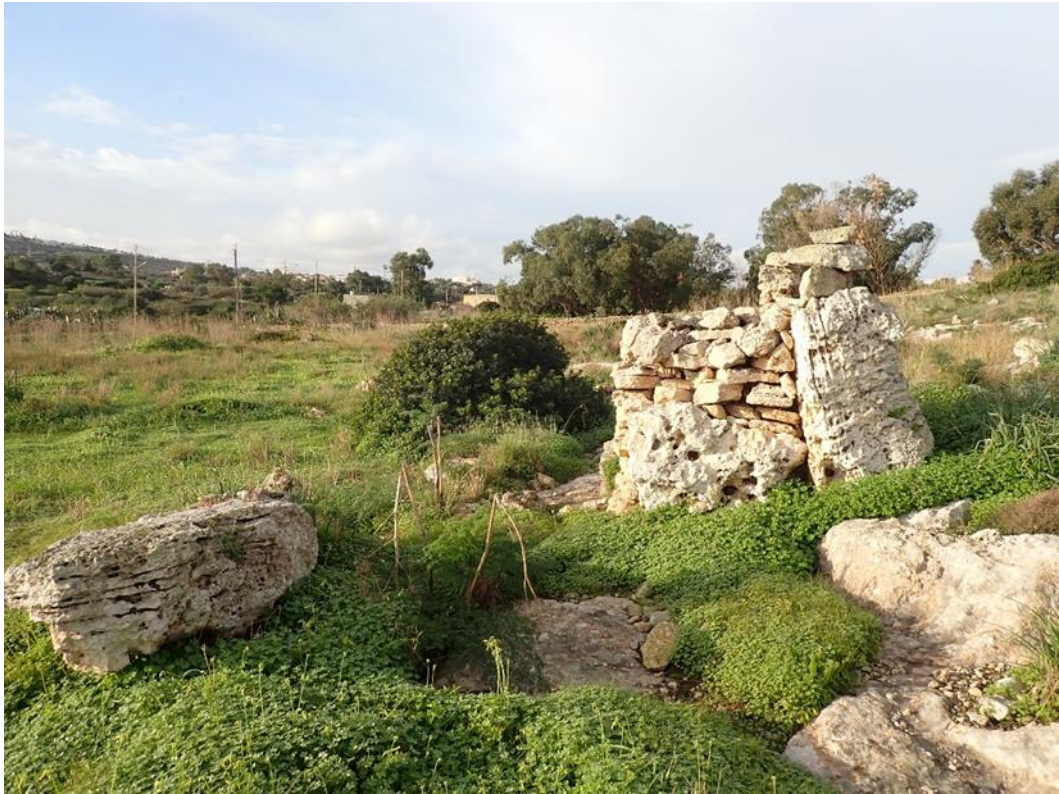
Figure 8: General view of Ta'Hammud dolmen with capstone still in place, looking West

Figure 9: General view of Ta'Hammud dolmen collapsed, looking West

Figure 10: General view of Ta'Hammud dolmen reused, looking S-SW

As mentioned in Paragraph 5.2.1, the Class A scheduled Ta' Hammud megalithic dolmens are located outside the limits of the Aol buffer zone. Given the distance, no direct impacts are anticipated in terms of physical or structural damage or alteration arising from the proposed construction activities. Nevertheless, the surrounding areas remain designated as potential archaeological zones due to their cultural and heritage significance.

For both scheduled sites, the only potential adverse impact, considered here as minor reversible, is the indirect effect from vibrations caused by possible trimming works. This impact can be readily mitigated through the use of sensitive construction techniques.

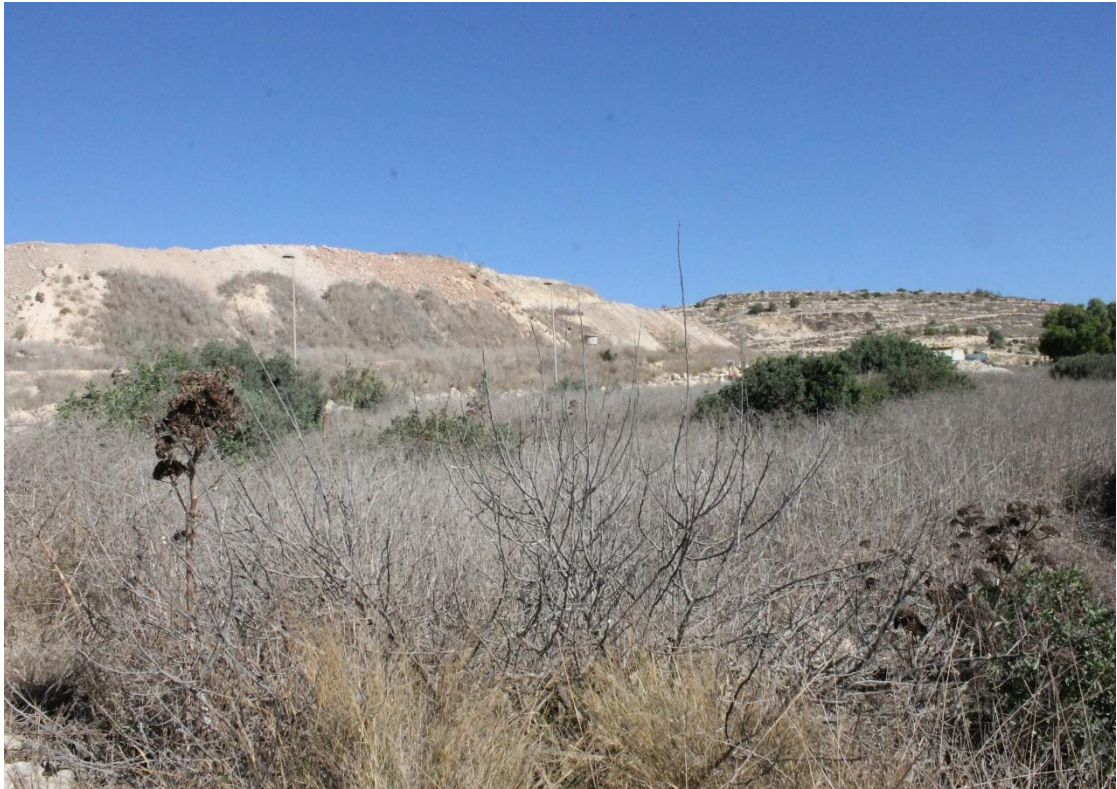
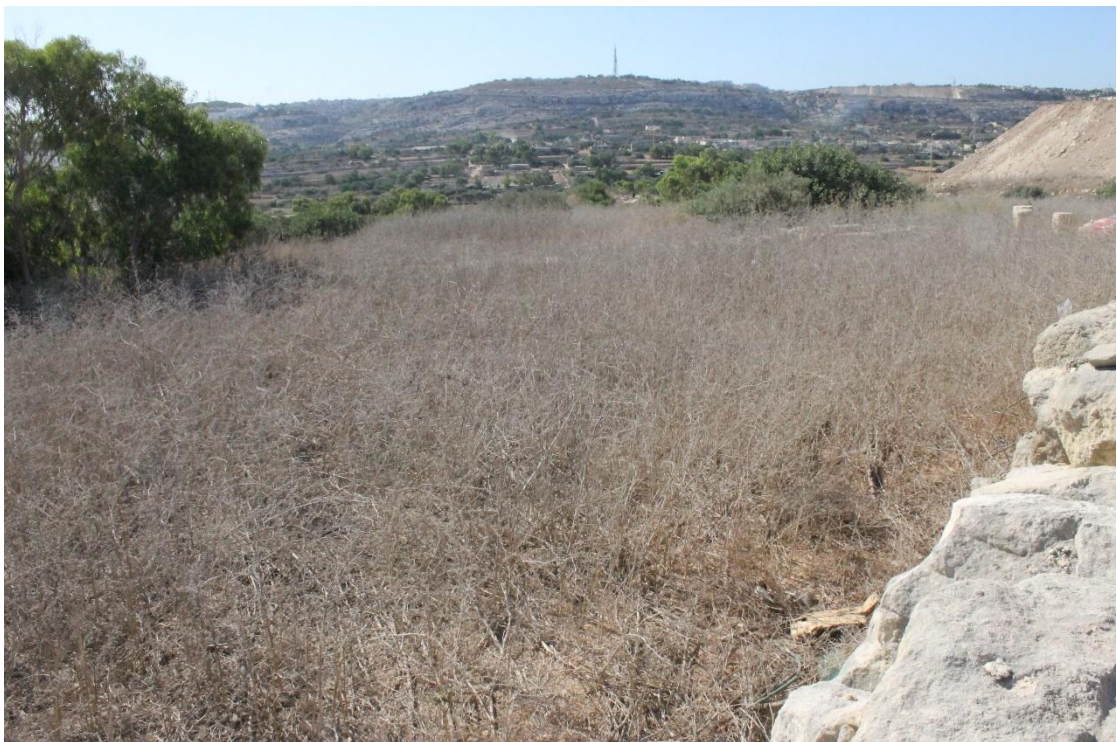
The area proposed for development is found within a rural landscape S-East of the Magtab landfill containing a number of presently used agricultural fields containing typical local rural structures and rubble walls. The Aol is delimited on its South and West by a recently built road that leads to the WasteServ treatment facilities (see Figure 12 and Figure 13). This is separated by a fence and a modern rubble wall (Figure 14). Its central and East side is composed by used agricultural fields which include rural vernacular features typical of a Maltese landscape and all related to agricultural activity (see Figure 15, Figure 16, Figure 24 and Figure 32), while its Western part, next to the mentioned road, is an overgrown area with no visible presence of rural features (refer to Figure 17, Figure 18 and Figure 23).

Figure 17: Overgrown area within Aol, looking North

Figure 18: Overgrown area within Aol, looking S-East

Due to the possibility of underlying cultural remains at undisturbed levels within the overgrowth and the underlying deposits, it is recommended that an archaeological monitor be present during any ground disturbance works, so as to ensure the preservation of any existing cultural features that might be uncovered during the course of the proposed works. It would also be advisable, during the mentioned works, to observe a distance from contact with the listed cultural heritage interests of at least of 50 meters to ensure their safety.

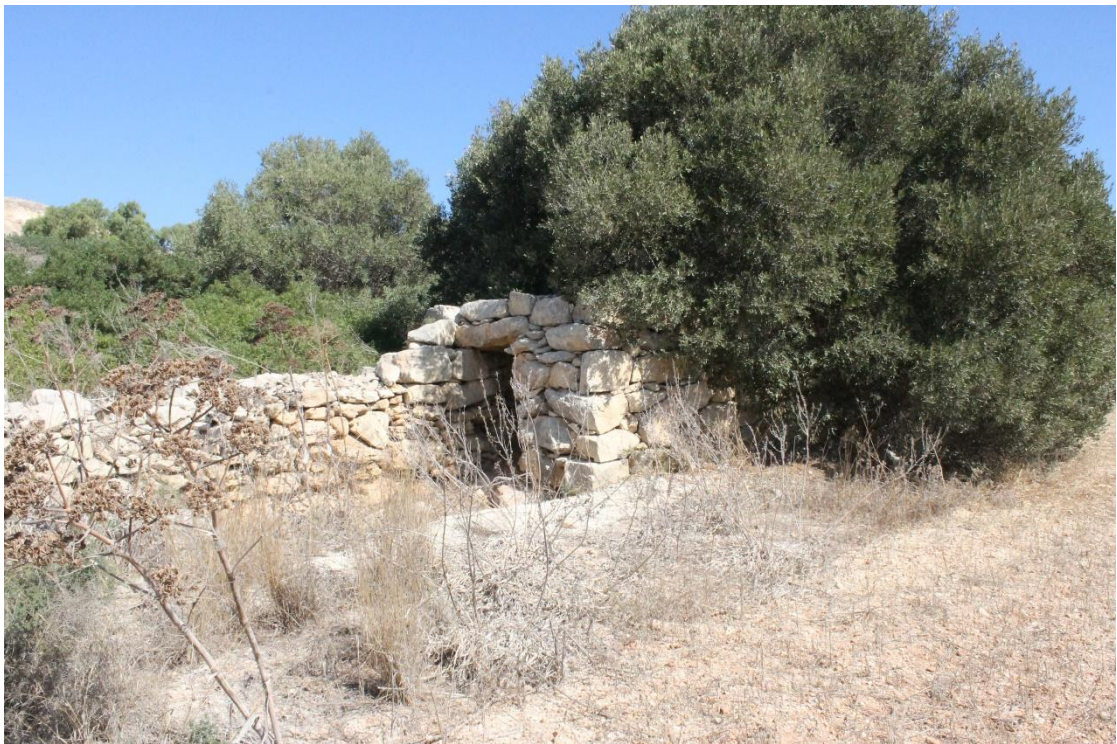
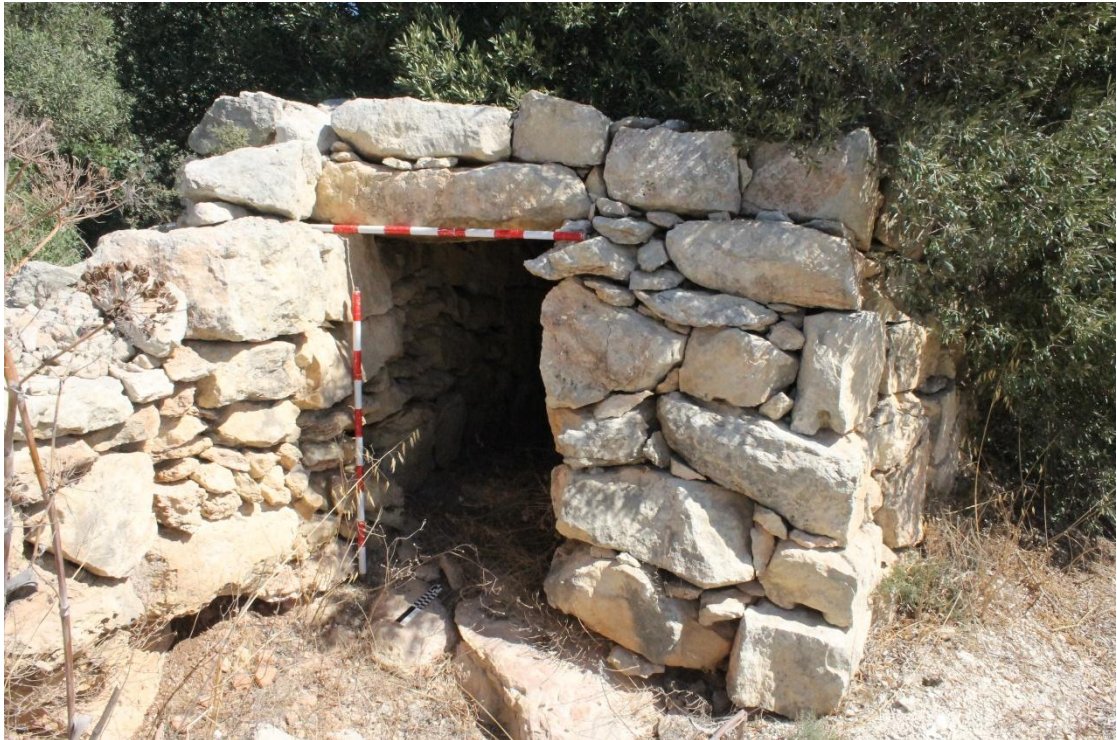
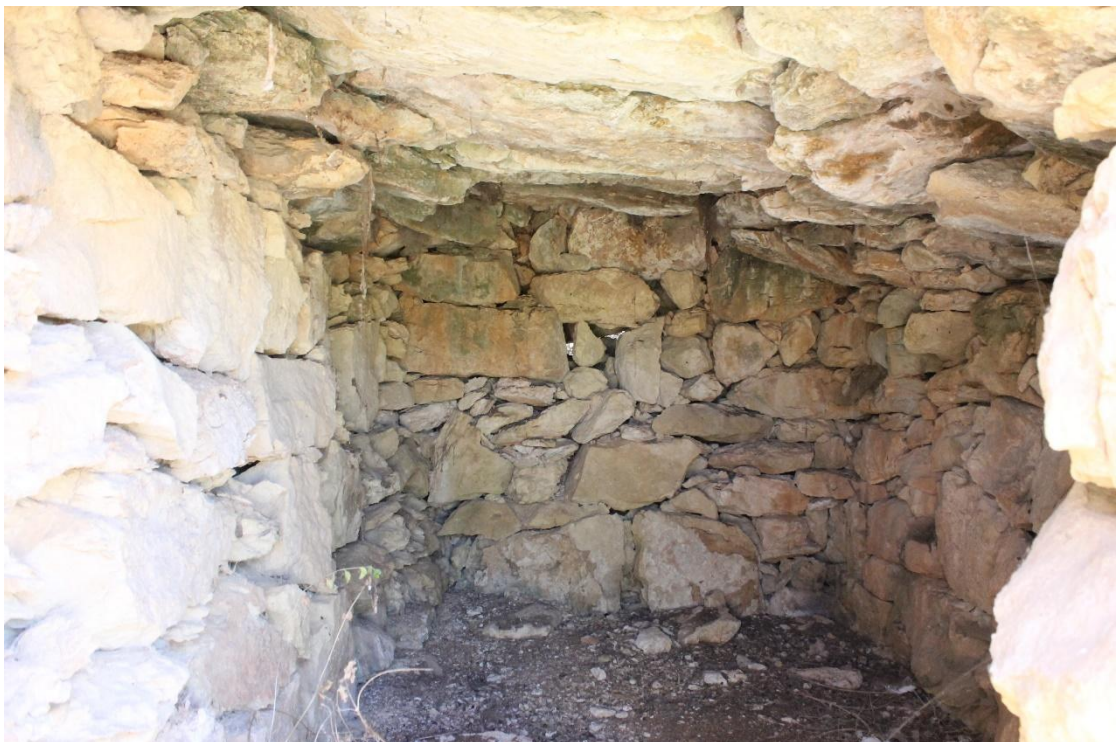
Figure 34: Feature B, Corbelled stone hut (girna) in the central area of site, looking N-West

Figure 35: Feature B, Corbelled stone hut (Girna) in the central area of site, looking North

Figure 36: Feature B, Intern of corbelled stone hut (Girna)

With regards to the identified cultural features within the Aol, the dry-stone huts (Features A, B and D in Figure 47), one of which contains a corbelled roof (Feature B), are very likely to suffer an adverse impact or damage, as shown in Figure 48. In the past these structures were very common throughout the island of Malta providing shelter to farmers and herdsmen or their livestock. Nowadays, these features are located mainly in the northern part of the island. Many of them have collapsed over the years due to the elements or simple neglect. Since the ones located within the Aol, like the mentioned feature B, are still well preserved, they should be considered a subject of architectural, cultural and ethnic value, also in due of the legal notice entitled "Rubble walls and rural structures", last amended in 2007, which declared rubble walls and non-habitable rural structures to be protected.

As mentioned in the impact assessment section, the identified Cultural or Archaeological features will be directly affected by the development. In light of the mentioned local legislations, it would be advisable to preserve these features (Features B and D in Figure 48) if technically possible, by relocating these features within other areas (Features A and D in Figure 48) in order to avoid any irreversible damage or loss. It is to be noted that, given the nature of the proposed works, scale of the project, and restrictions on site, relocation within the exact site boundary is not possible.

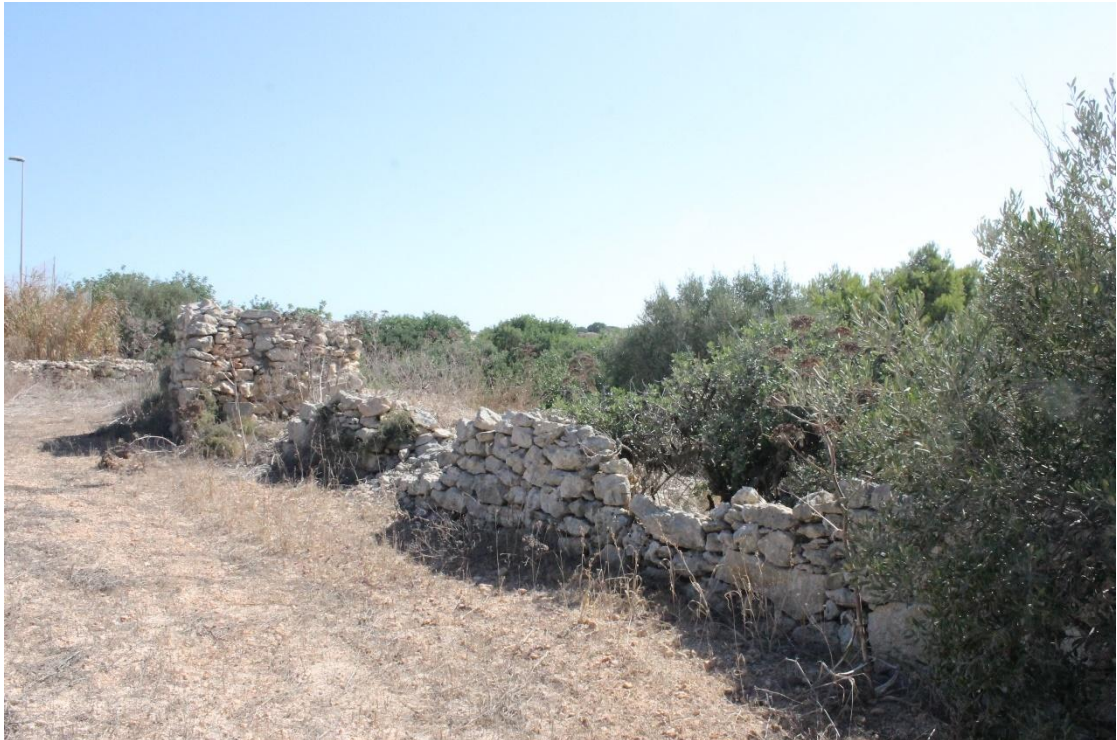
The central and Eastern side of the Aol include drystone/rubble walls from very poor/poor (Figure 33 and Figure 37) to fair/good state on conservation (Figure 44 and Figure 45); a squared corbelled stone hut (Feature A in Figure 47) still in good state of conservation (see Figure 34 to Figure 36), buttressed to a N-S oriented rubble wall; a stone hut (Feature B in Figure 47) without roof, probably recently altered for hunting purposes since a number of shotgun cartridges have been found in the proximity (Figure 38 to Figure 40); drystone enclosures forming a sort of passage (Feature C in Figure 47) in fair state of conservation (Figure 41 to Figure 43) and another drystone hut with no roof in good state of conservation (Feature D in Figure 47), located at the Eastern limit of the Aol (Figure 46).

Figure 37: Rubble wall in poor condition within Aol, looking N-East

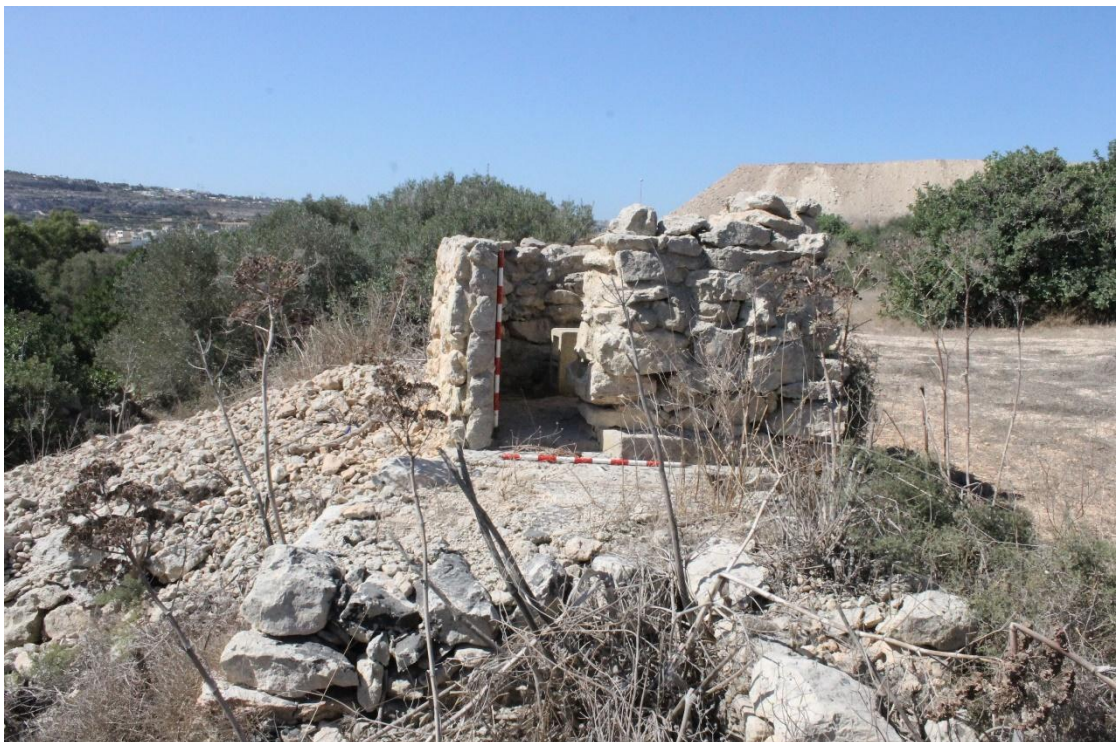
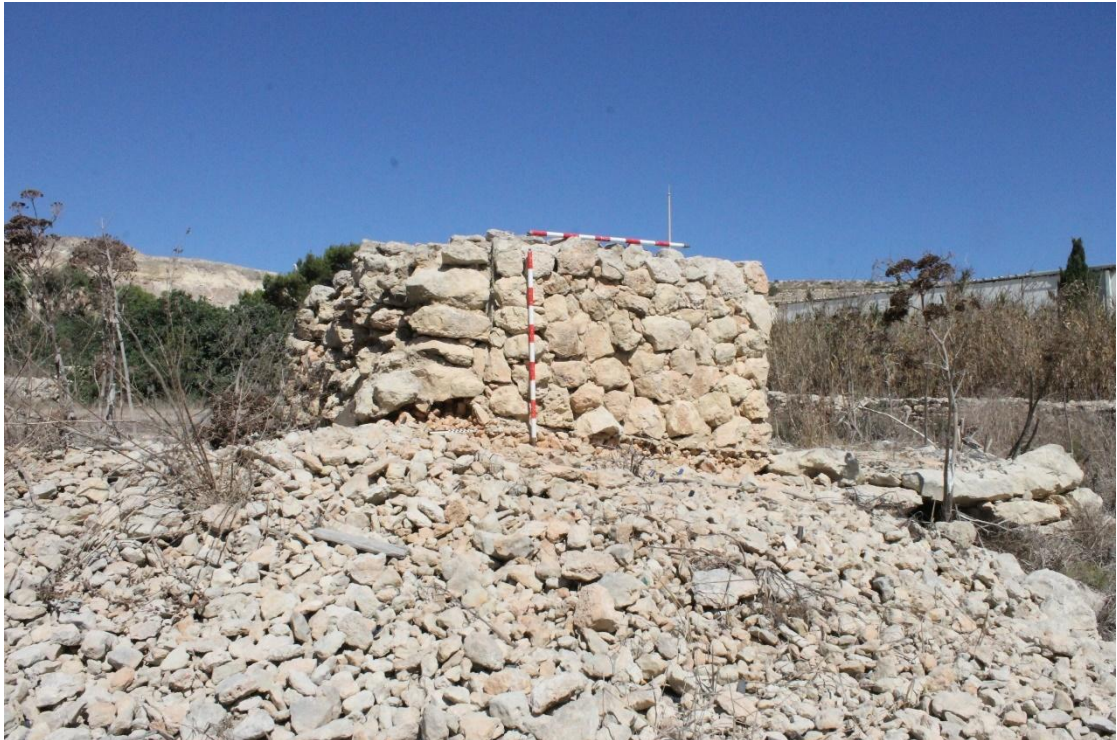
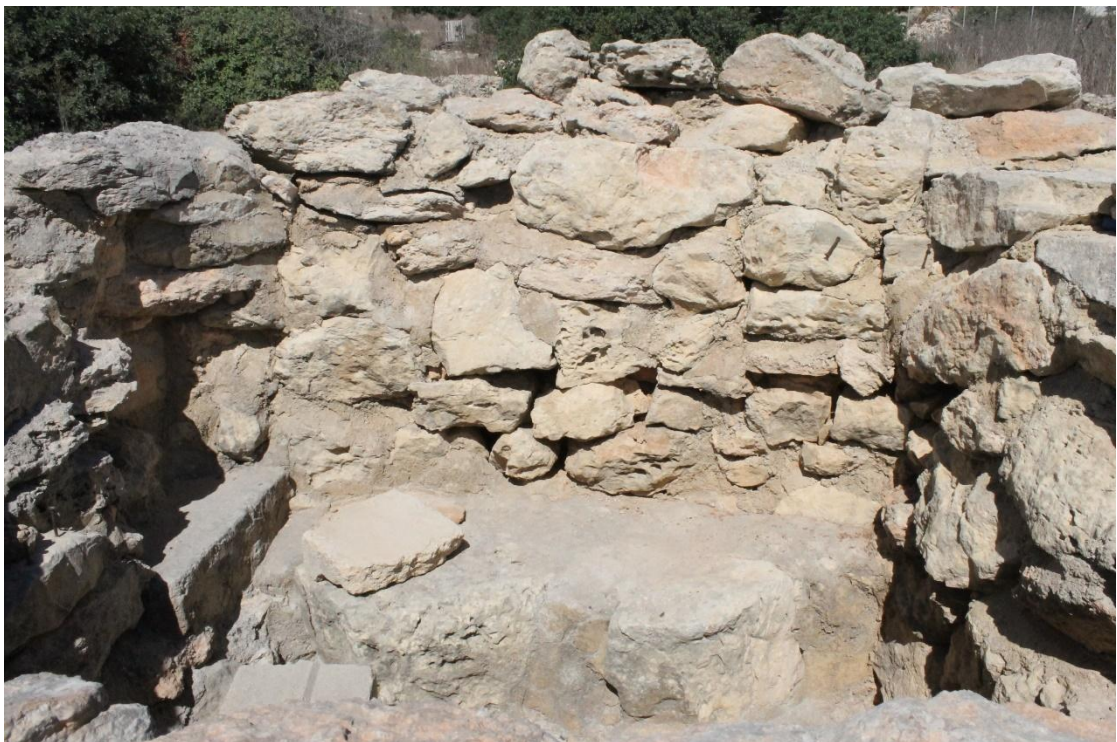
Figure 38: Feature A, Stone hut (Girna) in the N-East area, looking South

Figure 39: Feature A, stone hut (Girna) in the N-East area, looking west

Figure 40: Feature A, Intern of stone hut (Girna), looking West

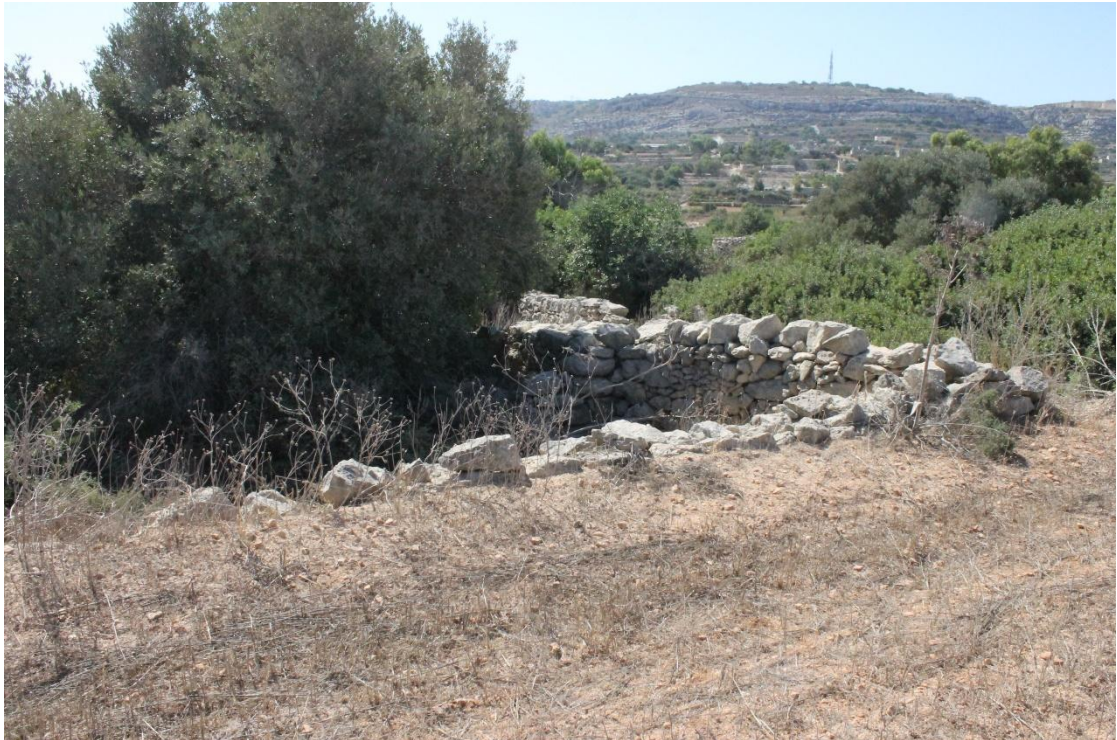
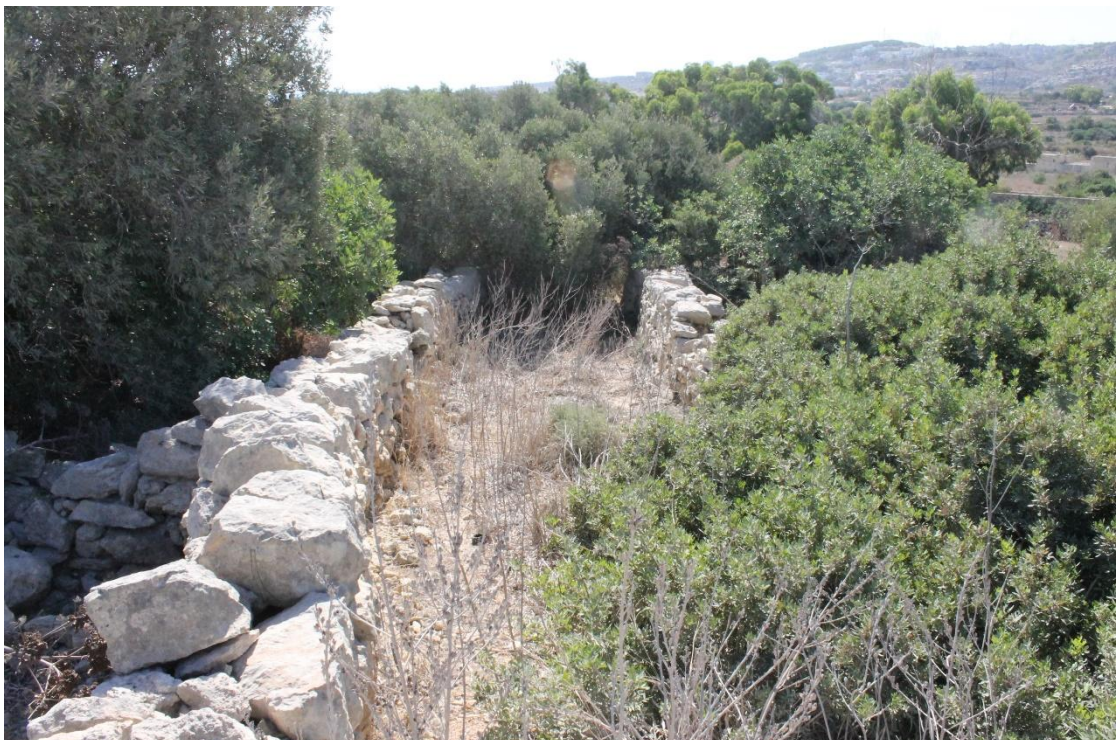
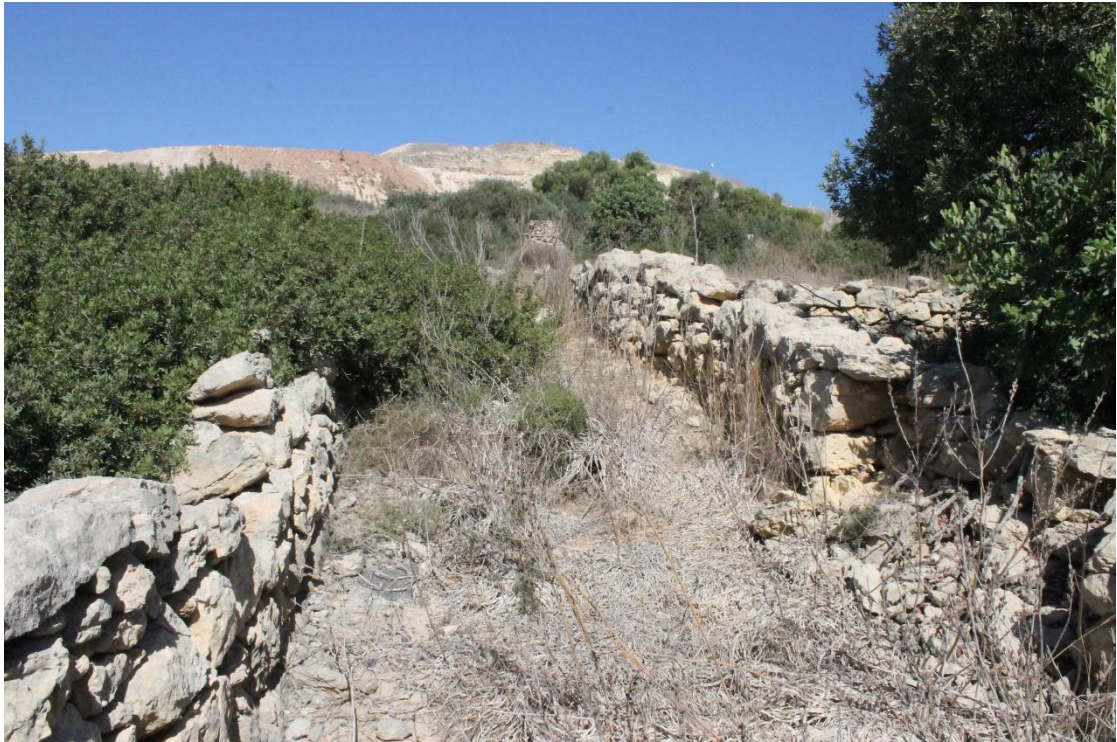
Figure 41: Feature C, drystone enclosure, looking S-East

Figure 42: Feature C, Drystone enclosures forming a passage, looking East

Figure 43: Feature C, drystone enclosures forming a passage, looking west

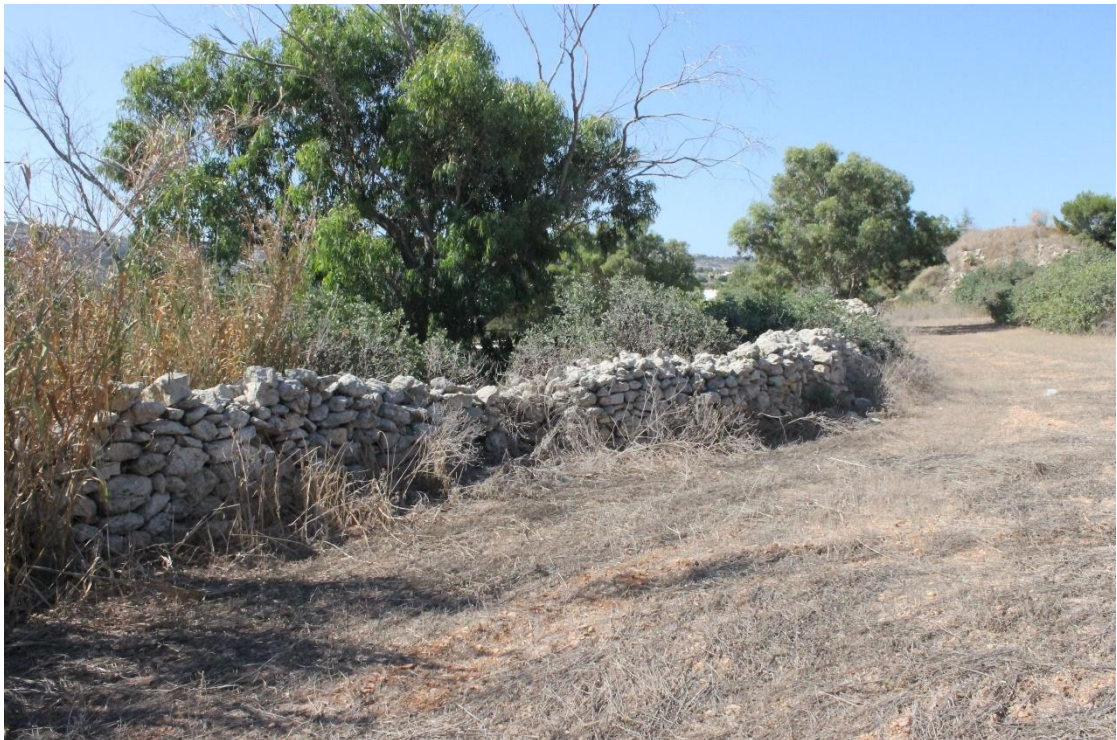
Figure 44: rubble wall in fair condition in the Eastern area of site, looking south

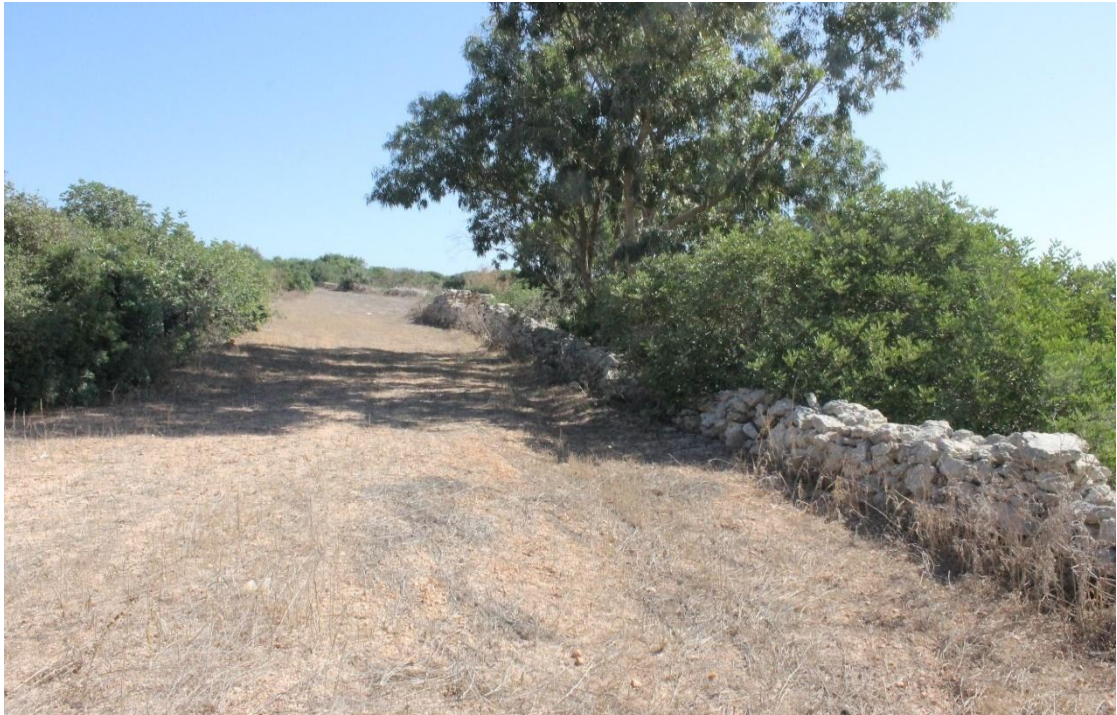
Figure 45: Rubble wall in fair condition in the Eastern area of site, looking N-East

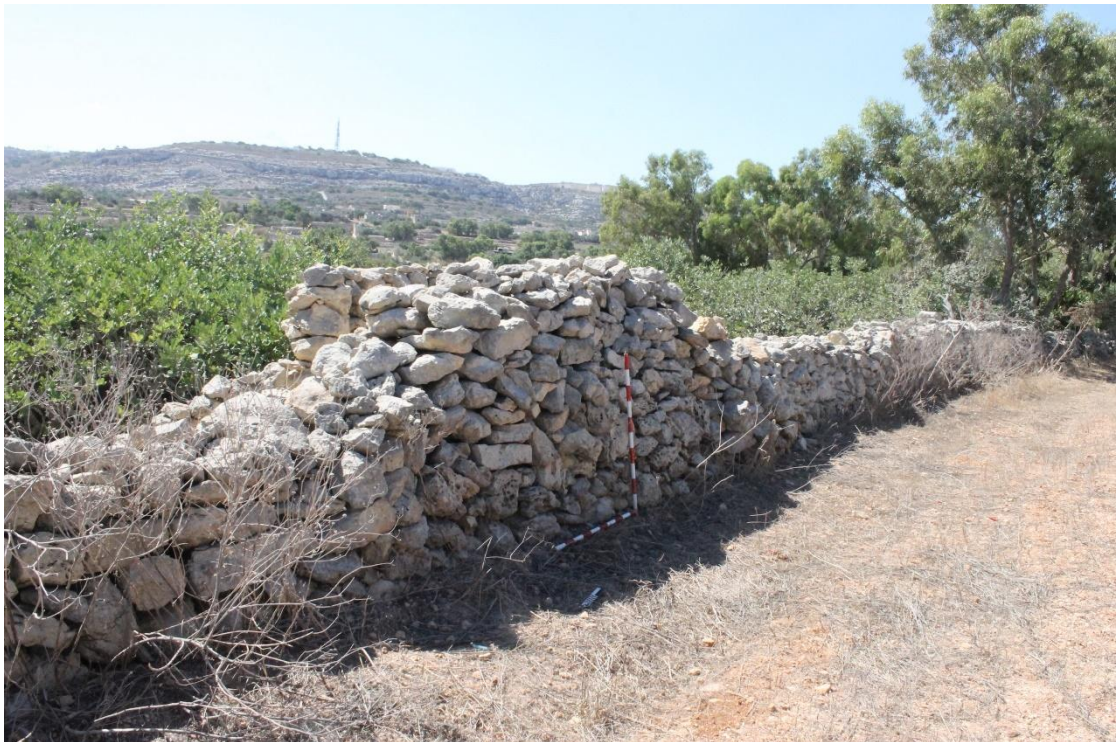
Figure 46: external wall of a drystone hut (Feature D) at the eastern limit of Aol

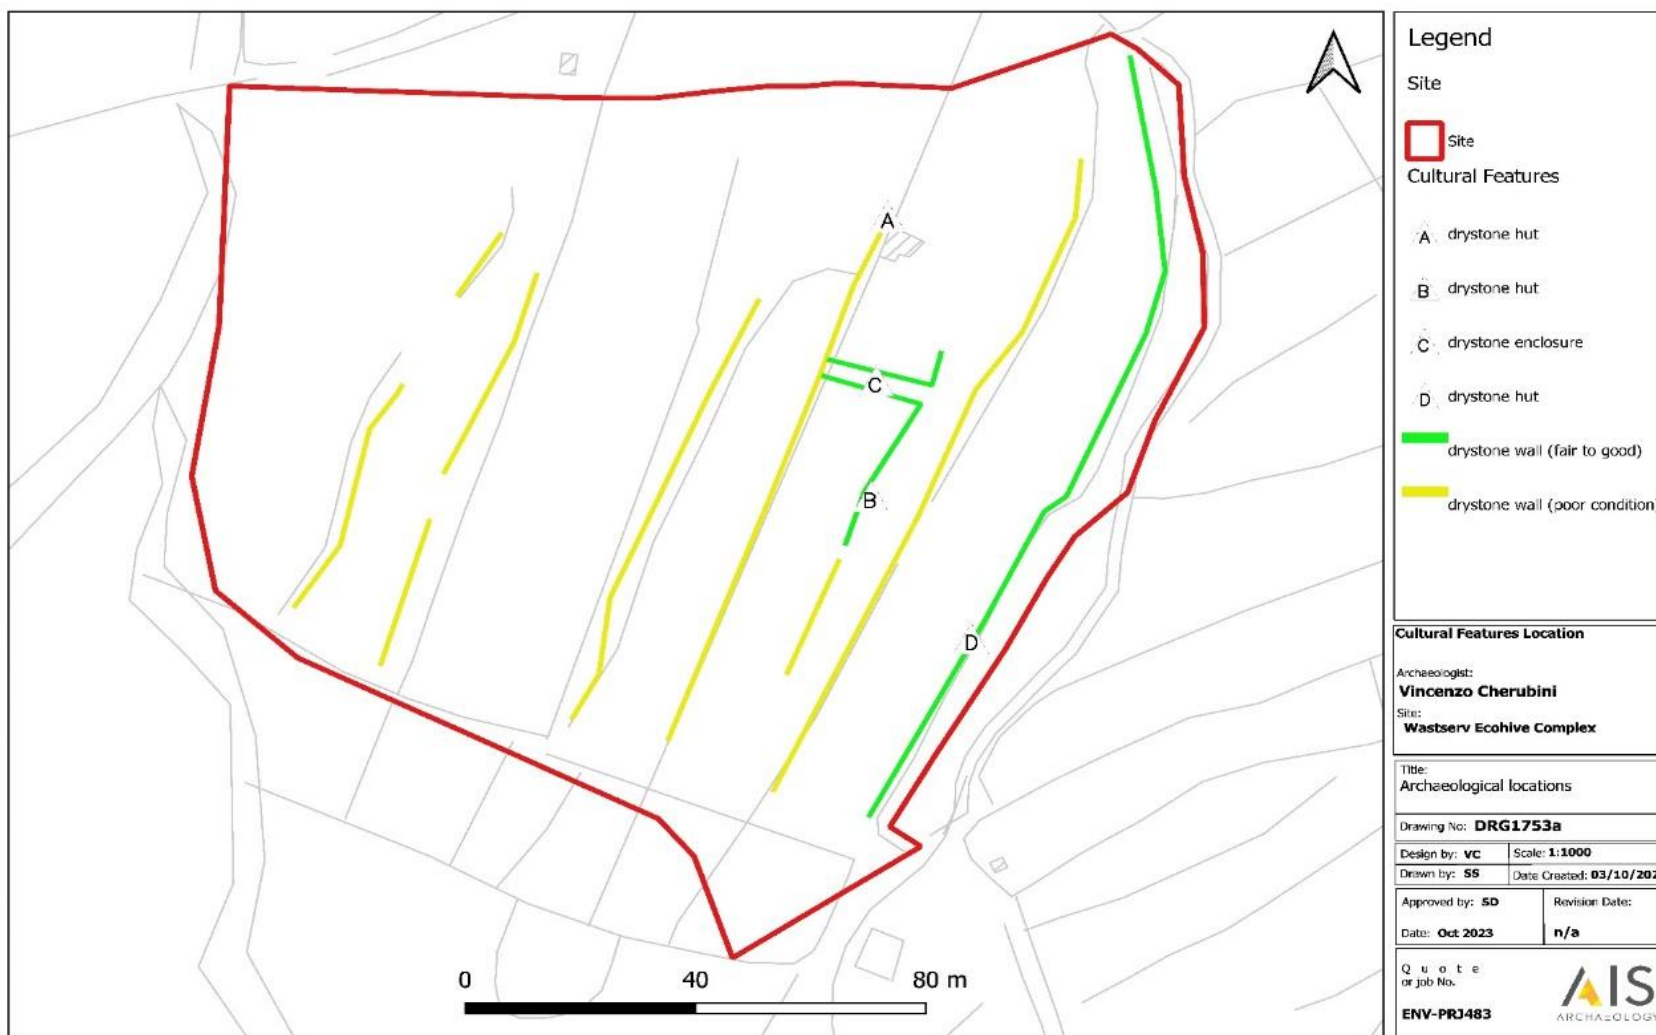
Figure 47: Location and states of Cultural Features identified within Aol

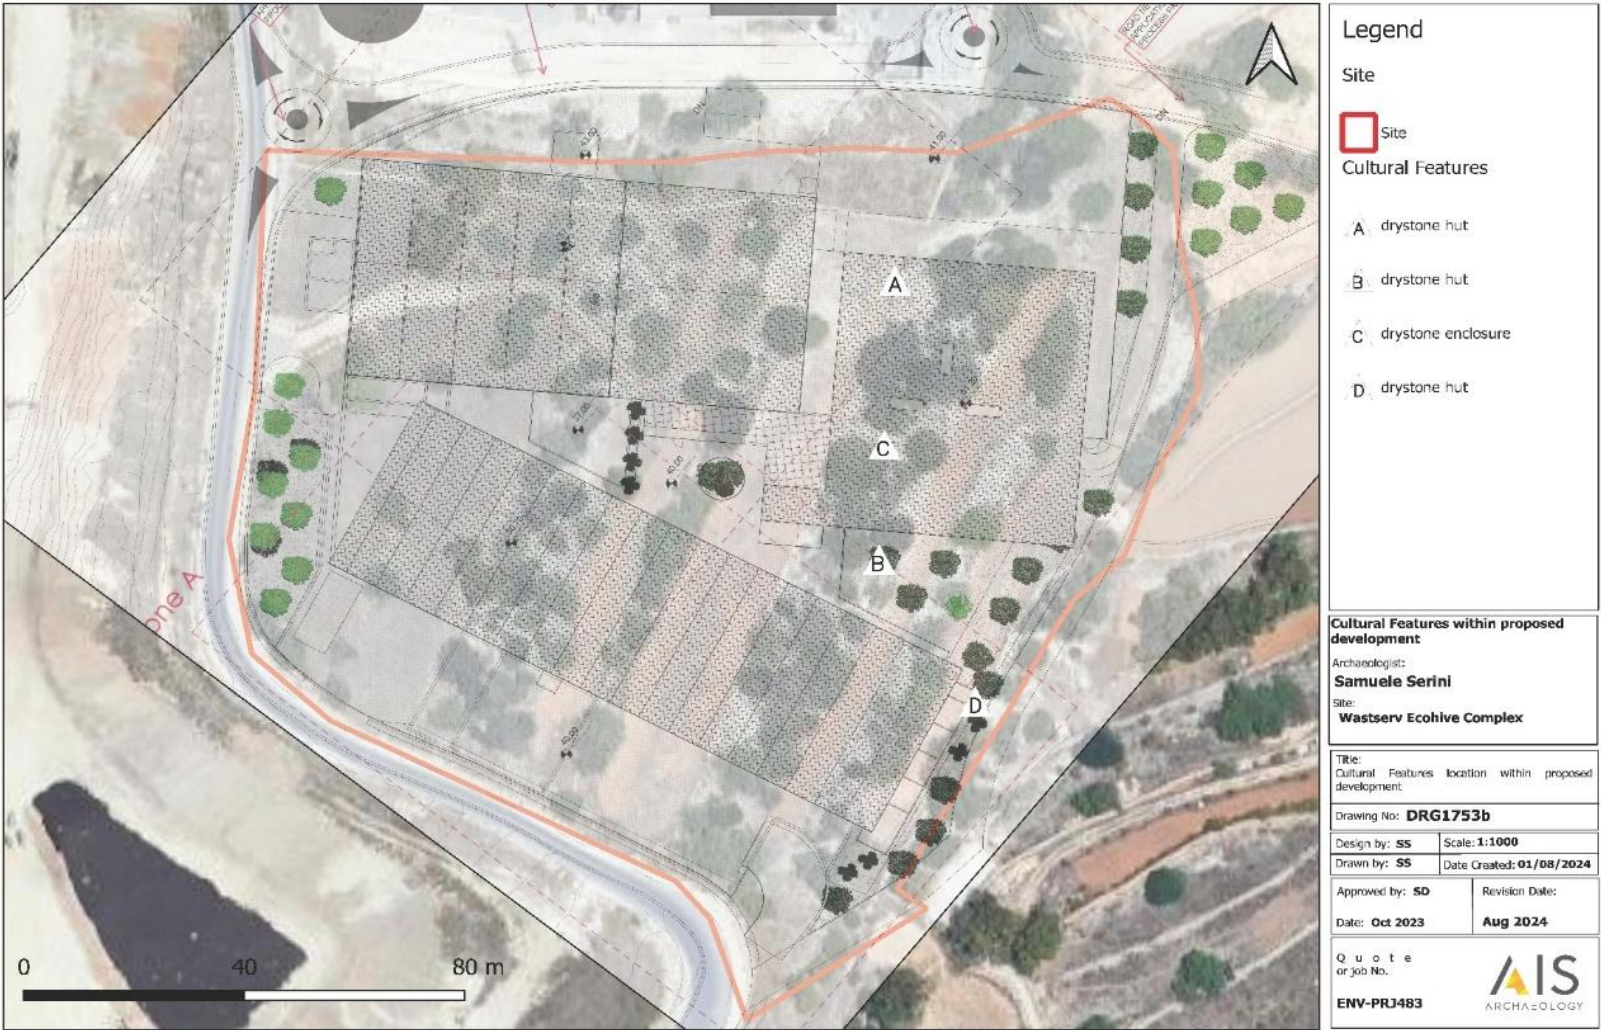
Figure 48: Location of cultural features within proposed development

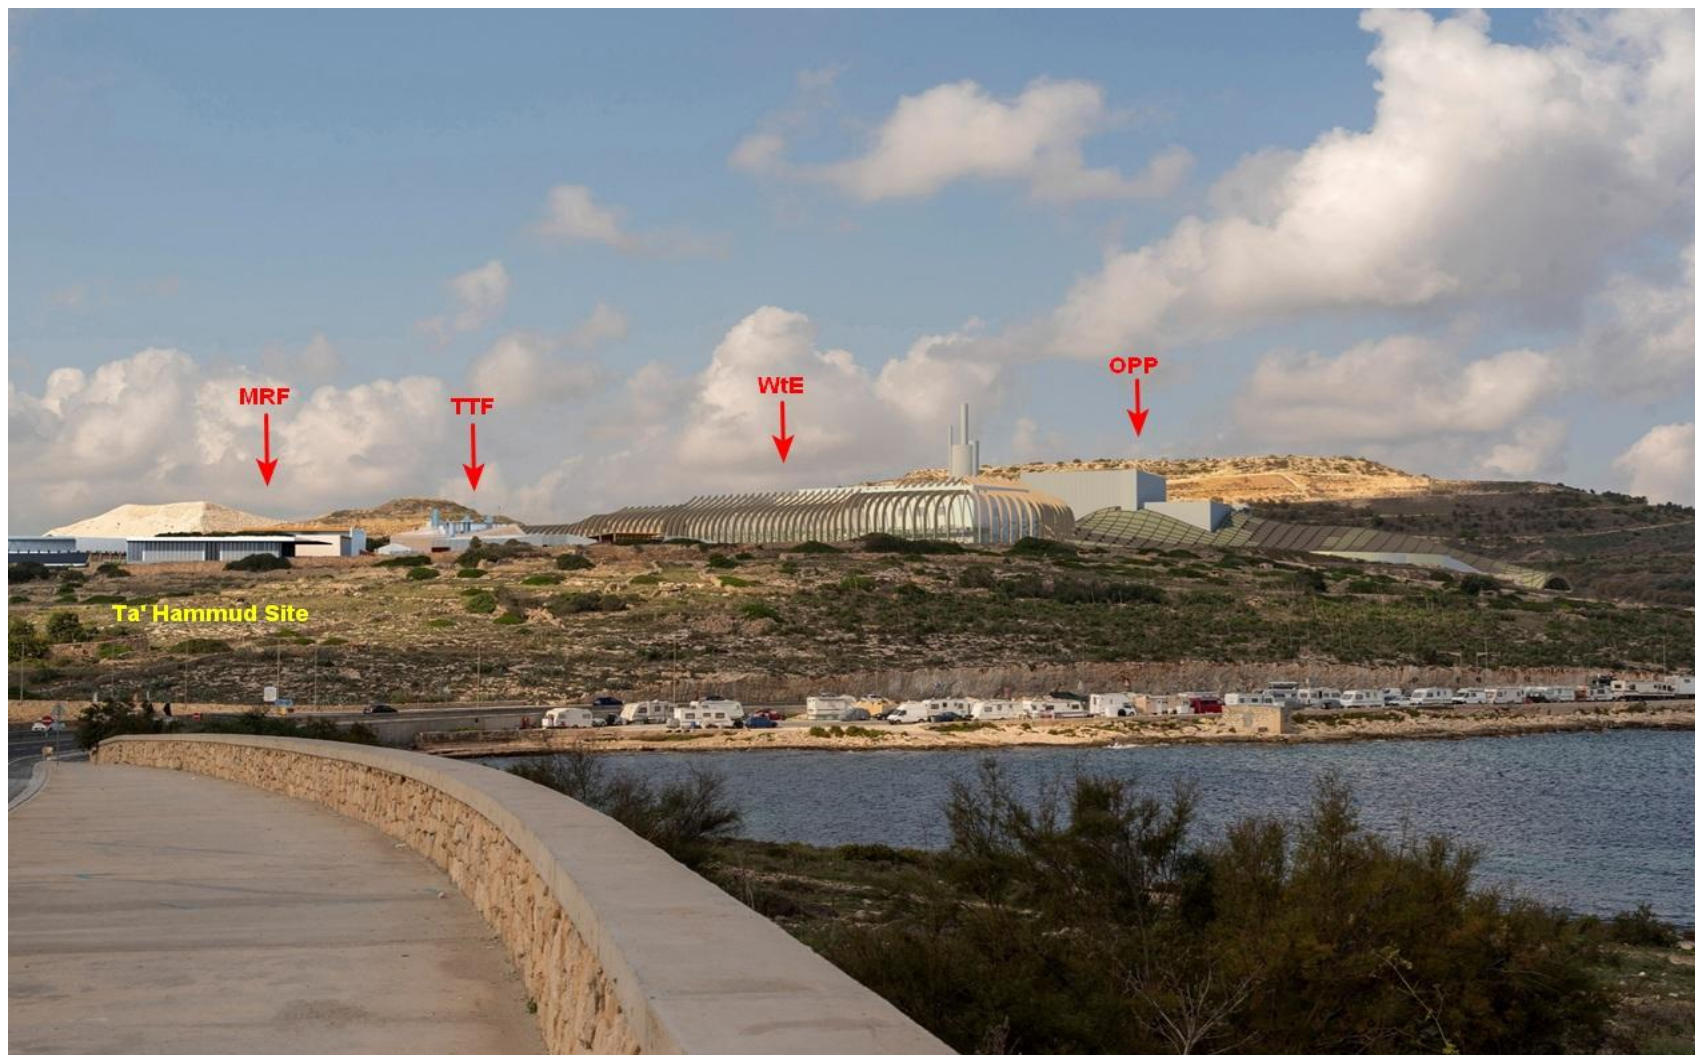
Figure 50: Cumulative view showing Ta' Hammud site and photomontage of MRF, TTF, WtE and OPP plant only at viewpoint 5

The area of Magthab is already severely affected by the visual impact of the waste disposal site located North and West of the AoI and other industrial activities. The proposed development and the simultaneous operation of other waste management facilities proposed in the proximity of the scheme, will cause a further deterioration of the cultural landscape and the context associated with the cultural heritage assets identified in this study, as shown in Figure 50.
