-----ENEMALTA DPS IPPC APPLICATION - FORM C-----

COORDINATED SAFETY REPORT FOR THE DELIMARA POWER STATION

**ENEMALTA PLC
ELECTROGAS MALTA LIMITED
D3 Power Generation Ltd.**

AS REQUIRED BY LN179/2015 CONTROL OF MAJOR ACCIDENT
HAZARDS

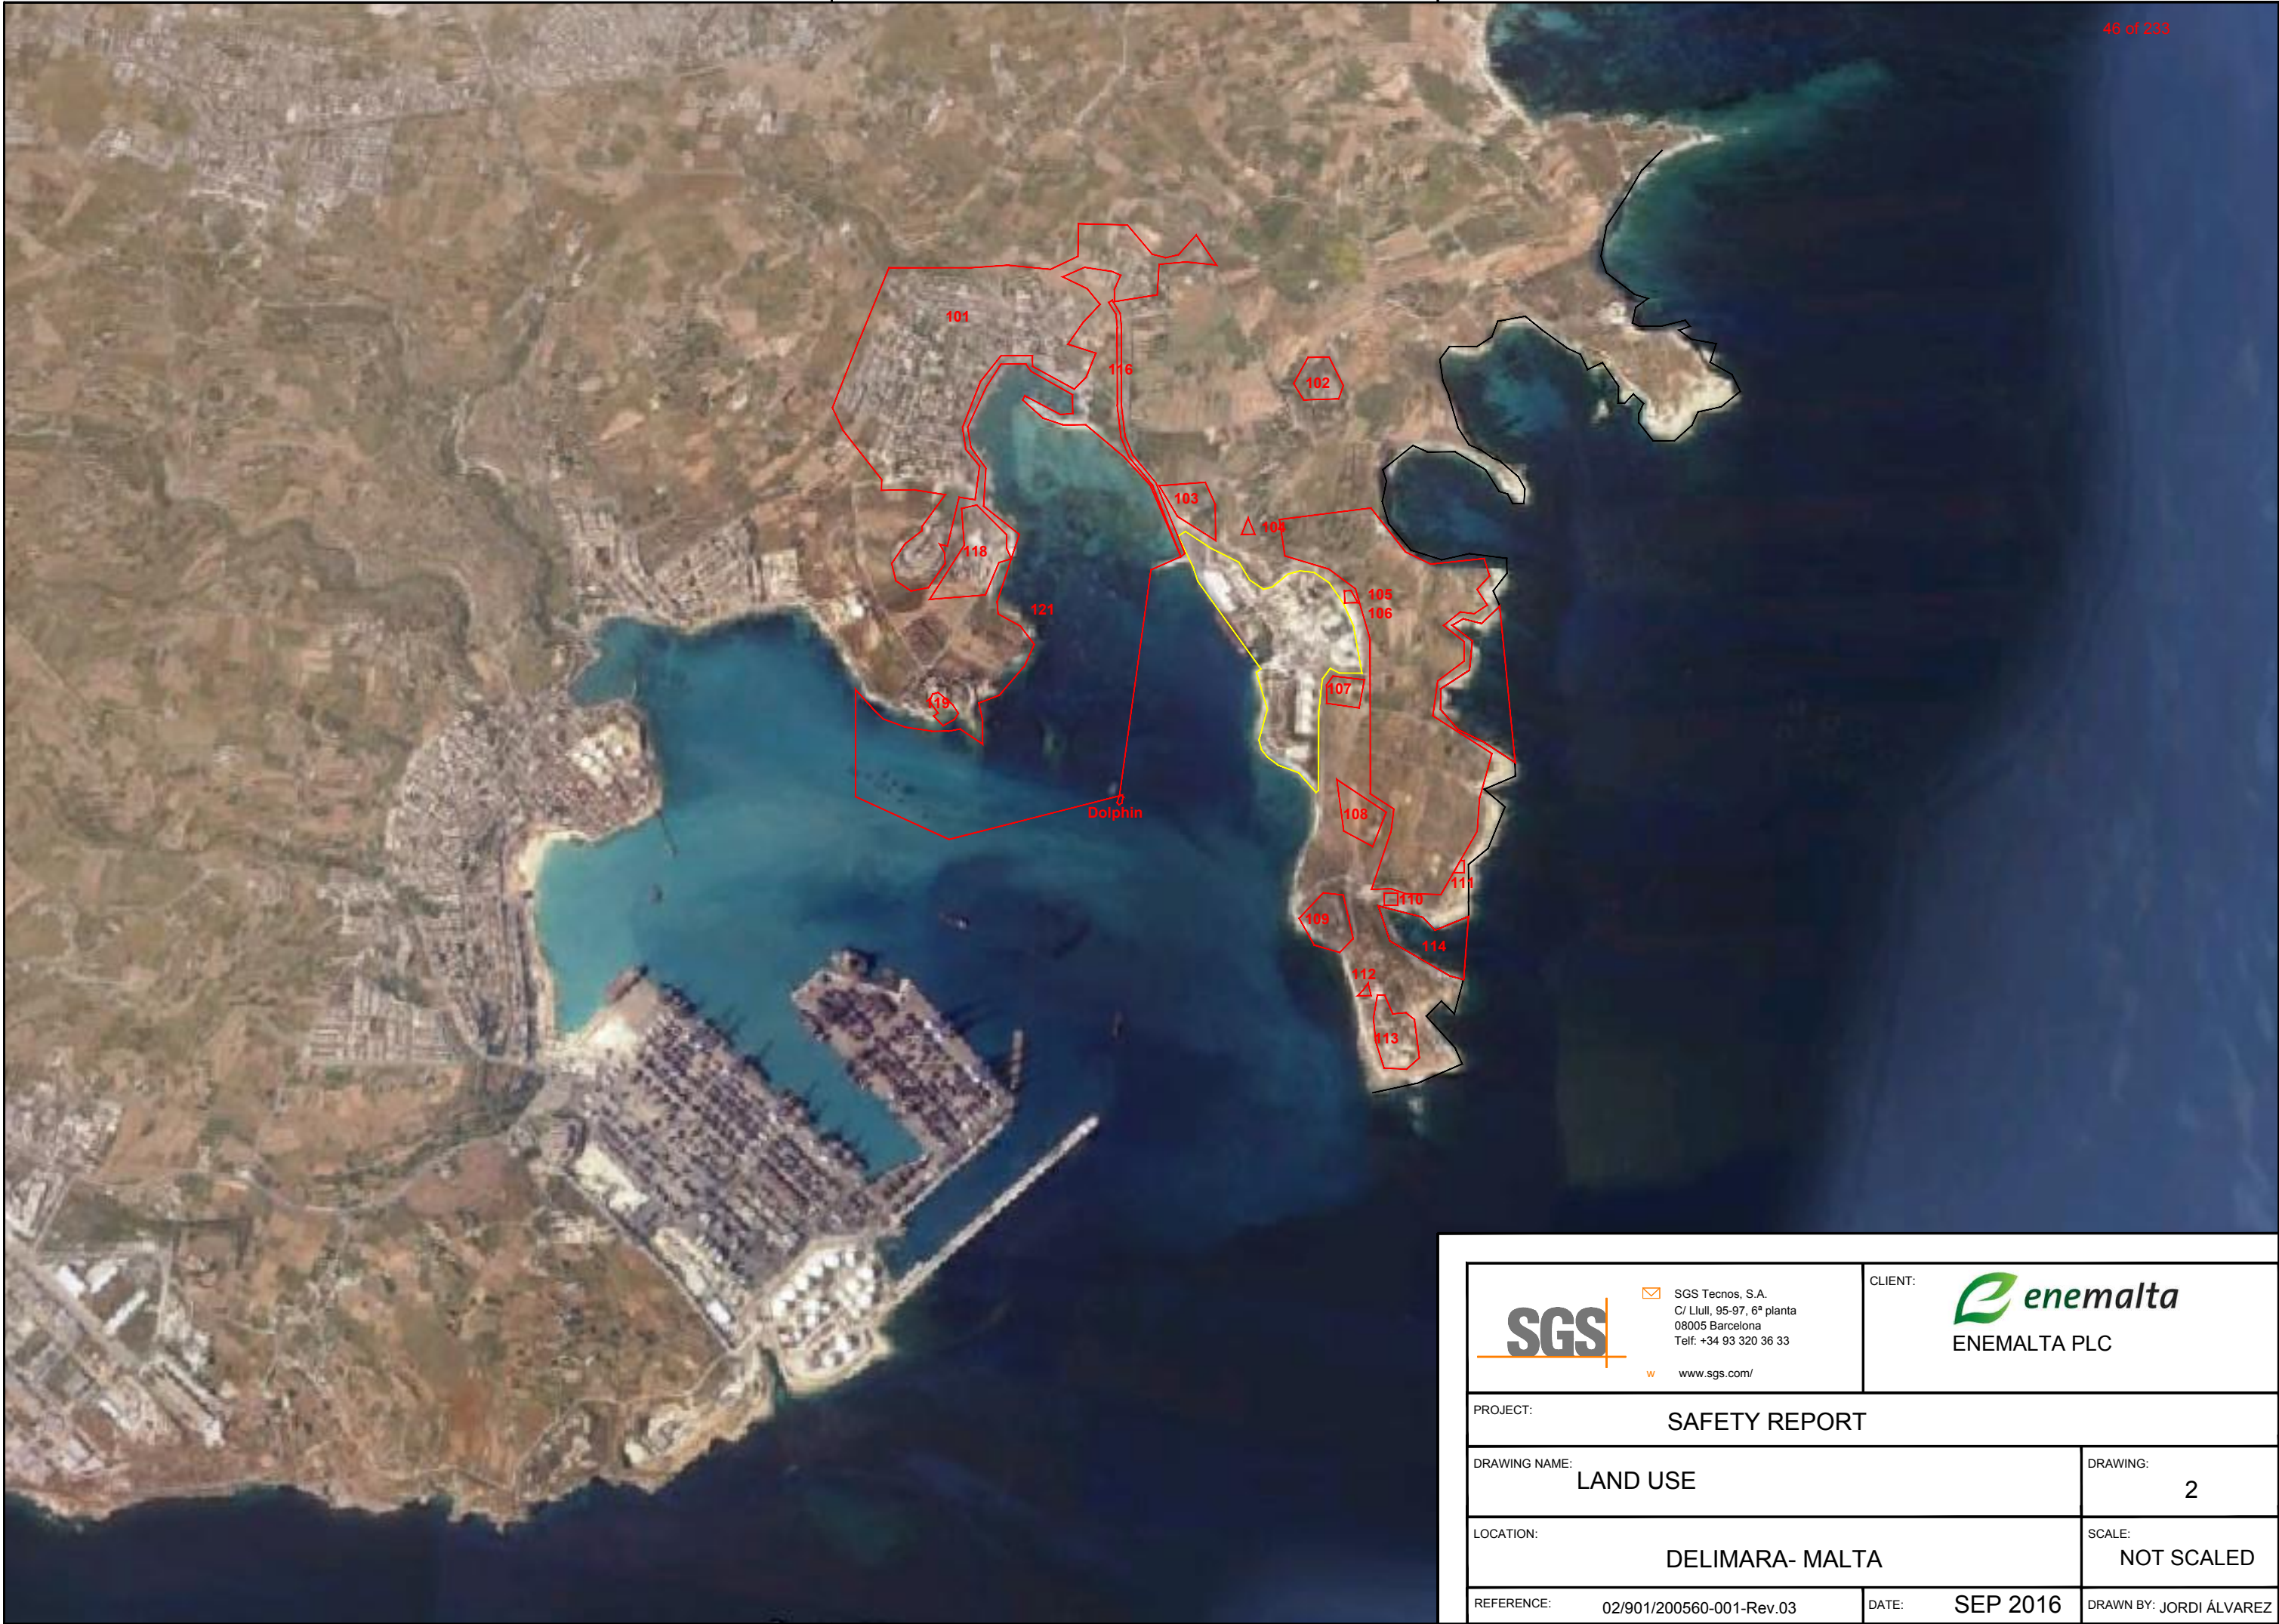
<div><div><div>SGS</div></div><div><div><div></div></div><div>SGS Tecnos, S.A. C/ Llull, 95-97, 6ª planta 08005 Barcelona Telf: +34 93 320 36 33 www.sgs.com/</div></div></div>		CLIENT: <div><div></div><div>enemalta</div><div>ENEMALTA PLC</div></div>	
PROJECT: SAFETY REPORT			
DRAWING NAME: LAND USE		DRAWING: 2	
LOCATION: DELIMARA- MALTA		SCALE: NOT SCALED	
REFERENCE: 02/901/200560-001-Rev.03	DATE: SEP 2016	DRAWN BY: JORDI ÁLVAREZ

NUMBER	DESCRIPTION	DRAWING SCALE
01	Area of concern	1 / 10,000
02	Land Use	N/S
03	General Plot Plan	1 / 3,000

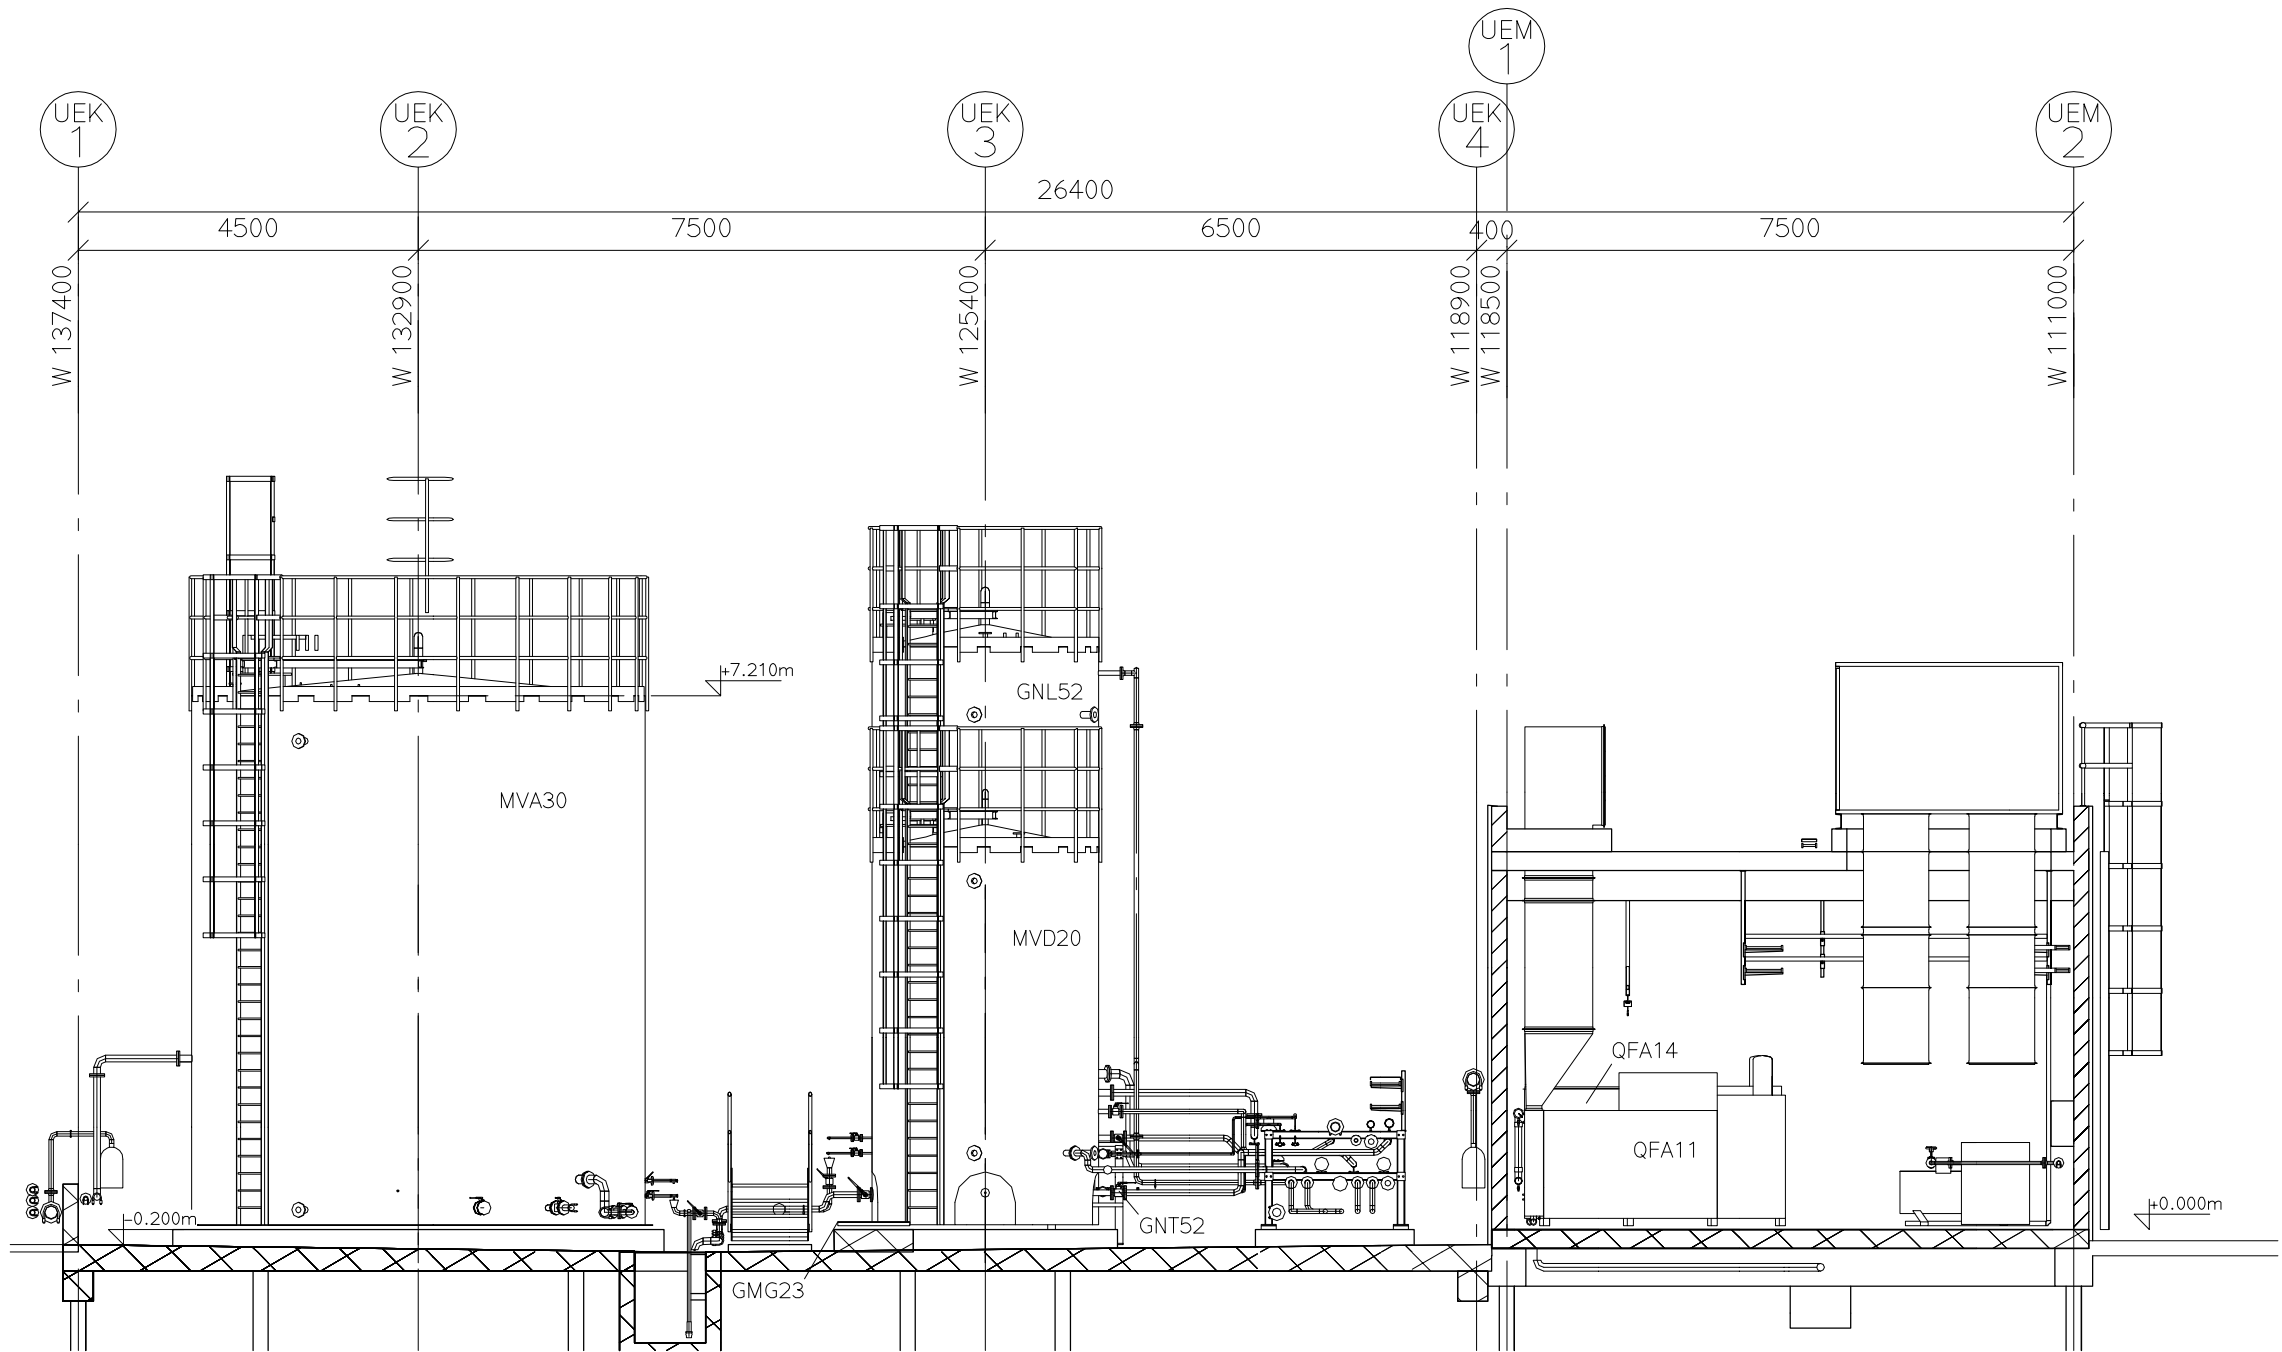
SECTION D-D, LOOKING NORTH

BURMEISTER & WAIN SCANDINAVIAN CONTRACTOR A/S DENMARK	
POST OFFICE BOX 235 DK 3450 ALLERØD, DENMARK TELEPHONE :+45 48140022 TELEFAX :+45 48140150					
PROJECT					
SUBJECT					
FOT BUILDING (UEM), SERVICE T. F. (UEK) & UREA T. F. (UVJ) LAYOUT SECTIONS, LOOKING NORTH					
SCALE		A1=1:100 A3=1:200		DWG. NO.

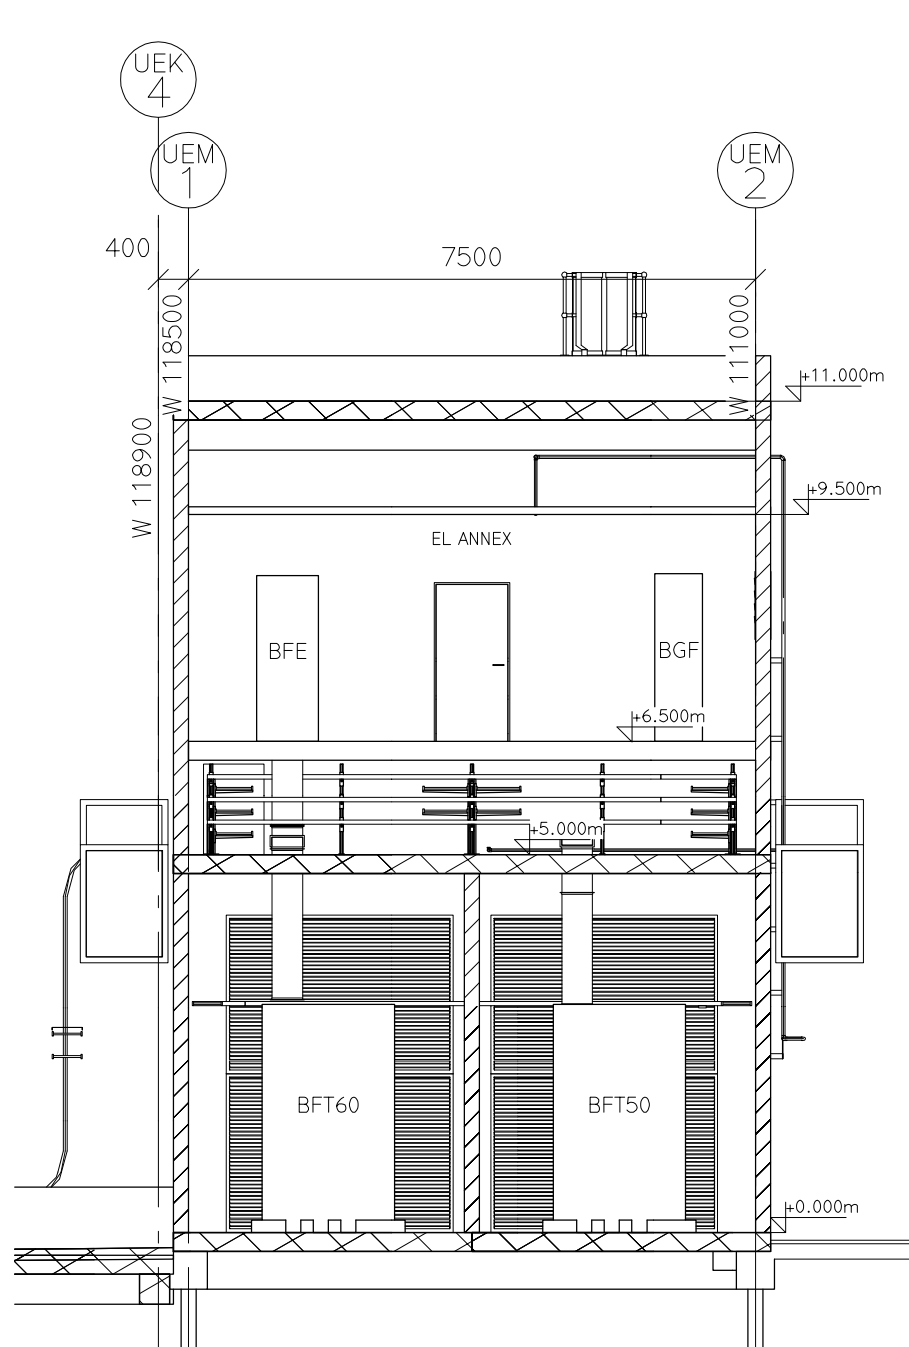
SECTION I-I, LOOKING NORTH

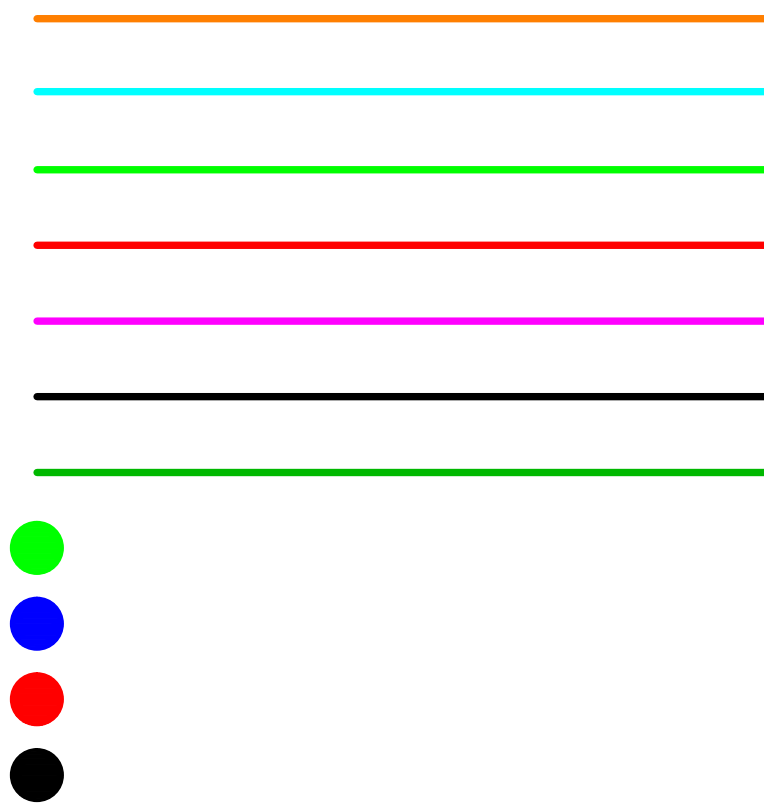
Drg. No. DPS-XZ-179

- TP13.D3 - STORM WATER TIE IN FOT AREA (ENEMALTA RESERVOIR OVERFLOWING TO SEA)
- TP14.D3 - OILY WATER TIE IN
- TP15.D3 - 415kV
- TP17.D3 - STEAM TIE IN
- TP18.D3 - SEA WATER OUTLET
- TP19.D3 - SEA WATER INTAKE ANTI-FOULING CHEMICAL INJECTION

- STEAM
- POTABLE WATER
- FOUL WATER
- DIESEL OIL
- OILY WATER
- HV CABLE ROUTE
- FIRE FIGHTING SYSTEM
- INPUT
- OUTPUT
- DISCHARGE
- INACTIVE

REV	DATE	BY	ALTERATION	CHK	APP
MARSA POWER STATION CHURCH WHARF MARSA MALTA TEL: 80072224 FAX: 21226637			DELIMARA POWER STATION DELIMARA MALTA, ZTN 09 TEL: 22980 800-3 FAX: 22980 867		
REFER ERRORS TO DRAWING OFFICE ALL DIMENSIONS IN mm					
TITLE ROUTES OF ENEMALTA SERVICES TO D3 PG					
SCALE	NTS	ISSUE	1	REV.	
DRAWN BY	A.MANGION	DATE	16/05/2019		
CHECKED BY	D.SAMMUT	DRG. No.	DPS-XZ-179		
APPROVED BY	I.STAFRACE
