-----ENEMALTA DPS IPPC APPLICATION - FORM C-----

APPENDIX Q - Decommissioning Plan – Part 2

Decommissioning Plan

Site Condition Report (SCR)

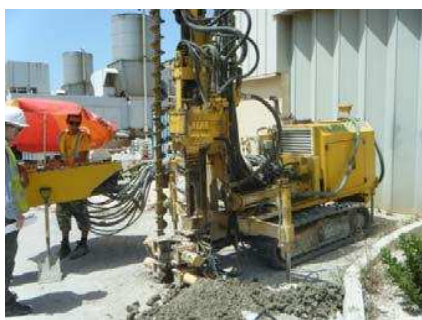
Photo 7.
Beretta T44 Drilling Rig

The drilling rig used was a Beretta T44; a tracked drilling rig with reducible tracks enabling it to move over soft ground and width restricted areas with minimal damage.

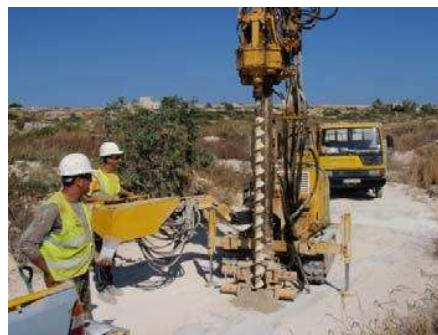
Photo 8.
Beretta T44 Drilling Rig.

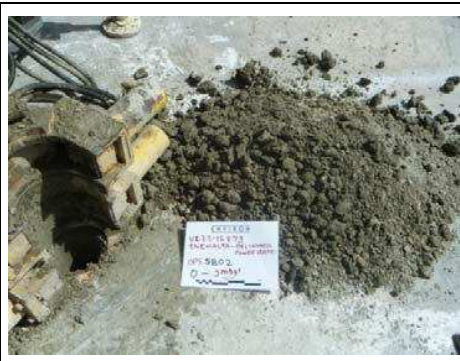
Photo 9.
Arisings from SB02 (0.0 – 5.0m bgl)

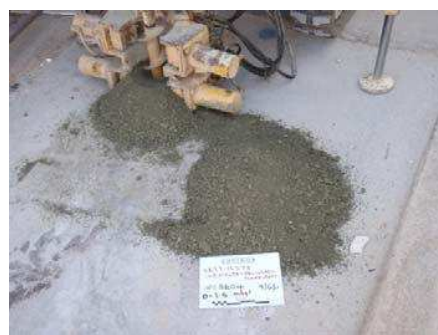
Photo 10.
Arisings from SB04 (0.0m – 2.5m bgl).

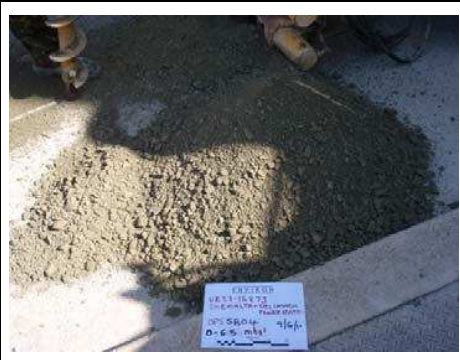
Photo 11.
Arisings from SB04 (0.0m – 6.5m bgl).

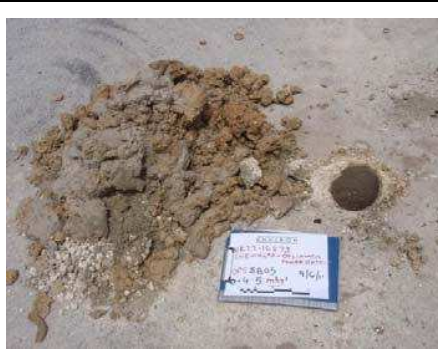
Photo 12.
Arisings from SB05 (0.0m – 4.5m bgl)

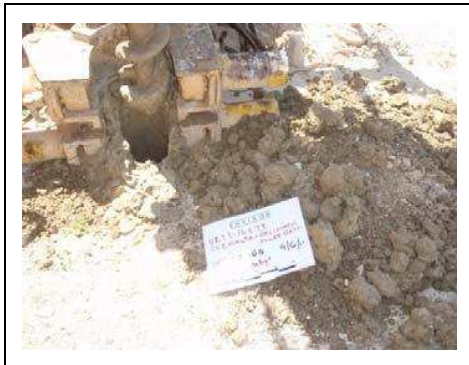
Photo 13.
Arisings from SB06B (0.0m – 5.5m bgl)

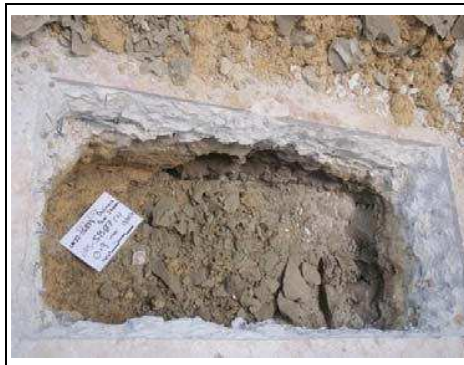
Photo 14.
SB07 Hand dug service pit to 0.9m bgl

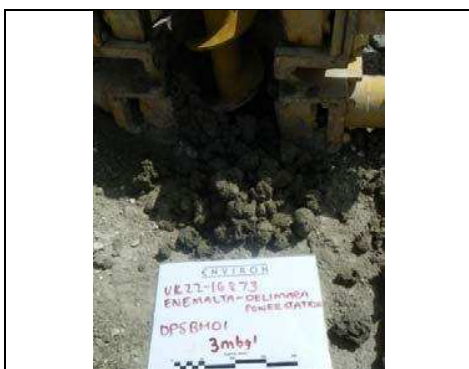
Photo 15.
Arisings from BH01 (3.0m bgl)

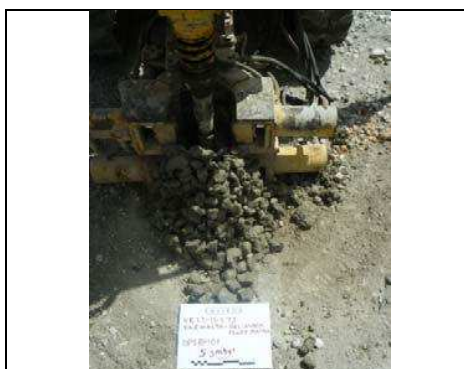
Photo 16
Arisings from BH01 (5.5m bgl).

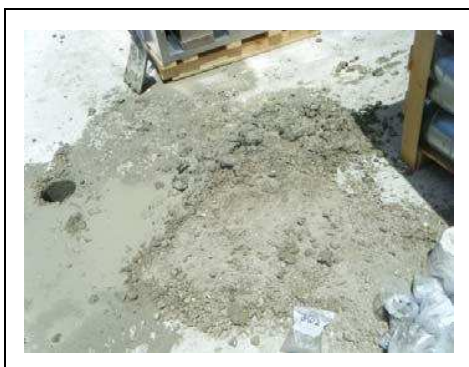
Photo 17.
Arisings from BH02 (0.0m-0.5m bgl)

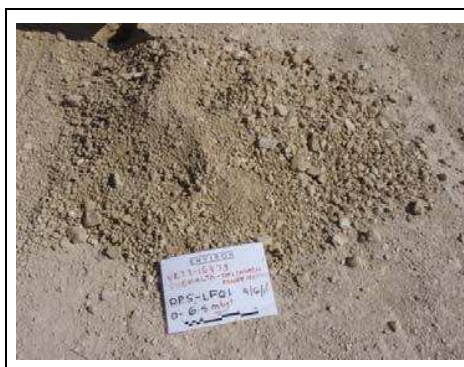
Photo 18.
Arisings from LF01 (0.0 – 6.5m bgl)

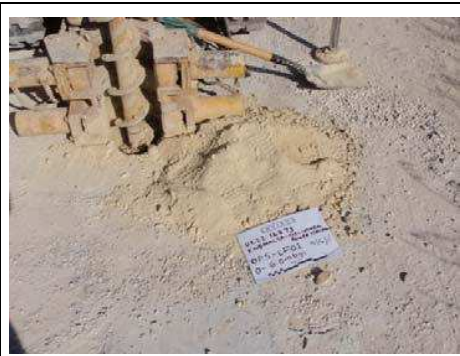
Photo 19.
Arisings from LF02 (0.0 – 6.0m bgl)

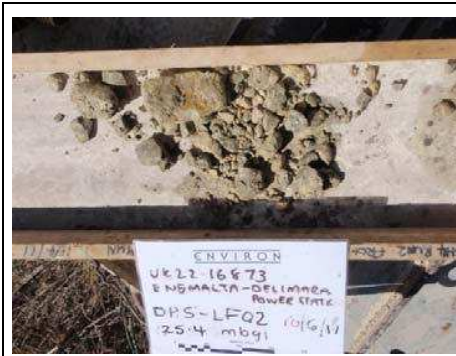
Photo 20.
Arisings from LF02 (25.4m bgl)

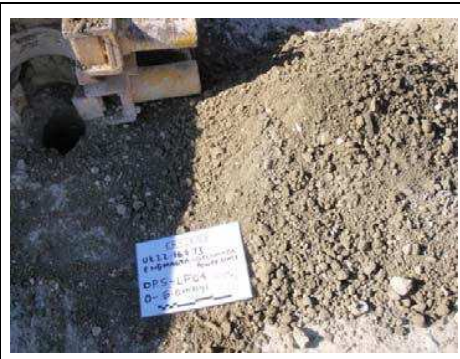
Photo 21.
Arisings from LF03 (0.0-6.0m bgl)
