BUND WALL TEST CERTIFICATE

Test Certificate No. 18-606-01

Place: Delimara Power Station
Triq il-Power Station
Marsaxlokk,
Malta.

Location: Jetty – Below LPG Manifold

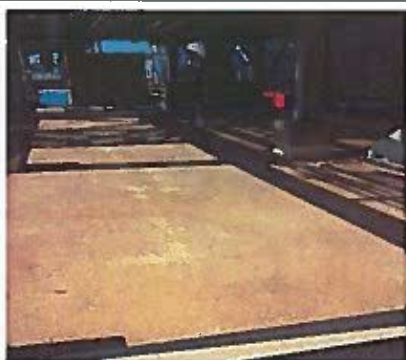
Description: 0.2m Thick Reinforced Concrete Bund Wall
Overall Dimensions: 7.43m x 13.25m x 0.25m;
Volume Capacity: Approx. 21.92m³ (Excluding concrete Plinths)

Jetty Bund Wall

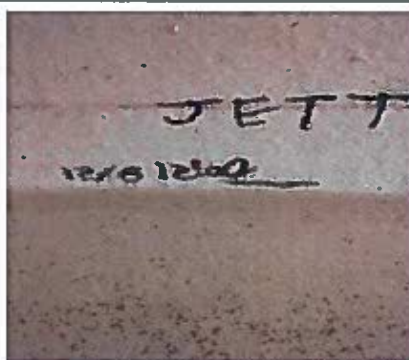
Methodology: Day 1: 12th June 2018 at 12.00hrs
Bund cleaned of debris and any other liquids. Bund filled with Water and level of water noted to be 78mm
Water level marked and allowed to settle for 24 hrs.
Day 2: 13th June 2018 at 12.30 hrs
Level of Water in Bund Wall Noted to be 78mm

Initial Level of Water

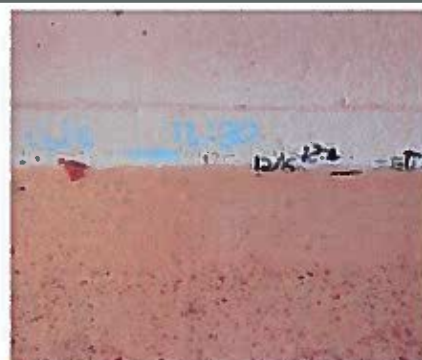
Result: Bund Wall Holds - Satisfactory

Final Level of Water – After 24 hrs
