Appropriate Assessment for the Storm
water relief tunnel upgrades to relieve
flooding problems near Mater-Dei
Hospital Roundabout

As per ERA requirements for PA/6860/21

APPROPRIATE ASSESSMENT
AIS REF. No: **PRJ-ENV730**
CLIENT REF. No: **PA/6860/21**
FOURTH VERSION

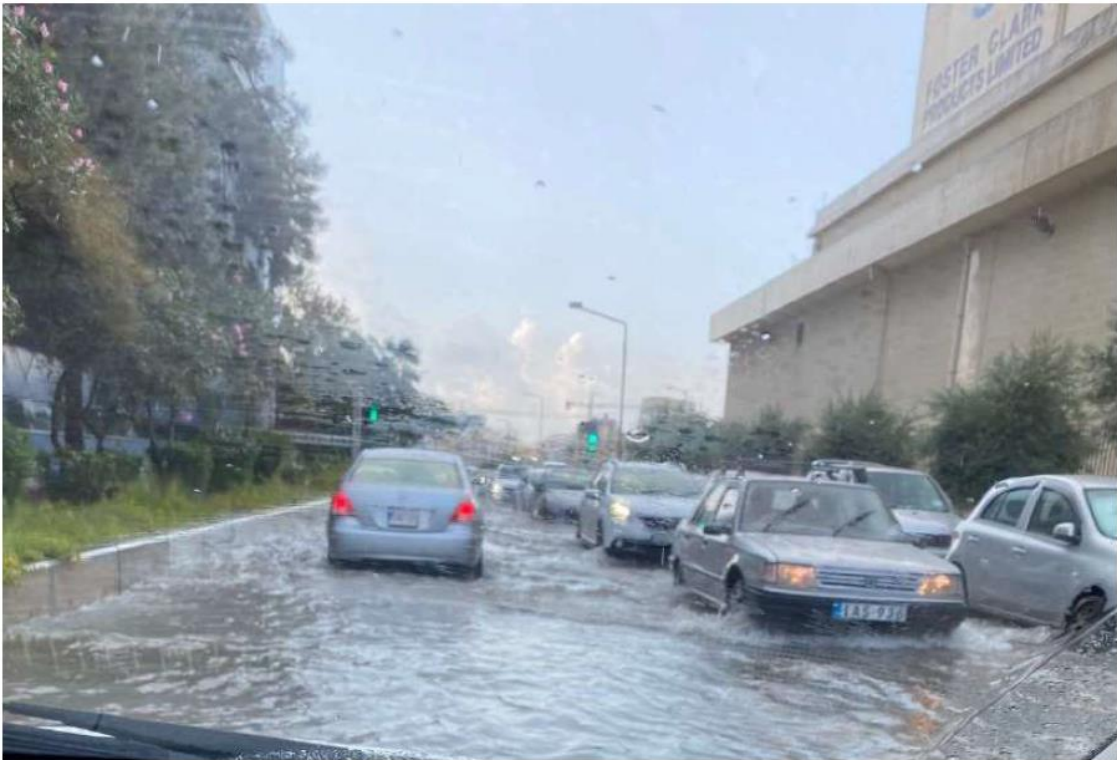
FIGURE 1: FLOODING AT TRIQ SIR ANTHONY MAMO, AS MAPPED IN FIGURE 2

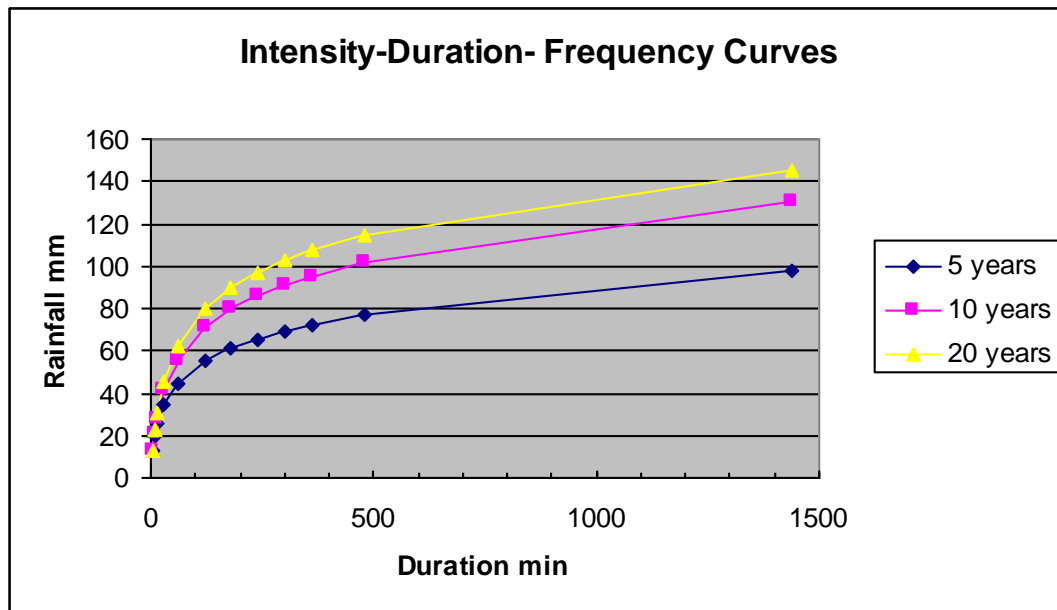
FIGURE 14: PLOT OF INTENSITY- DURATION FREQUENCY DATA SHOWN IN TABLE 6, ABOVE.

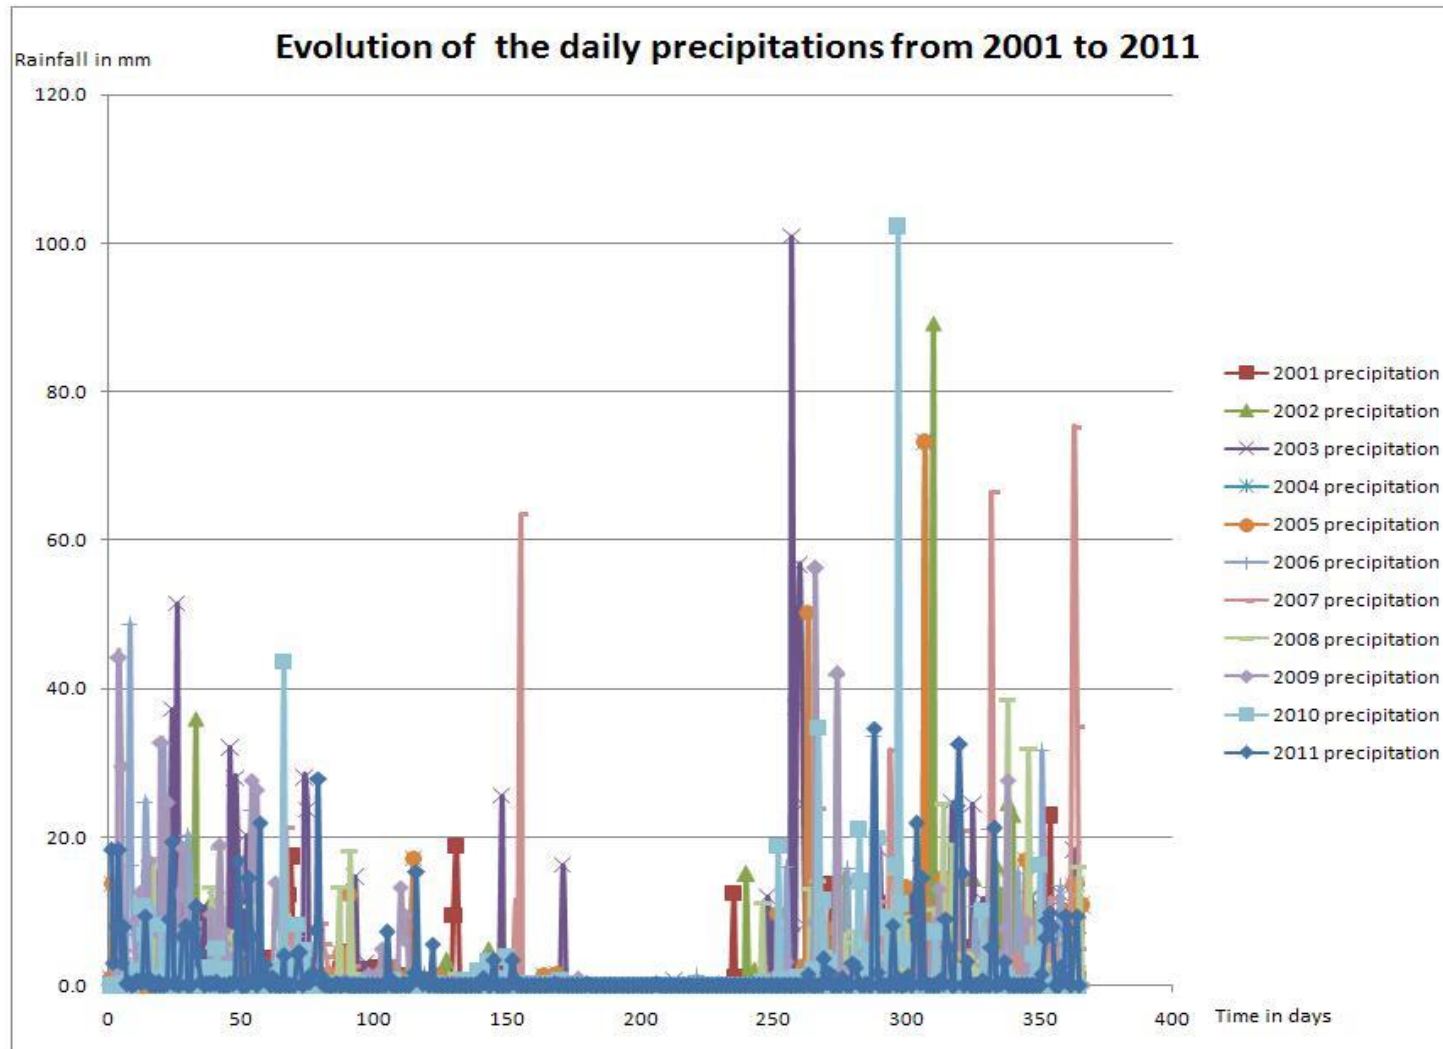
FIGURE 15: CHART REPRESENTING DAILY PRECIPITATION IN MM BETWEEN THE 1/01/1980 TO THE 31/12/1990, DATA FROM MET OFFICE, LUQA STATION.

FIGURE 16: CHART REPRESENTING DAILY PRECIPITATION IN MM BETWEEN THE 1/01/1991 TO THE 31/12/2000, DATA FROM MET OFFICE

FIGURE 17: CHART REPRESENTING DAILY PRECIPITATION IN MM BETWEEN THE 1/01/2001 TO THE 31/12/2011, DATA FROM MET OFFICE

FIGURE 18: CHART REPRESENTING DAILY PRECIPITATION IN MM BETWEEN THE 1/01/1980 TO THE 31/12/2011, DATA FROM MET OFFICE

Although the data appears cluttered, the scope of the charts is to identify the number of days with daily rainfalls peaks which are over 40mm, over 60mm and over 80mm. These appear as (few) peaks which stand out in the charts. The peaks with a daily rainfall over 80mm (Storm rainfall event) are even fewer. The peaks have been counted to calculate the storm return period by statistical analysis methods.

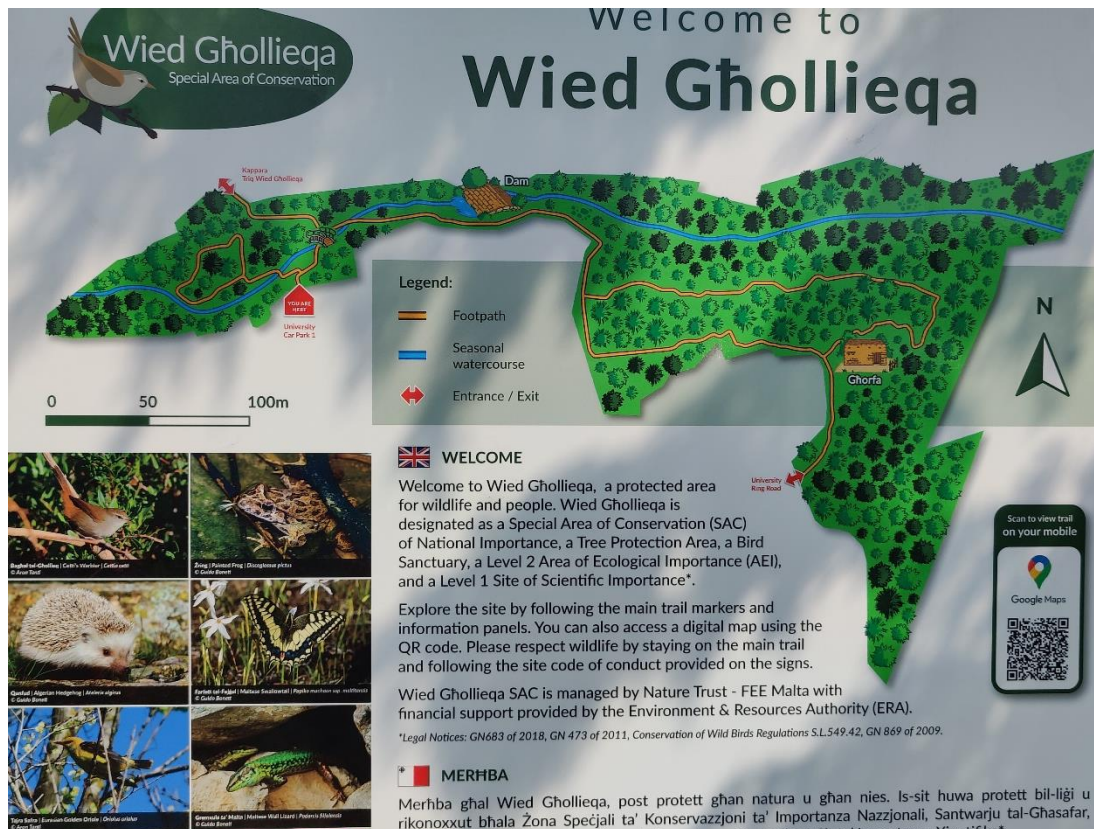
FIGURE 21: SITE NOTICE SHOWING SEASONAL WATER COURSE AND FOOTPATHS AT WIED GHOLLIEQA

The path taken by runoff within the water catchment area is marked in blue in Figure 20 and Figure 21. The valley is also subdivided into various zones as indicated. The San Ġwann Industrial Estate is over 90% developed and built up. A true water course is lacking on the upstream section suggesting that run-off is scarce and Wied Ġhollieqa is in fact a dry valley. In fact, the valley is partitioned into land parcels bounded by rubble walls with no evident watercourse. A true watercourse is only developed further downstream close to the discharge point.

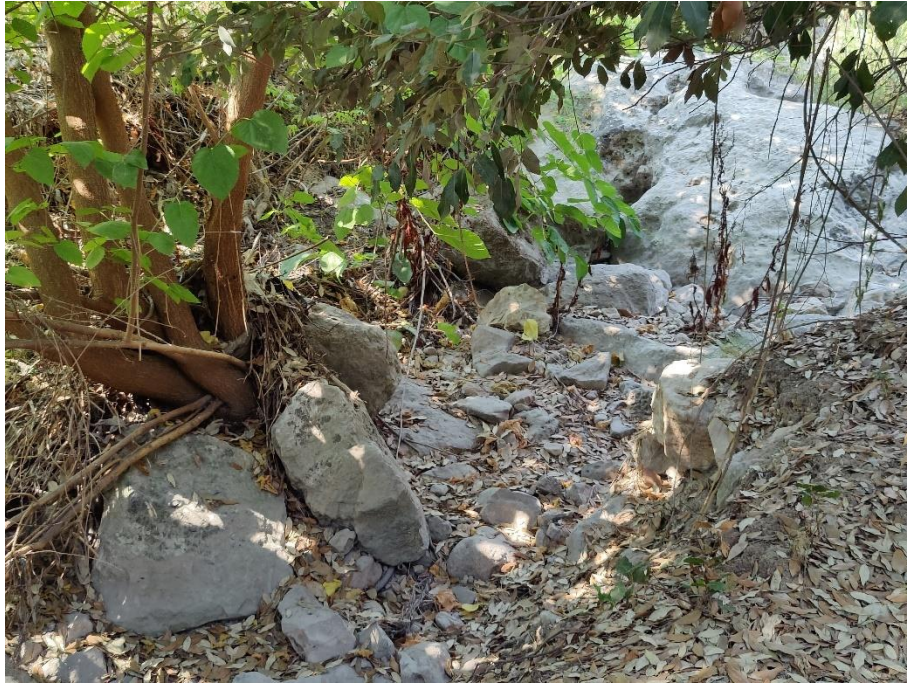
FIGURE 27: ROUTE TAKEN BY THE SEASONAL WATERCOURSE AT WIED GHOLLIEQA

As elucidated in the hydrology section, the site experiences substantial influxes of stormwater, which flow seamlessly from the entire catchment area in response to the gravitational forces dictated by the valley's topographic contours. This dynamic process contributes to the formation of small, localized pools of stagnant water along the fringes of the valley. Simultaneously, the main valley bed typically undergoes complete desiccation during the summer months, showcasing the cyclic nature of water availability and its profound impact on the ecosystem's functioning.

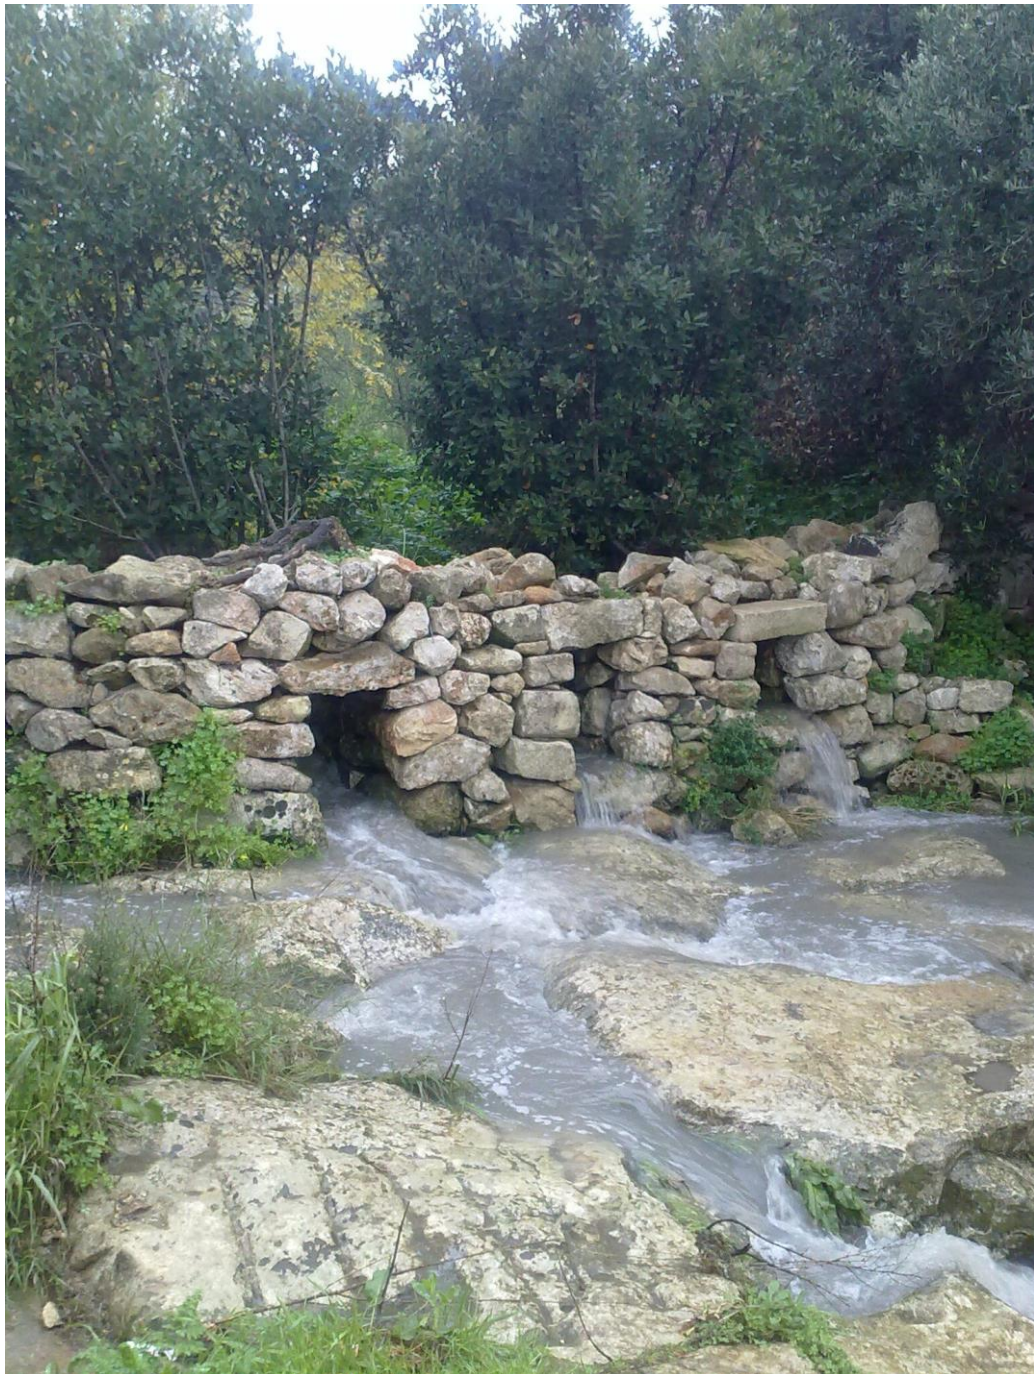
FIGURE 28: WATER RUNOFF WITHIN THE VALLEY BED (SOURCE: NATURE TRUST MALTA)²

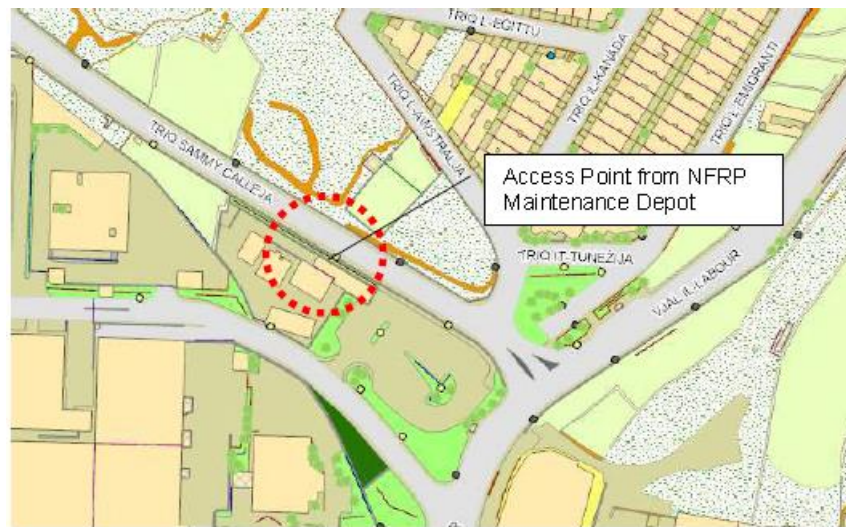
FIGURE 36 – ACCESS POINT B - MOSTA

However, it's imperative to acknowledge that this access point does hold significant value in contingencies and urgent situations that could emerge during the course of the envisaged drilling operations. In such critical scenarios, Access Point B assumes a pivotal role as an emergency resource, standing ready to be utilized effectively as necessitated by unforeseen circumstances.
