***Environmental Impact Assessment***  
**EA/00042/20:**  
**Construction of a Material Recovery**  
**Facility (MRF)**  
**at the Ecohive Complex,**  
**Geology and Hydrology**

**Saviour Scerri**

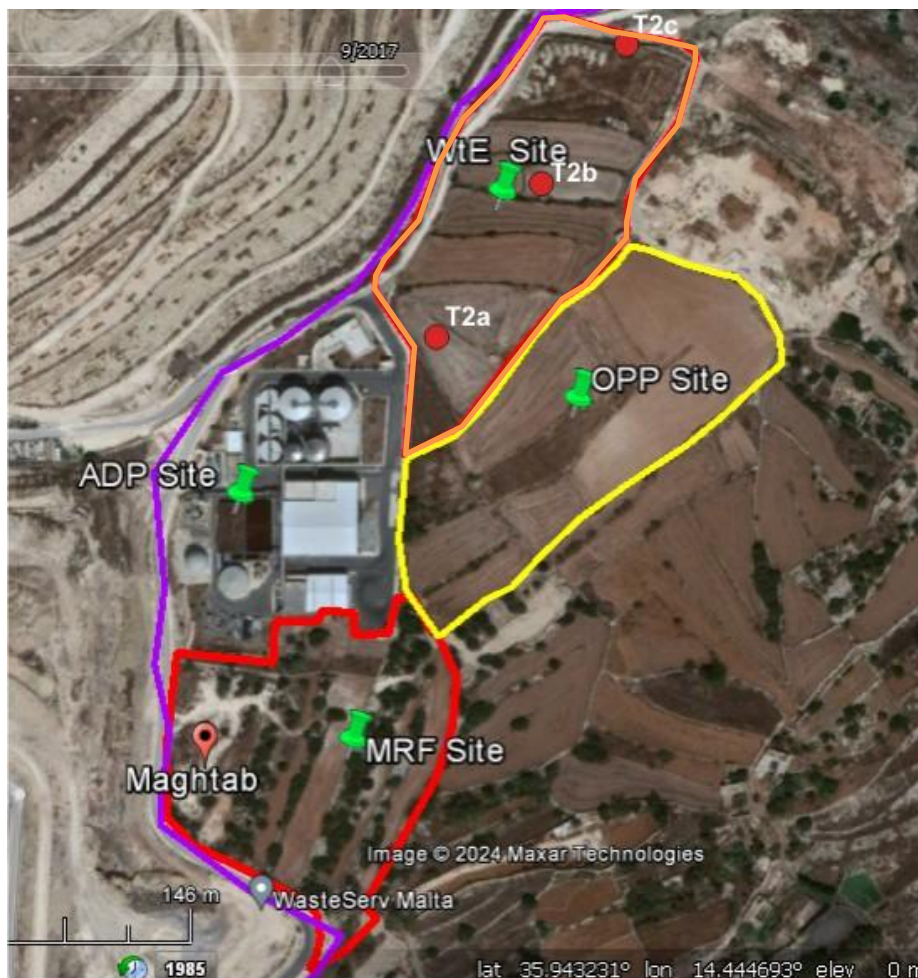
Figure 11: Plan showing the location of the boreholes drilled by continuous rock core sampling for the EIA for the WtE Facility.

In addition to the field survey, it is being proposed to use the exhaustive subsurface ground investigation undertaken in 2020 in connection with the construction of the Waste to Energy Facility, located in the vicinity of the site, for the proposed MRF facility (Figure 11).

An exhaustive chemical study of the nature of the material to be excavated, whether it is contaminated/hazardous or not, has already been undertaken in connection with the construction of the WtE Facility located next to the site. During this investigation a total of 30 samples, collected from 5 boreholes each 30m deep have been tested and none were revealed to be hazardous or contaminated. The 5 Borehole tested were BHT1B, BHT1C, BHT1D, BHT2A and BHT2B (**Figure 11**).

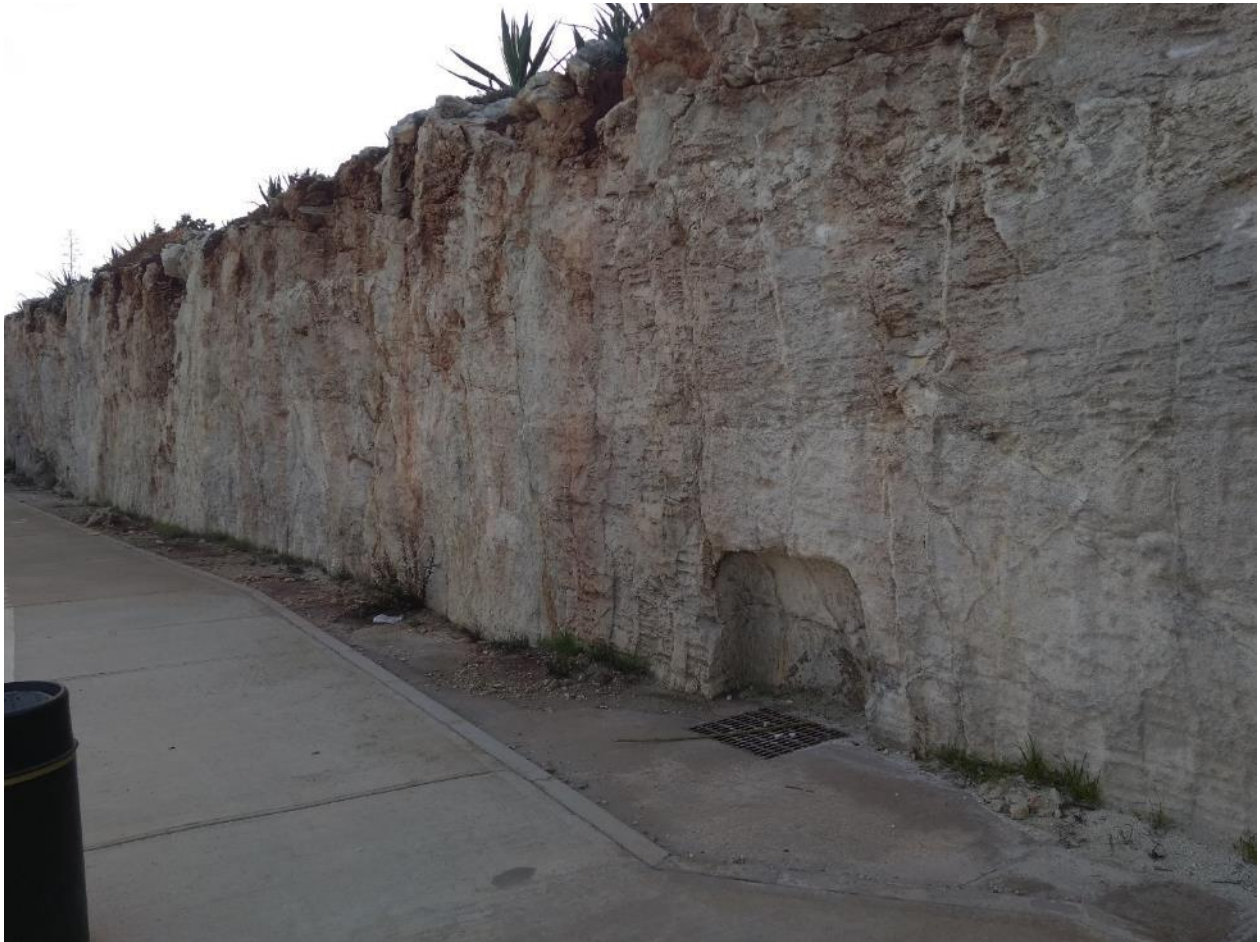
Figure 15: Coast Road cutting about 4m high exposing strata of the Xlendi Mb (Note the typical cross bedding)

Of these members, the rock that dominates the area of influence is the Xlendi Member, which from past ground investigations in the area is known to be about 9m to 11m thick and is composed of brown or light brown very coarse bedded foraminiferal Limestone in wedge –shaped mega-forests beds of 20cm to about 80cm thick (Figure 16 and 16). The rock has a relatively high porosity but due to its non-homogeneous nature t is quite variable.

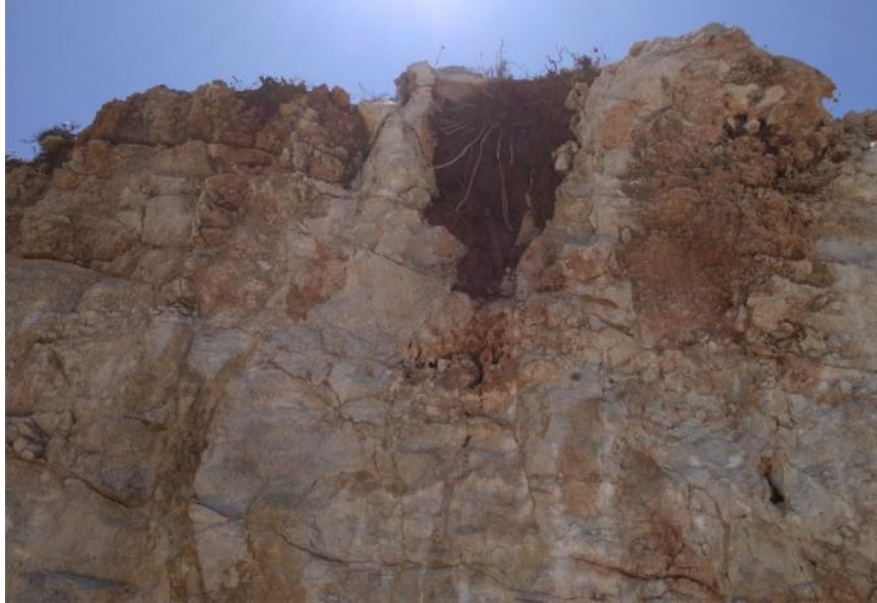
Figure 16: Photograph showing Xlendi Mb with Karst conduits filled with terra rossa

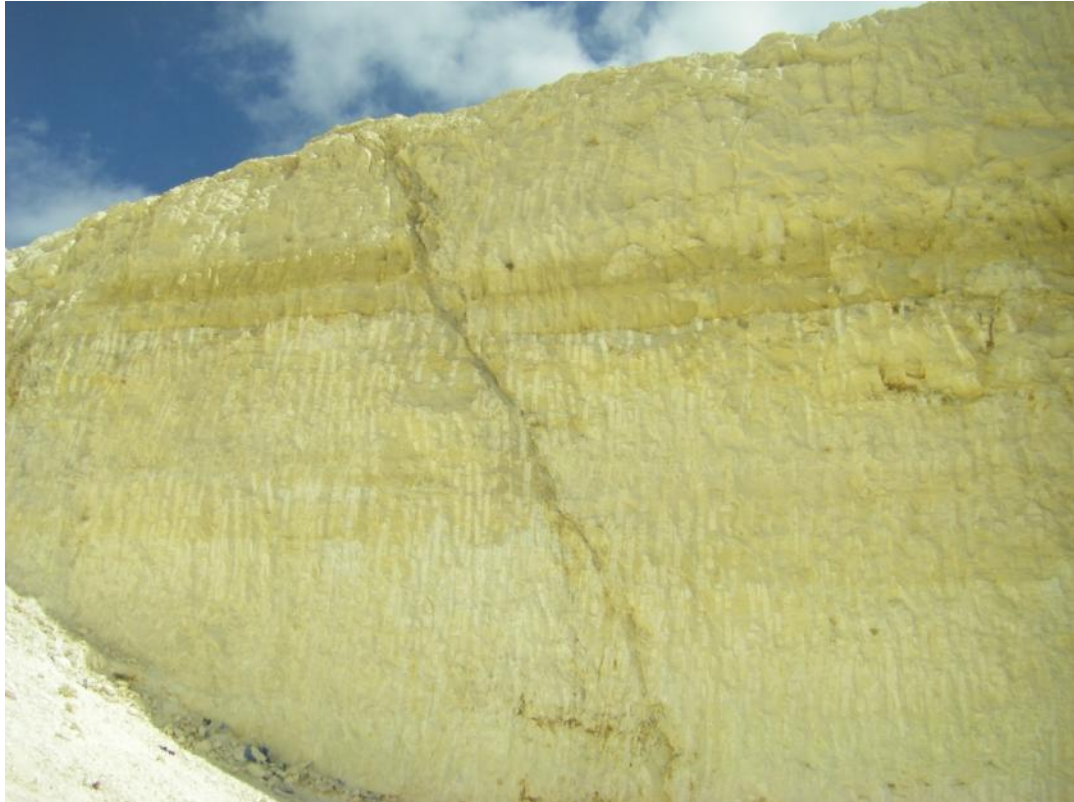
*Figure 17: Cutting in the Ghallis Land fill showing the contact between Lower Coralline Limestone and the overlying Lower Globigerina Limestone marked by two slightly darker yellow beds*

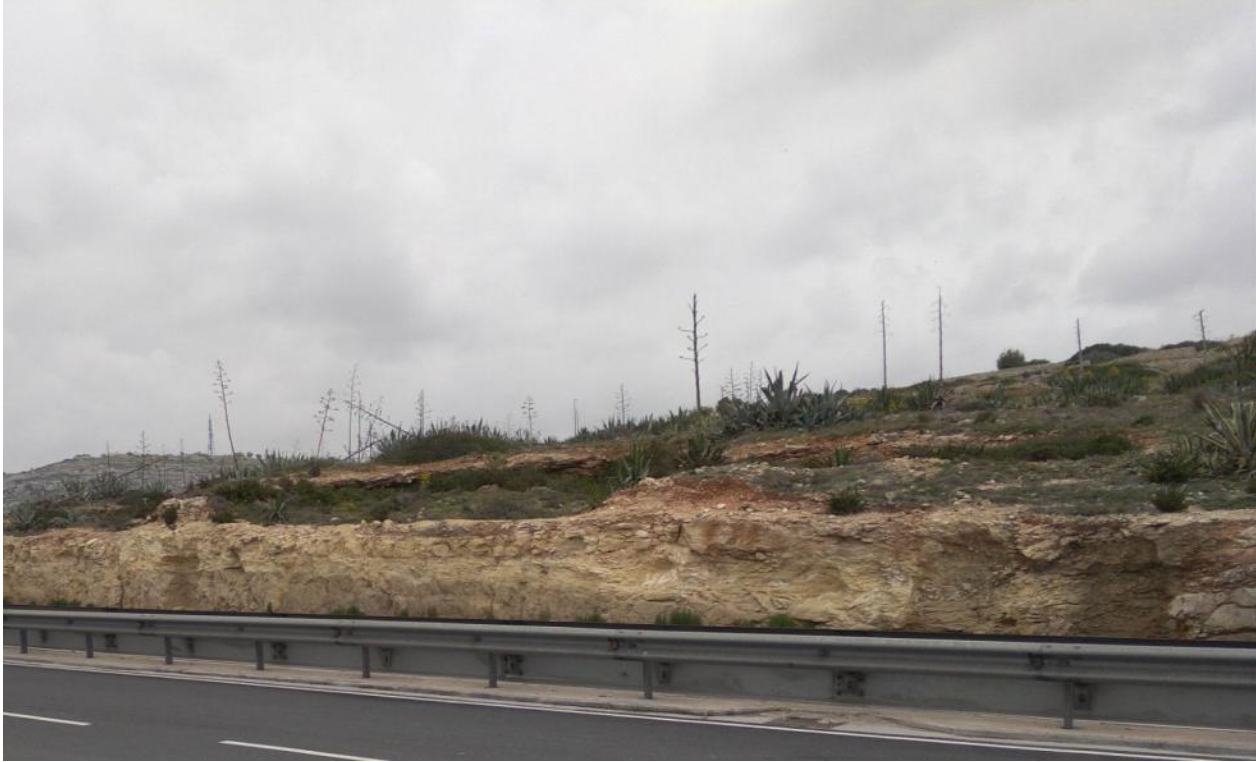
*Figure 18: Photograph showing a surface lithified layer of red Quaternary slope deposits underlain by Lower Globigerina Limestone. Such deposits are usually associated with faults*

During the Field survey a red partly lithified slope scree exposure was observed along the coast road. The slope scree is associated with minor faulting which can be seen along the Coast Road (Figure 18).

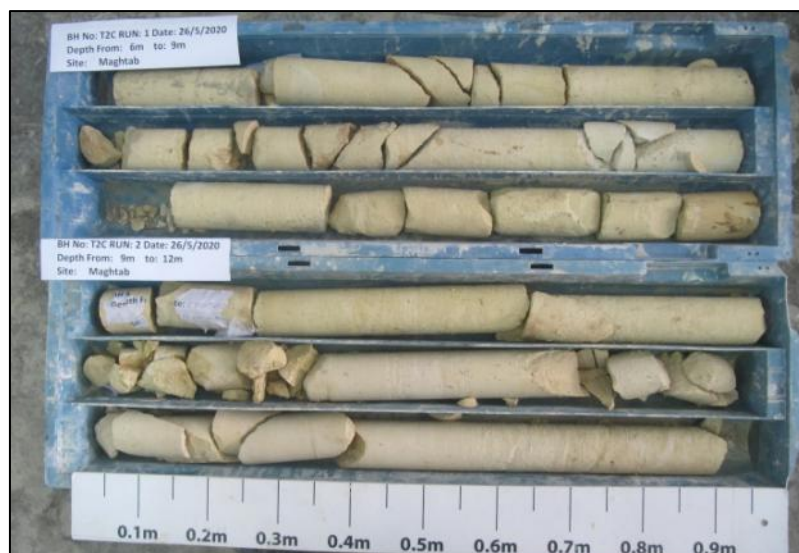
Figure 20: Photograph of Lower Globigerina Limestone core samples recovered from BHT2c Depth interval 6m to 12m below ground level

**Table 7** below shows the values of the quality of the rock cores recovered from boreholes T2A, T2B and T2C; namely the Total Core Recovery (TCR), the Solid Core Recovery (SCR), the Rock Quality Designation (RQD) and the Fracture Index (S5930:2015). Photographs of typical rock core samples of Lower Globigerina Limestone and Lower Coralline Limestone recovered are shown in Figure 20 and Figure 21.

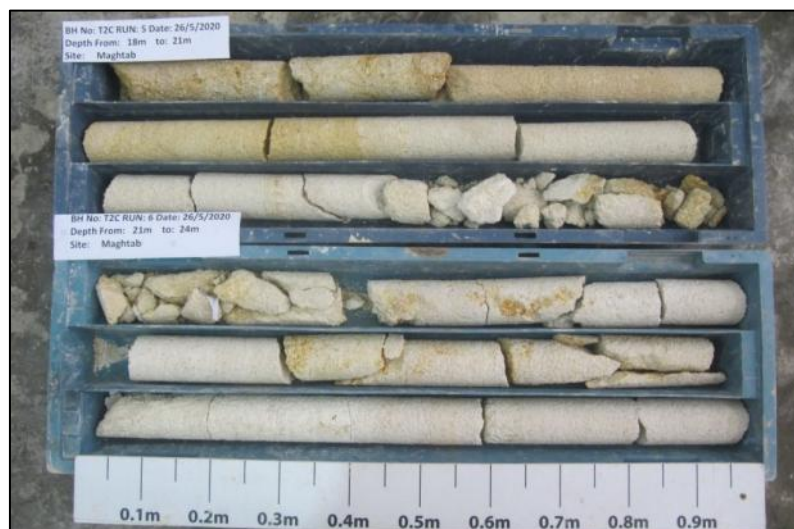
Figure 21: Photograph showing Lower Coralline Limestone core samples recovered from BHT2c Depth interval 18m to 24m below ground level

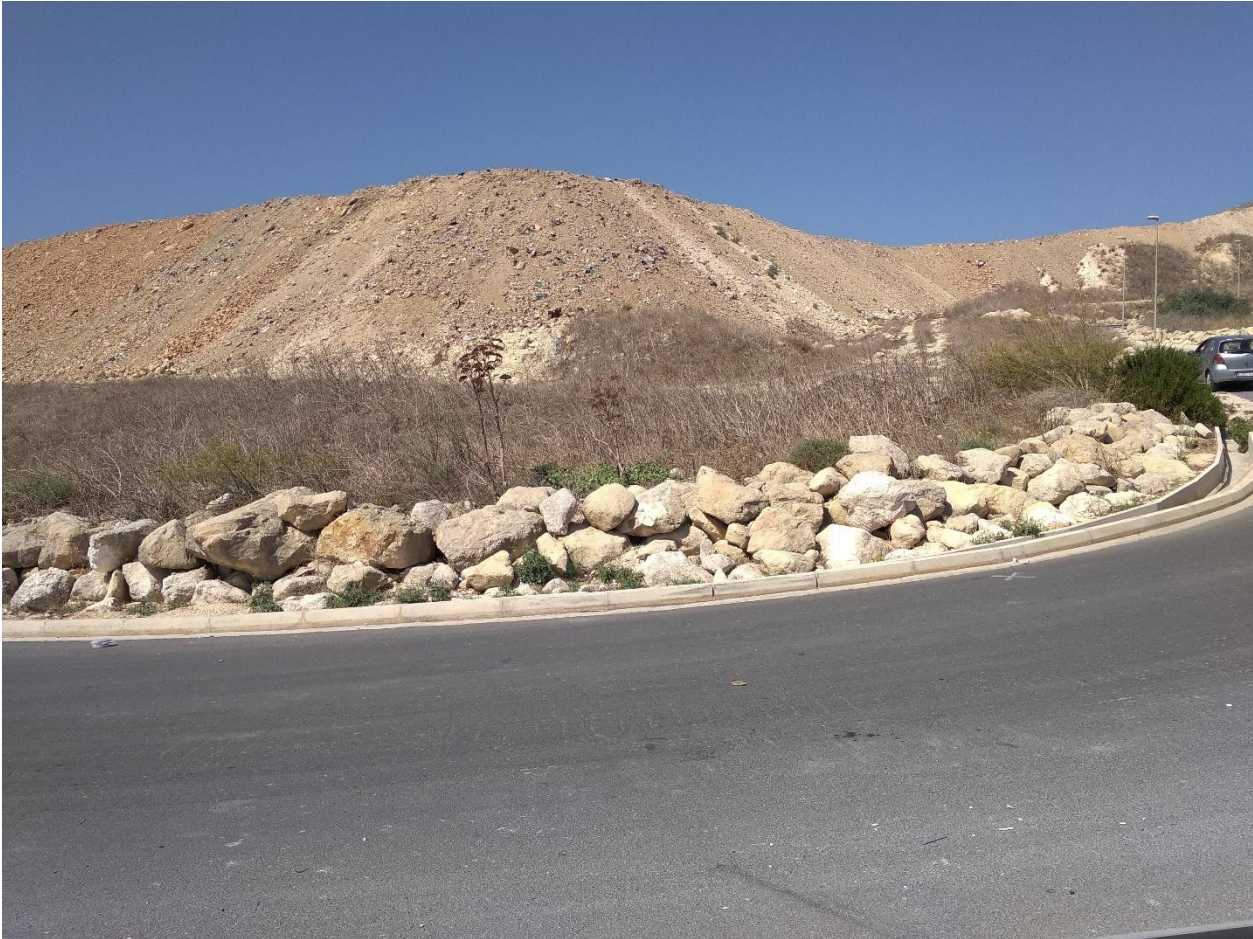
Figure 25: Freshly laid landfill composed of excavation and construction material west of the road skirting the MRF site

A road runs along the north-western boundary of the MRF site and separated the site from the freshly deposited landfill. The toe of the landfill is protected by a thick concrete gravity wall. The landfill itself is loose and its slope has assumed the natural angle of repose.

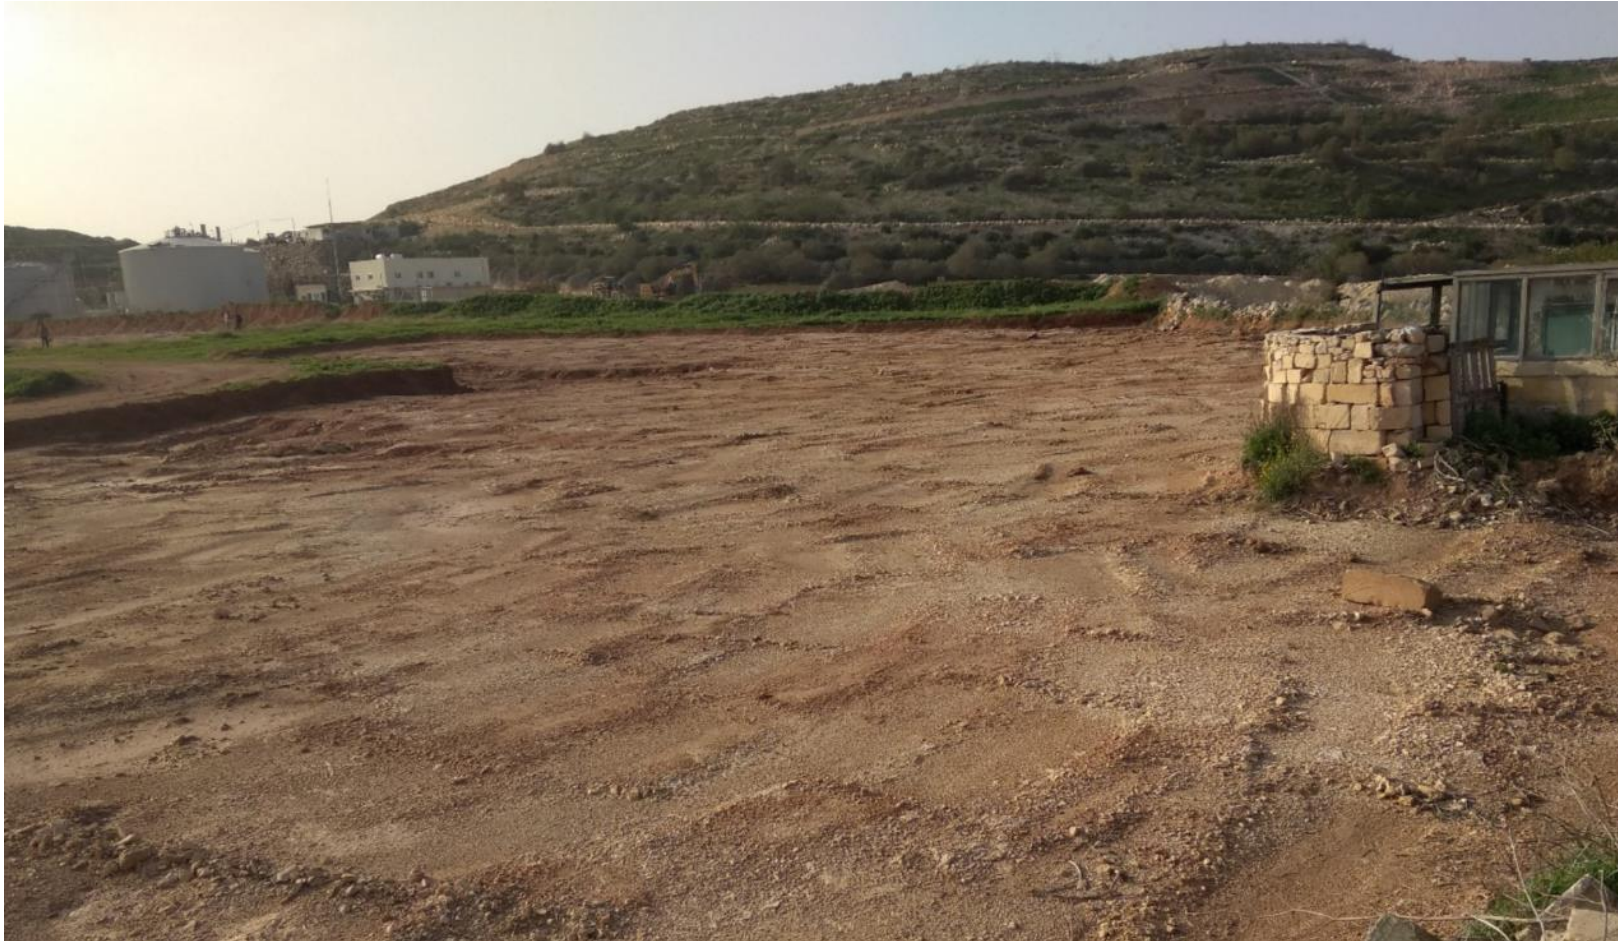
*Figure 26: View of the eastern sector of the landfill as seen from the proposed WtE site (2020). Presently this site is an excavation about 5m deep. The moderate slope of the landfill is evident*

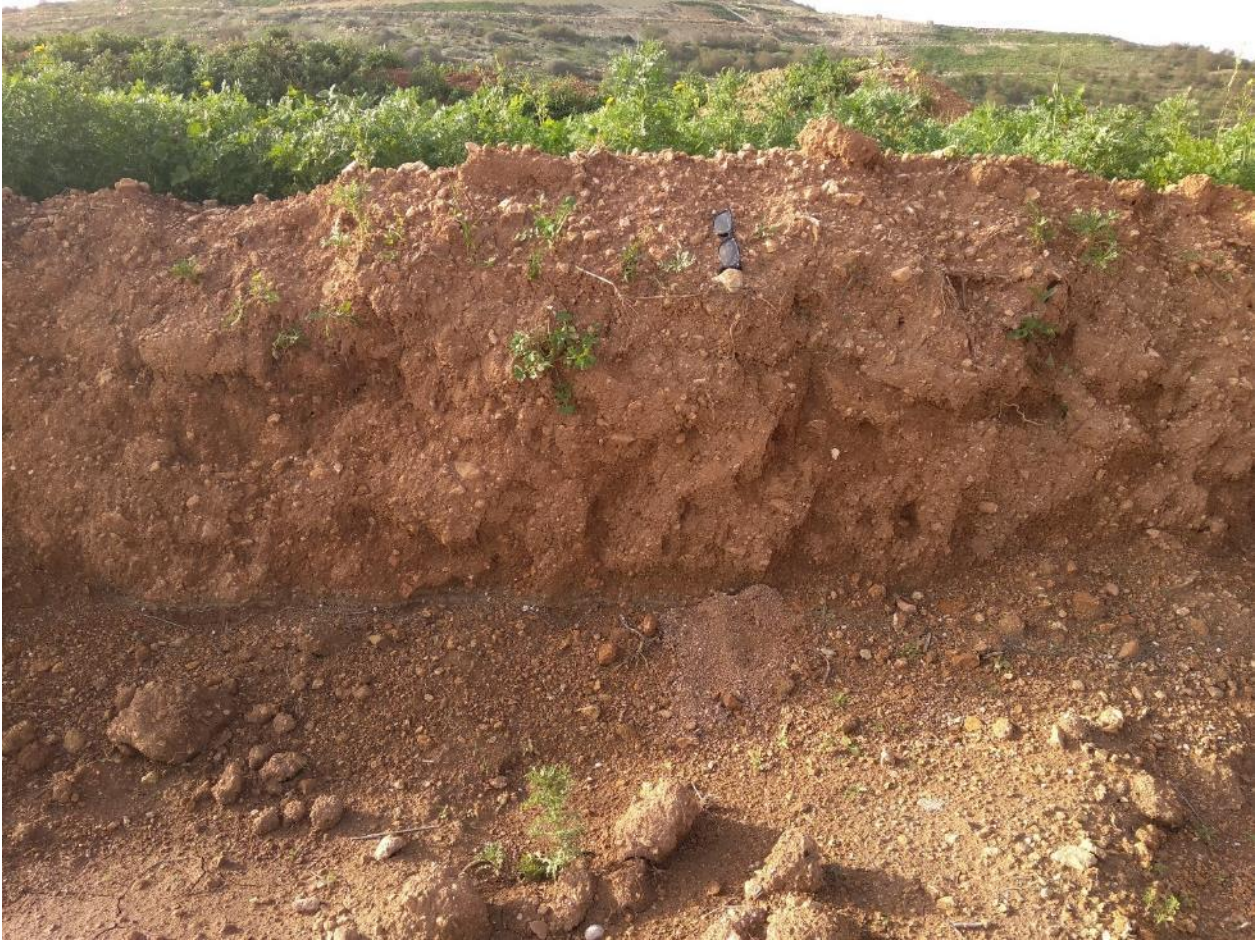
*Figure 35: Photograph of a typical soil profile at the OPP site about 0.4m thick*

Clearance of the top soil for archaeological studies in connection with the WtE site and OPP site shows that the thickness of the overburden is under 0.5m. Moreover, the topsoil is being removed for later reuse at the site. The topsoil does not present any stability hazards. The overburden does not pose any stability hazards.

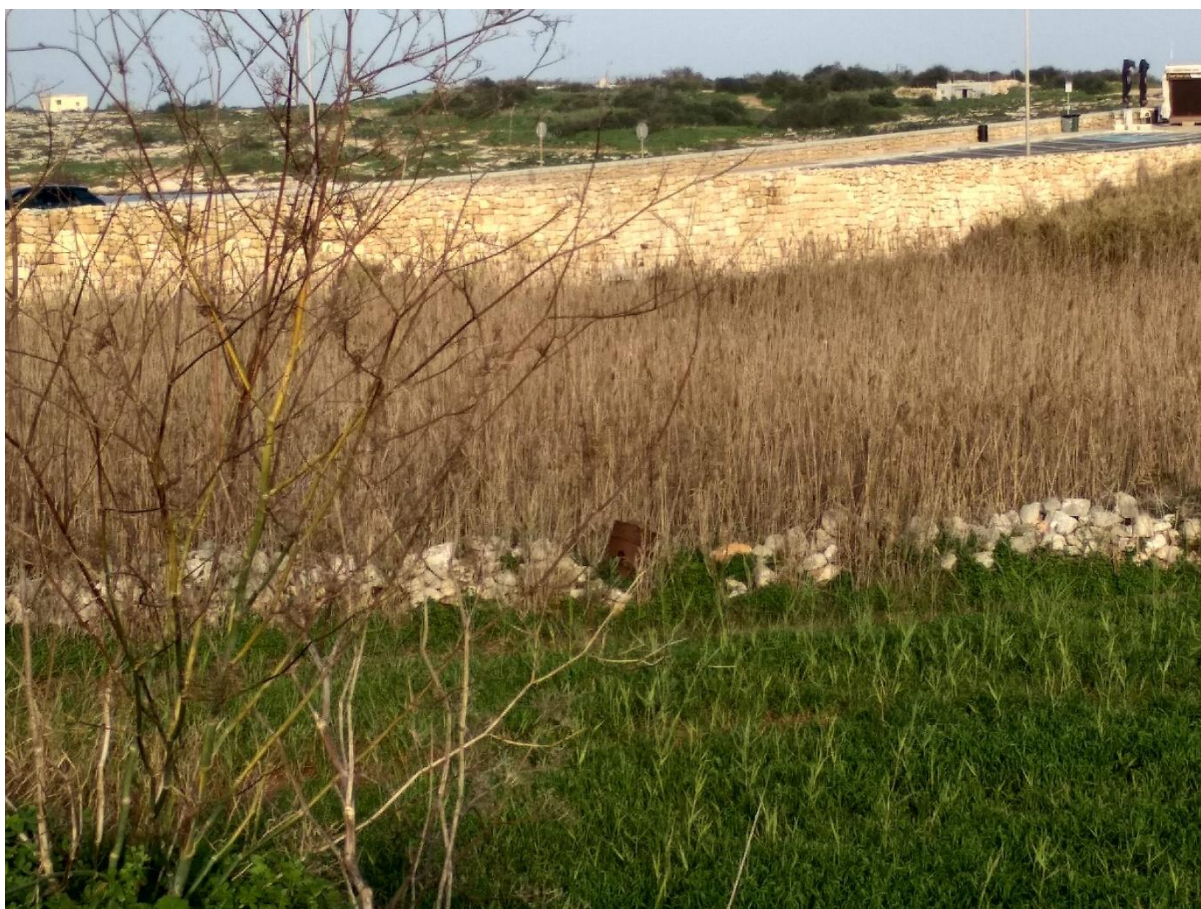
*Figure 39: Photograph showing a field along Triq Tull il-Kosta at the discharge point of Wied ta'Kieili which appears to form a temporary wetland*

A field at the discharge point of Wied Ta’Kieli is covered by vegetation usually associated with wetlands. This site behaves as a semi-permanent wetland due to temporary flooding during heavy rain events which generate runoff and water appears to linger for some time before drying or discharging at sea (Figure 39).
